LINE OF DUTY DEATH REPORT

REPORT F2021-12 • May 2025

Volunteer Firefighter Dies after Becoming Lost during a Residential Structure Fire – Pennsylvania

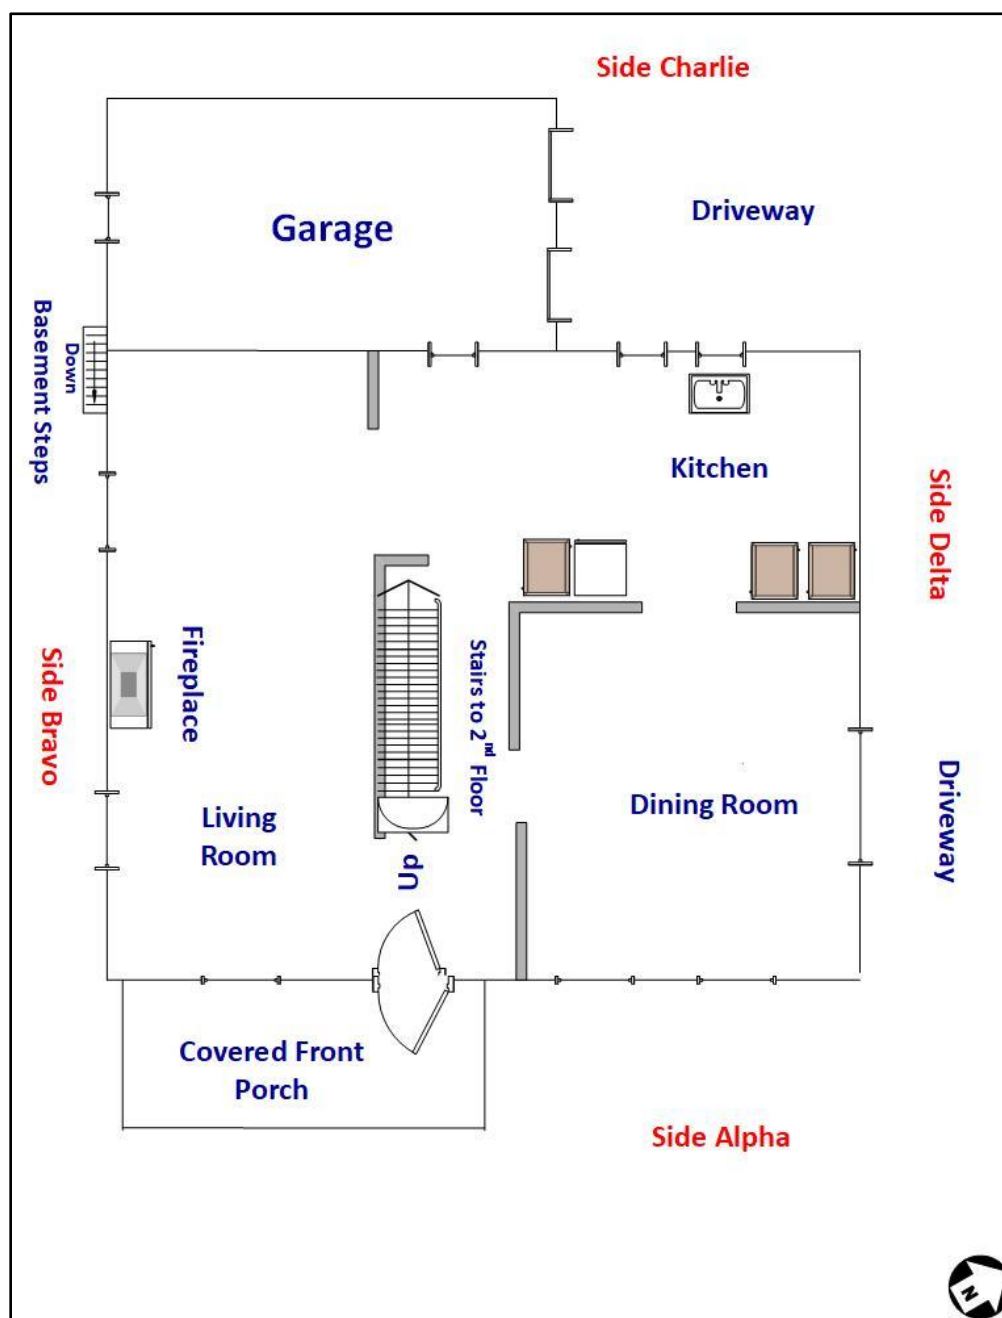
The 1st floor of the structure consisted of a living room, dining room, and kitchen (**see Diagram 1**). The 2nd floor of the structure consisted of three bedrooms and two bathrooms. There was a 2nd floor door that opened to a wooden deck off the rear of the structure (**see Diagram 2**). The basement was partially finished. A large stone masonry chimney and fireplace were located within the living room and located on Side Bravo of the house. The primary roof over the 2nd floor was a gabled style raftered-constructed roof with a half-story space. Another smaller gabled style raftered-constructed roof was located on the opposite end and consisted of a small, embedded dormer and room. The concealed roof attic space did not have a ½-story space. A single large dormer was framed into the rear roof of the ½-story space with the rear roof having a continuous roof deck.

Diagram 1. The floor plan of the 1st floor of the fire building.
(Prepared by NIOSH)

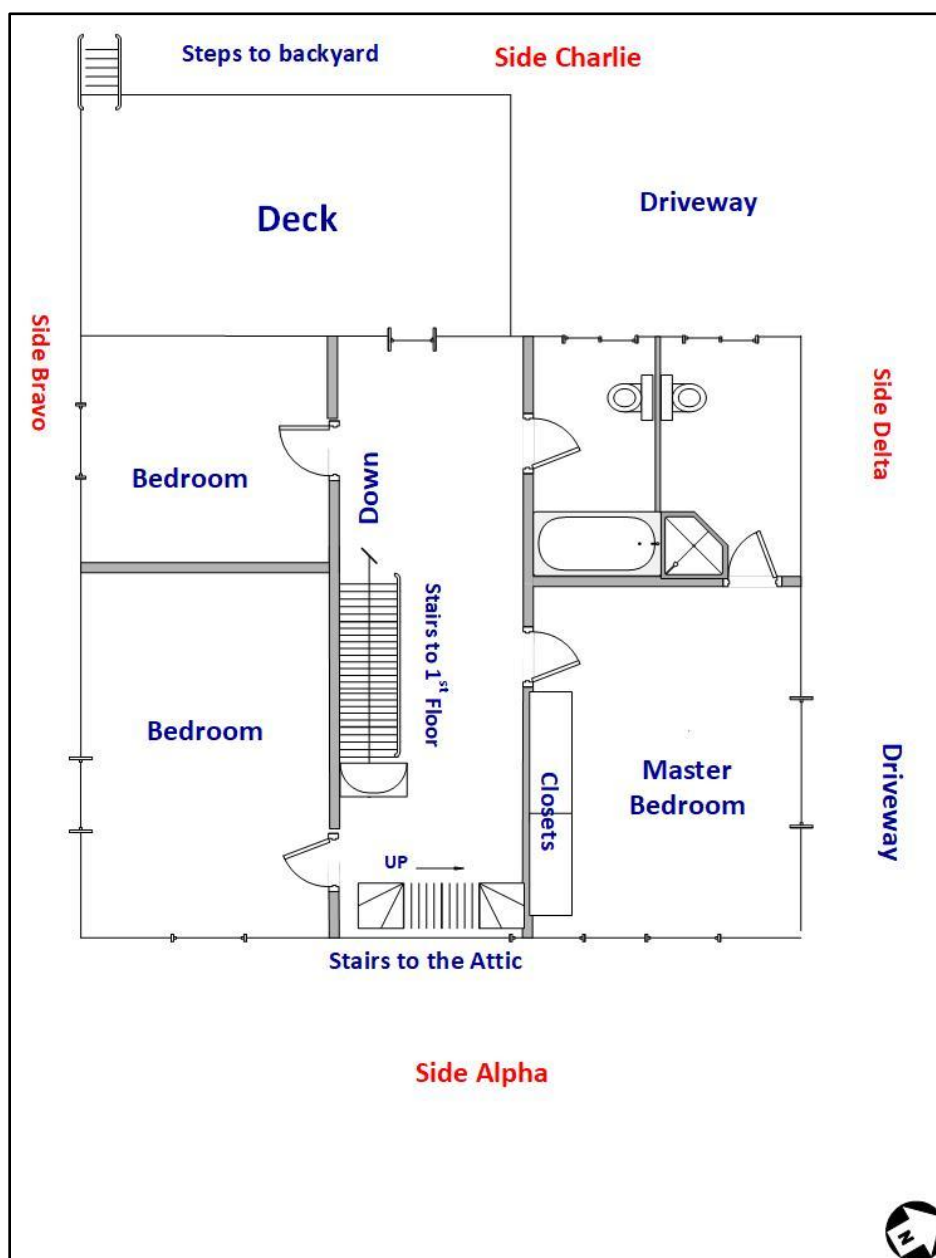
Diagram 2. The floor plan of the 2nd floor of the fire building.
(Prepared by NIOSH)
