LINE OF DUTY
DEATH REPORT

REPORT F2021-14 • June 2025

Captain Falls into the Basement and Dies While Fighting a Fire in a Large Residential Structure - Maryland**Executive Summary**

On August 11, 2021, a 46-year-old career captain died after falling into a basement while fighting a large area residential structure fire.

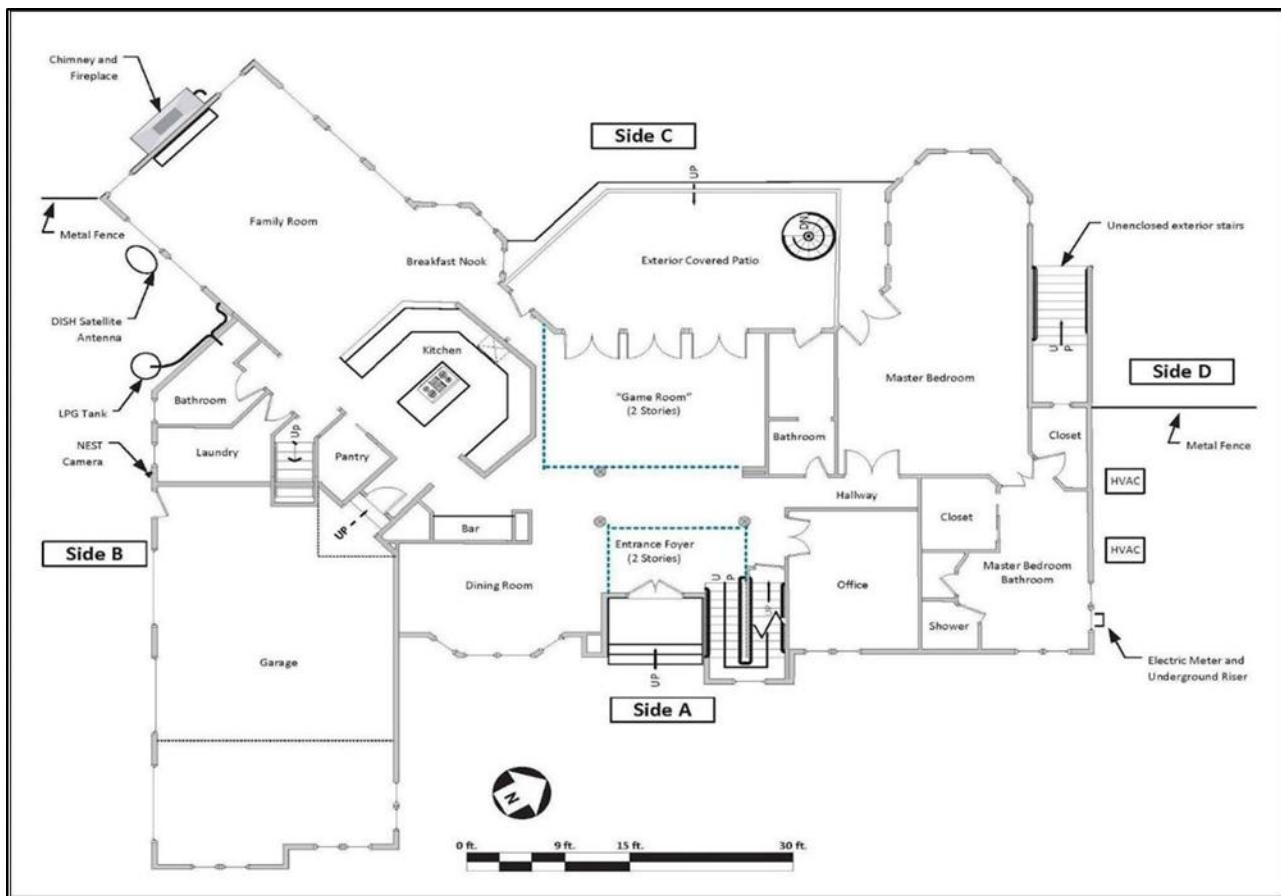
The structure had an open floor plan, built of lightweight material using engineered structural elements, which contributed to the fire load and early collapse. The structure was an unprotected wood frame construction. The first floor and exterior walls were sheathed in an external insulation finishing system (EIFS) and manufactured stone veneer (MSV). The EIFS was imitation stucco and was a one-coat system with fiberglass mesh installed over oriented strand board (OSB) panels and wooden wall studs. The MSV was imitation stone, individual pre-cast concrete stones, installed over OSB panels and wooden wall studs.

The first floor had a master bedroom with a full bath, an office, two half-baths, a dining room, a game room, a kitchen with a breakfast nook and pantry, a laundry room, a family room, garage, and exterior covered patio as shown in Diagram 2.

Diagram 2. First floor house plan.
(Courtesy of the ATF)

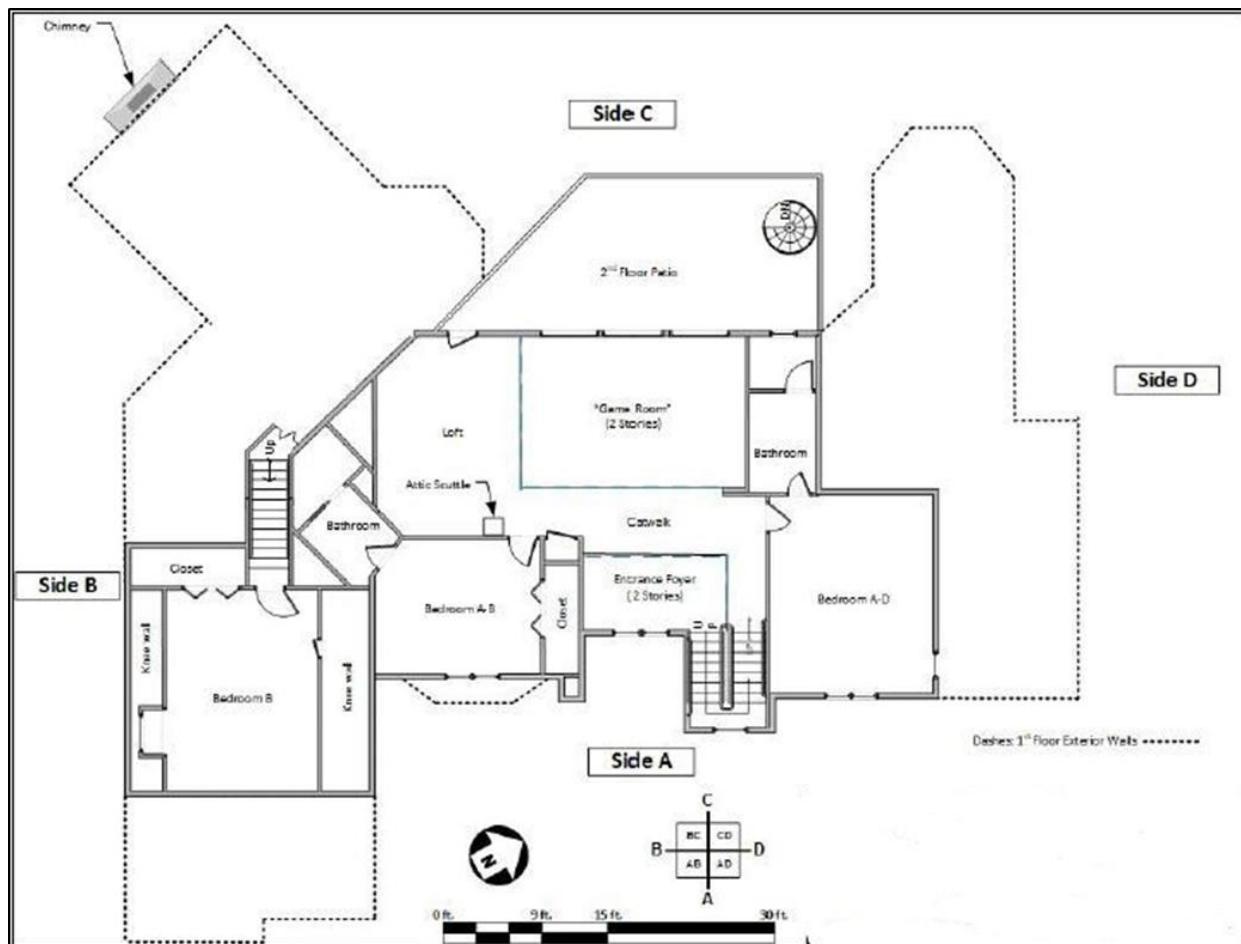
The second floor had three bedrooms and two full baths (see **Diagram 3**).

Diagram 3. Second floor house plan.
(Courtesy of ATF)
