LINE OF DUTY DEATH REPORT

REPORT 2022-01 • April 2025

Three Firefighters Die and another Seriously Injured During the Collapse of an Abandoned, Derelict, 3-story Row House Fire – Maryland

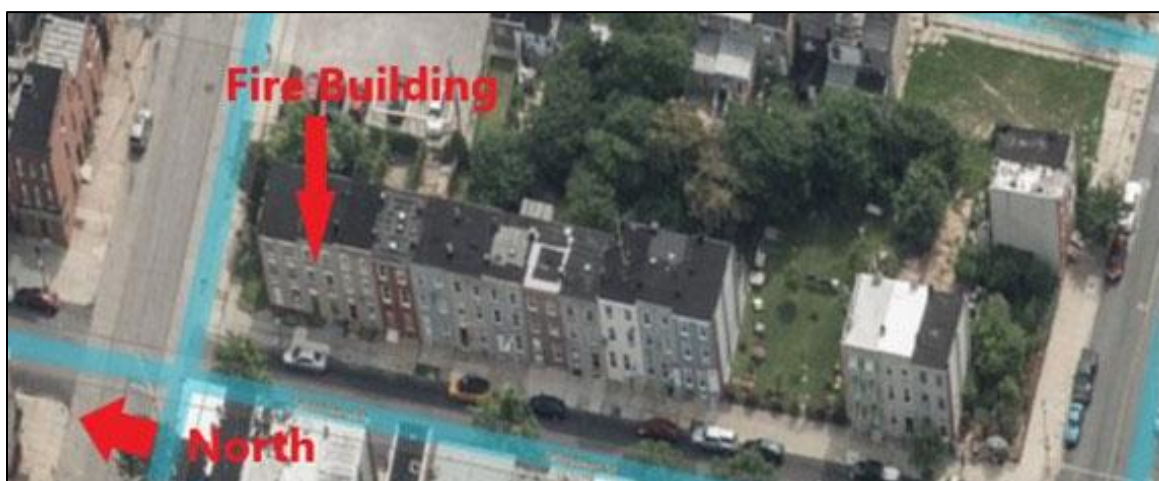
Photo 7. The site plan from an aerial view of the fire building and exposures Circa 2019.
(Courtesy of Google Earth)

The row house had not been occupied since 2008 and had fallen into a severe state of neglect and disrepair. The city's Housing Department, Code Enforcement conducted an inspection in 2010, and declared the building unfit for habitation due to deteriorated building conditions. The row house shared a wall, Side Bravo, with a three-story abandoned, derelict row house (also previously burned) and a three-story occupied row house located on Side Delta (see **Photo 7** and **Photo 8**).

There were ten occupied row house units present along the row separated by a double open-area lot, followed by three additional attached occupied row house units along this side of the street. There were 12 attached row houses that spanned the city block on the east side of the street. This arrangement is consistent with the original design and construction of the neighborhood and streets between 1880 - 1890. Similar row houses were present across the street (west side of the street) from the residence. Additionally, row houses were located on Side Charlie (rear) the structure along the adjacent city street [Naum 2024] (see **Photo 7**).
