LINE OF DUTY DEATH REPORT

REPORT F2022-10 • April 2025

Two Volunteer Firefighters Die while Conducting Fire Attack at a Single-Family Residence – Pennsylvania

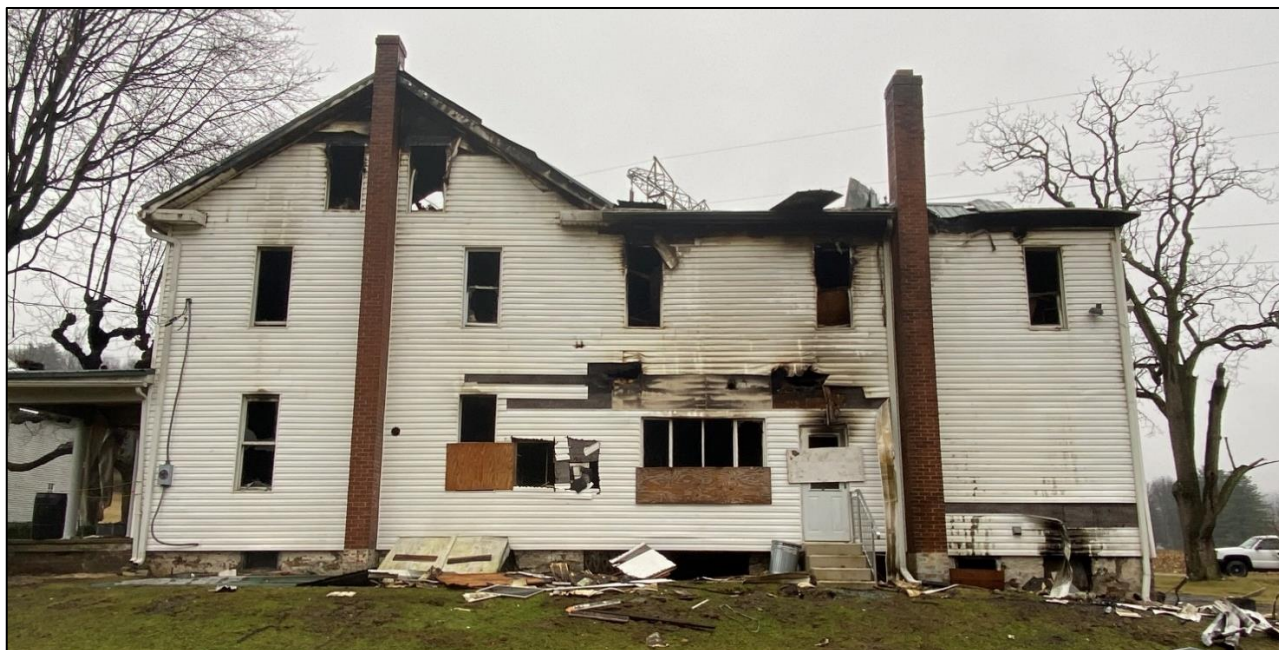
Photo 4. Side Delta. The Bilco door to the front cellar is visible.
(Courtesy of NIOSH)

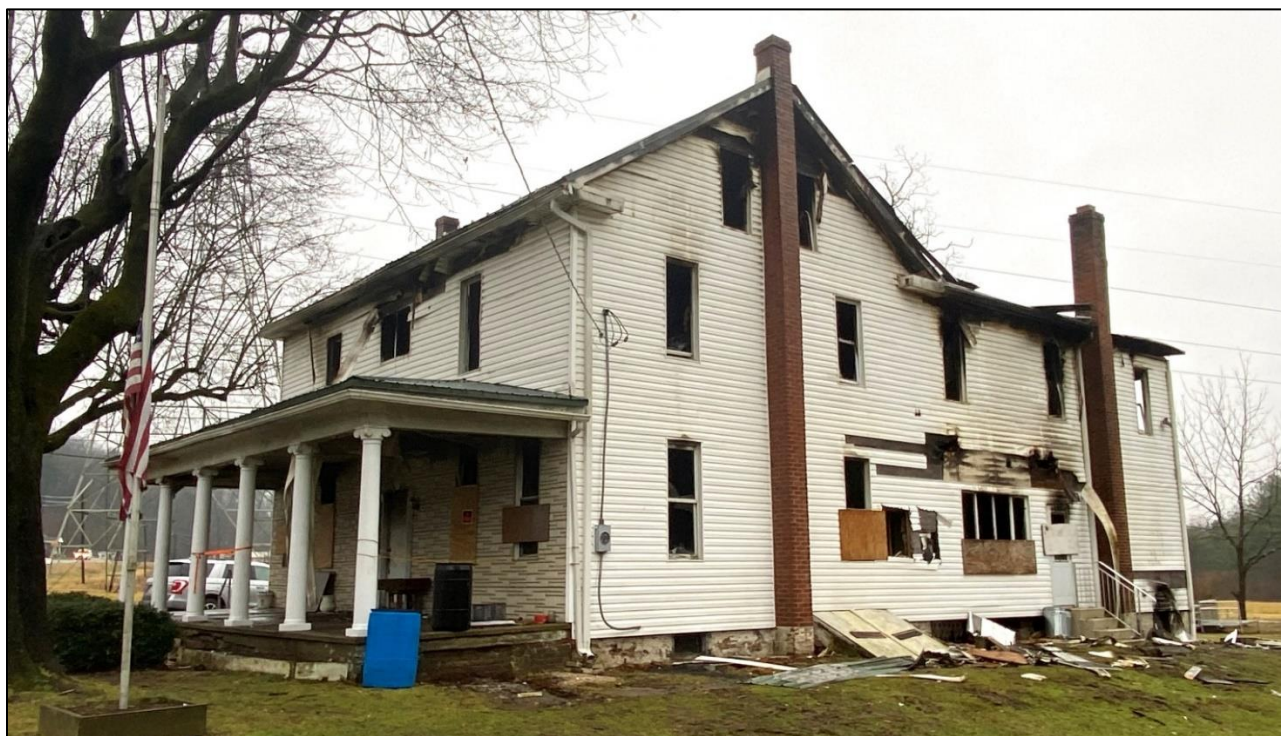
Photo 5. Sides Alpha and Delta.
(Courtesy of NIOSH)

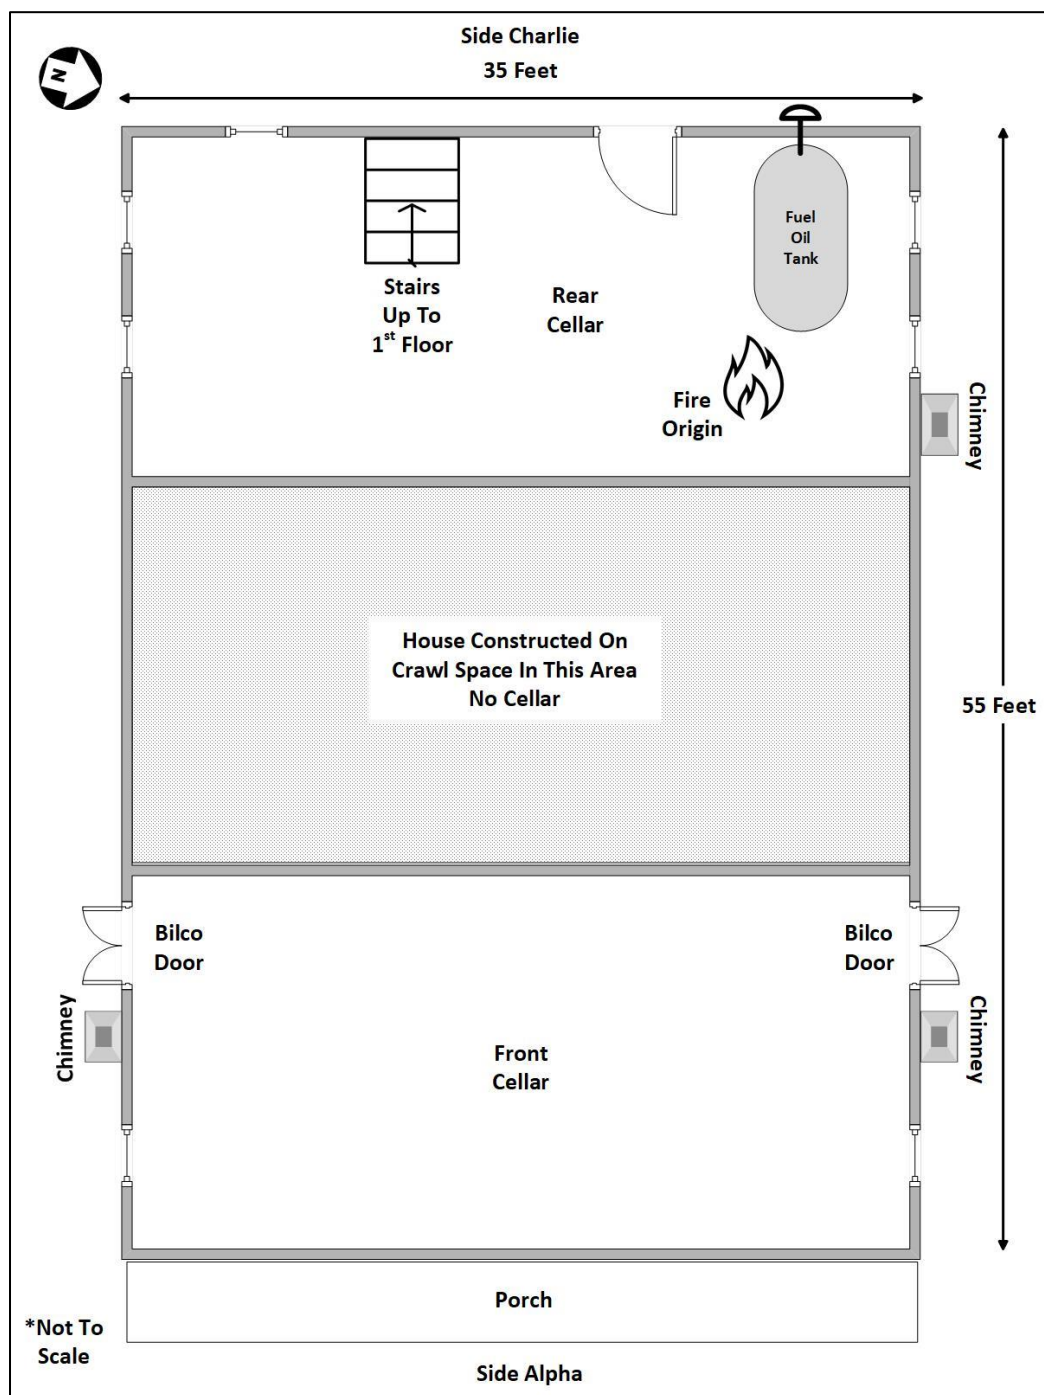
The foundation consisted of a front and rear cellar (see **Diagram 1**). The front cellar had access on Side Bravo and Side Delta via exterior Bilco doors. The rear cellar had access via an exterior door on Side Charlie and interior stairs that led to the first floor. The rear cellar had a fuel oil storage tank in the Charlie/Delta corner that served as a fuel source for the origin of the fire.

Diagram 1. Front and rear cellar layout.
(Prepared by NIOSH)

The origin of the fire was determined to be in the rear cellar, along Side Charlie of the structure. The valve of a fuel oil storage tank in the Charlie/Delta corner of the rear cellar (**see Diagram 1**) was intentionally damaged which allowed the fuel oil to flow out and onto the cellar floor where it was intentionally ignited (**see Photo 8**).

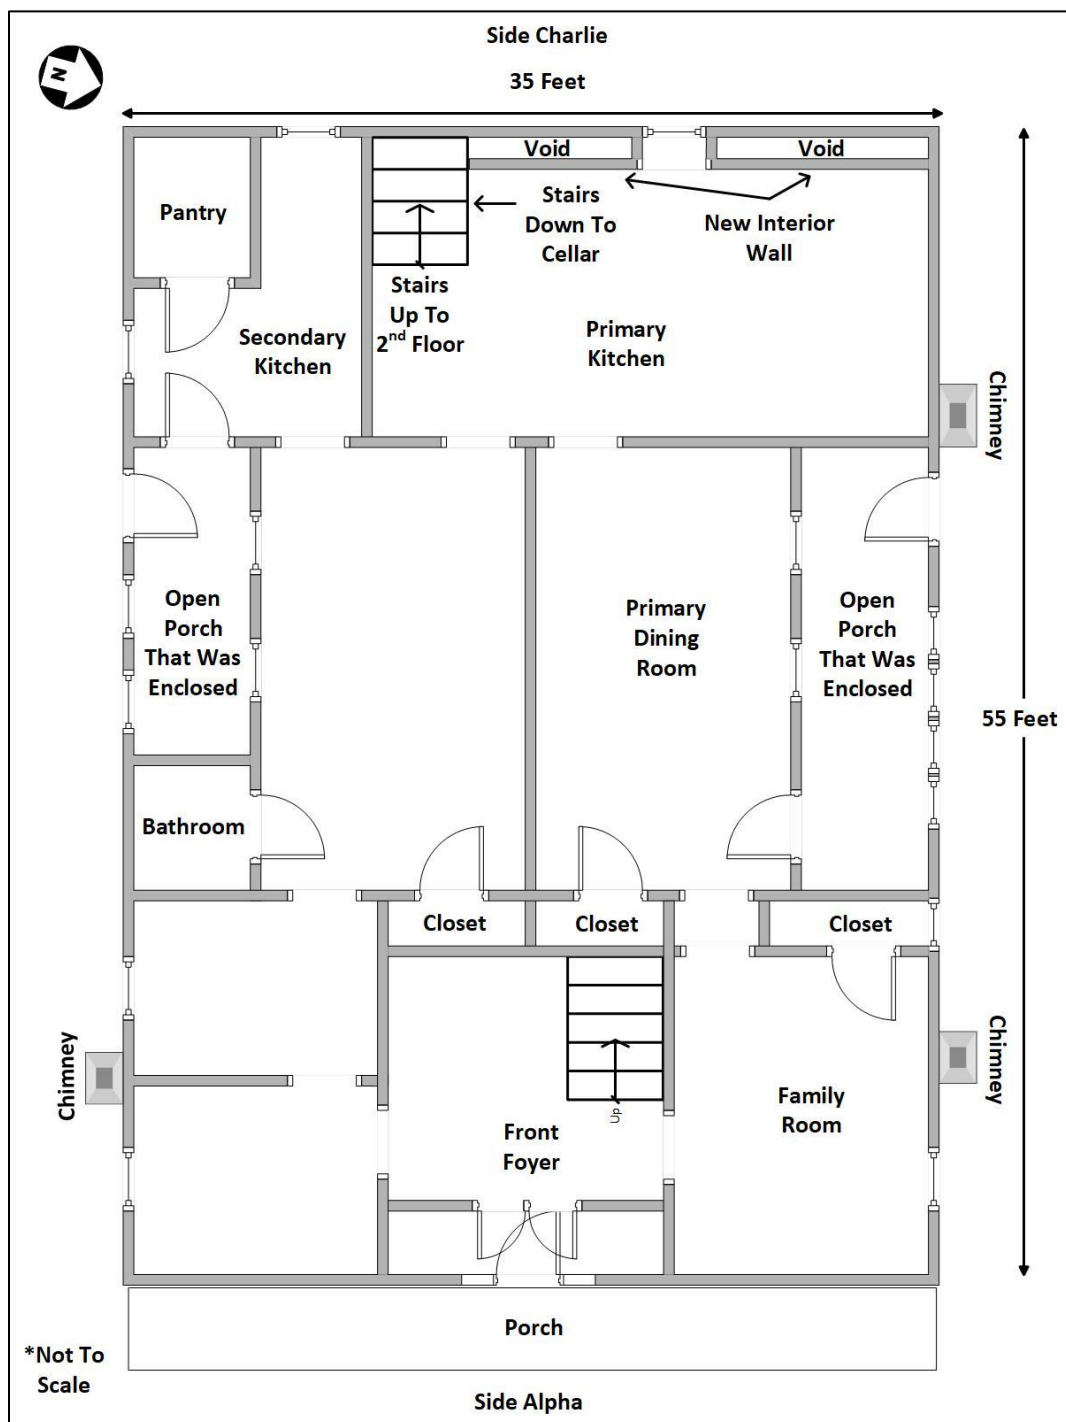
The first floor consisted of 11 primary rooms (see **Diagram 2**). There was an exterior entry door on all sides except for Side Charlie. There was a front staircase that led up to the second floor and a rear staircase that led both down to the cellar and up to the second floor.

Diagram 2. First floor layout.
(Prepared by NIOSH)

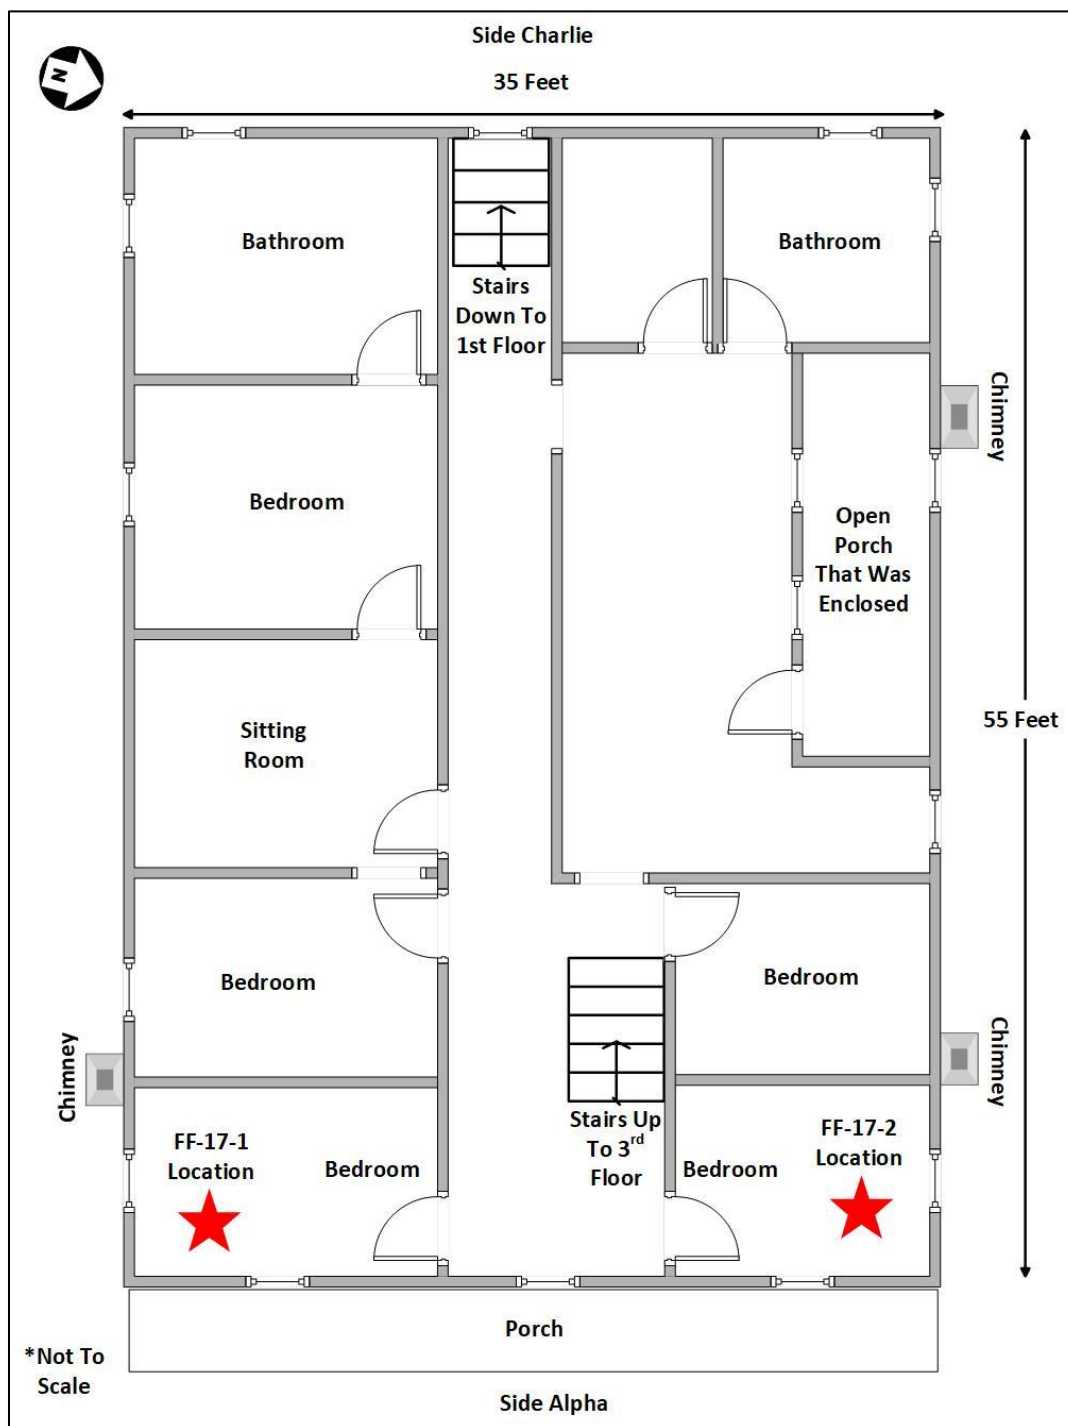
The second floor consisted of 11 primary rooms (see **Diagram 3**). There was a front staircase that led both down to the first floor and up to the half story third floor. There was a rear staircase that led down to the first floor only.

Diagram 3. Second floor layout.
(Prepared by NIOSH)
