LINE OF DUTY DEATH REPORT

REPORT F2023-11 • March 2025

Lieutenant and Probationary Firefighter Die after experiencing Thermal Degradation of Self-Contained Breathing Apparatus Facepiece Lenses – Maryland

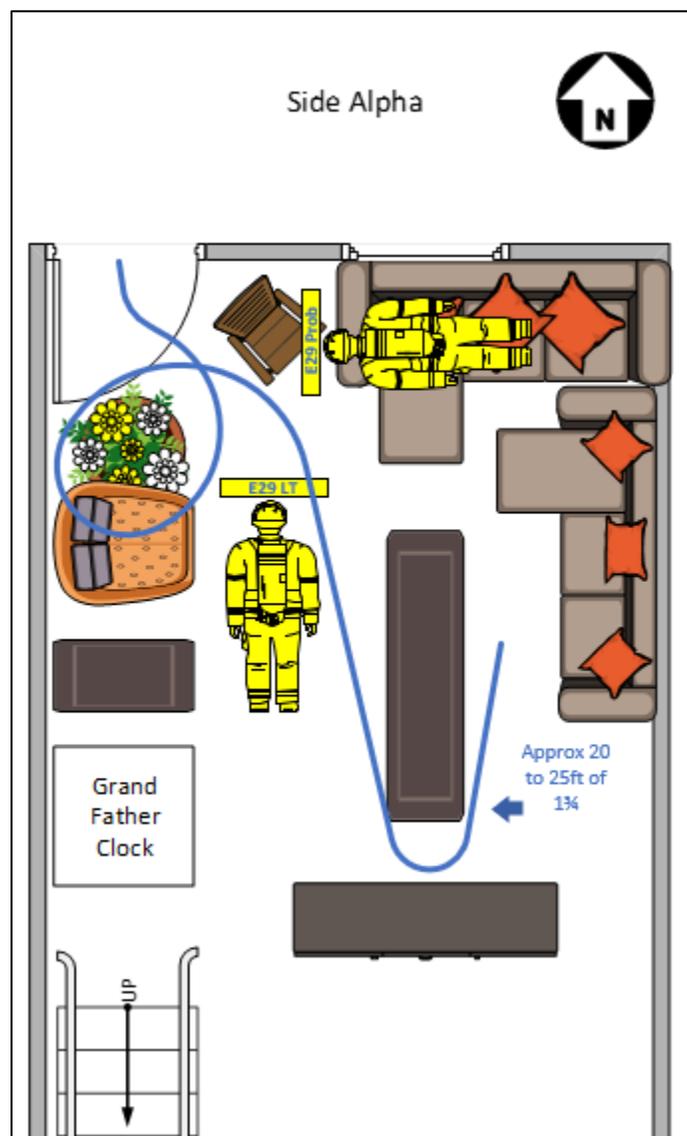
Diagram 3. Approximate location the probationary firefighter and lieutenant were located on the first floor. (Courtesy of NIOSH.)
