LINE OF DUTY DEATH REPORT

REPORT F2024-05 • March 2025

Career Battalion Chief Dies from Explosion while Fighting Tractor Trailer Fire – Georgia

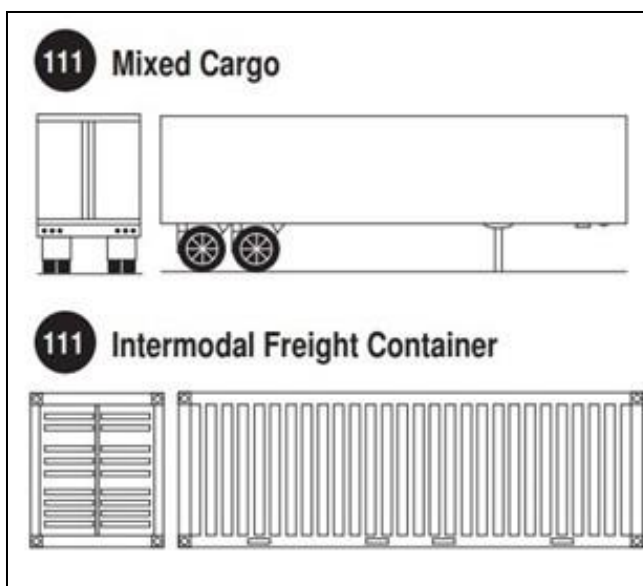
Diagram 1: Type 111 road trailers.
(Courtesy of 2024 Emergency Response Guidebook)

The vehicle involved in this incident was a tractor trailer style commercial vehicle (see **Diagram 1** and **Photo 2**). The trailer portion of the vehicle consisted of a container chassis with a refrigerated intermodal container secured to the chassis with twistlocks on all four corners of the container. The refrigerated intermodal container had a portable generator, or genset, affixed to the bulkhead of the container. The genset in this incident ran on diesel fuel and included a self-contained diesel fuel tank on the lower portion of the genset device. Based on the information provided by the UL Research Institutes team, a visual inspection of the diesel tank did not present any evidence of bulging or rupture. The container was loaded with frozen chicken.

The 2024 Emergency Response Guidebook (ERG) identifies this type of trailer as a type 111 intermodal freight container. These containers are for general freight that carry bulk or non-bulk packages. They may transport hazardous materials/dangerous goods in small packages (e.g., bags, boxes, drums) or intermediate bulk containers (IBCs), sometimes referred to as “totes”. These

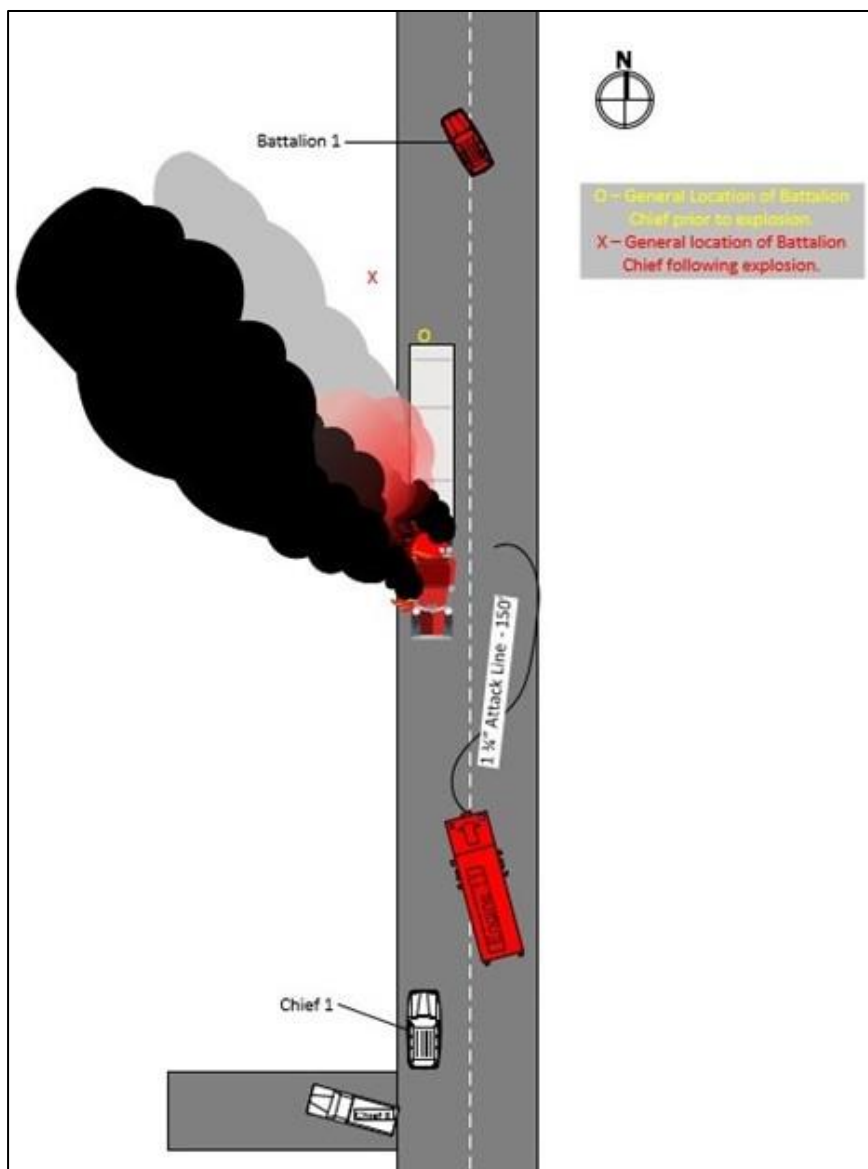
Diagram 2: Approximate locations of all on scene apparatus and attack line at the time of explosion.
(Diagram prepared by NIOSH)

At approximately 0928 hours, Battalion 1 arrived on-scene and positioned his vehicle past the involved tractor trailer on the North side, blocking the south bound lanes to close the road in that direction. Battalion 1 established command of the incident and sized the incident up as a tractor trailer fire with heavy fire involvement at the rear of the tractor including the tires and diesel fuel tanks. The fire from the rear of the tractor provided direct flame exposure to the underside of the front portion of the trailer. The fire extended up between the rear of the tractor's cab and the front of the trailer. The cargo and occupant status were unknown upon his arrival and relayed to the dispatch center. Battalion 1 provided an additional update to all responding units that there was off-gassing and fire involvement at the rear of the tractor from an unknown source. He ordered Engine 11 to stop short, South of the incident, deploy an attack line from the front bumper, and utilize foam. Engine 11 stopped approximately 100' short of the involved tractor trailer and deployed the 100' 1 3/4-inch front bumper attack line. Chief 1101, who arrived just before Engine 11, assisted with deployment section of attack line that was stored updated dispatch that they had water

At approximately 0932 hours, while investigating at the rear of the trailer, Battalion 1 updated all units on-scene that the cargo was still unknown but the rear of the trailer indicated it was refrigerated. At approximately 0933 hours, as Battalion 1 attempted to open the rear trailer doors, the trailer exploded

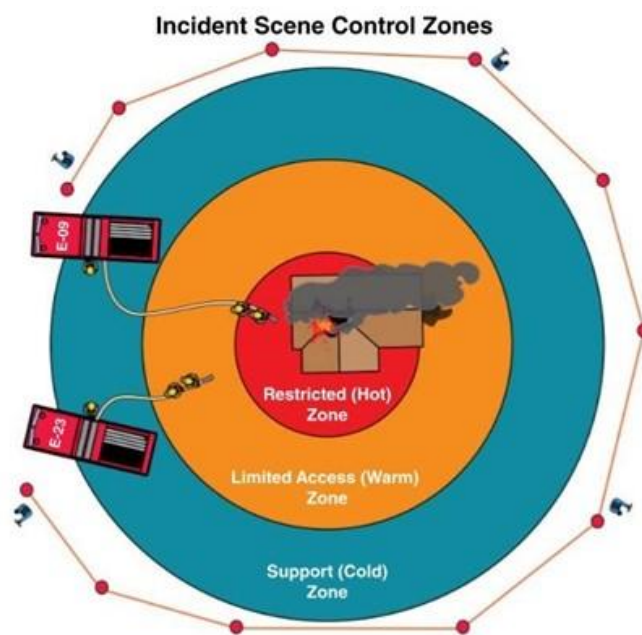
Diagram 3: Incident Scene Control Zones 1.
(Courtesy of International Fire Service Training Association)

Discussion: NFPA 1550, chapter 18.3.1.4, states the IC should have the responsibilities and duties of all unassigned incident command system positions. In organizations where personnel are not plentiful and arriving early at incidents, this creates a situation in which task oversaturation for the IC can happen quickly. NFPA 1550 chapter 5 states the Incident Safety Officer (ISO) role is a position within the ICS at an incident or planned event that is charged with ensuring action is taken to mitigate any immediate life safety threats. Within the scope of the ISO position is the necessity to determine hazardous incident conditions and advise the IC to establish or modify control zones at any given incident. These control zones must be communicated to on-scene personnel and entry into the hazardous area must be controlled by the ISO as specified in chapter 5 of NFPA 1550. These actions require the ISO to possess comprehensive knowledge of hazardous conditions, operations, departmental SOPs/SOGs, control zones protocols, and the IMS. An ISO also needs to be able to evaluate the effect of proximity for incident hazards so that risk to members will be limited to emergency responders assigned tasks to mitigate the incident (i.e., in the hot zone) [NFPA 1550 2024].

In this incident, the IC applied various techniques that fell under responsibilities of an ISO. He ordered Engine 11 to stop short of the affected vehicle, placing it outside of the hazard zone. He applied the process outlined in the department SOGs and attempted to locate the driver as well as determine if the cargo was considered a hazardous material. The IC also communicated all other hazards noticed during his ongoing investigation of the incident including that there was something off-gassing at the rear of the tractor and that the trailer was refrigerated.

Recommendation #5: ICs should establish control zones on incidents where IDLH environments exist.
