HETA 86-092-1870
FEBRUARY 1988
50 STANIFORD STREET OFFICE BUILDING
BOSTON, MASSACHUSETTS

NIOSH INVESTIGATOR:
John R. Kominsky, M.Sc., CIH

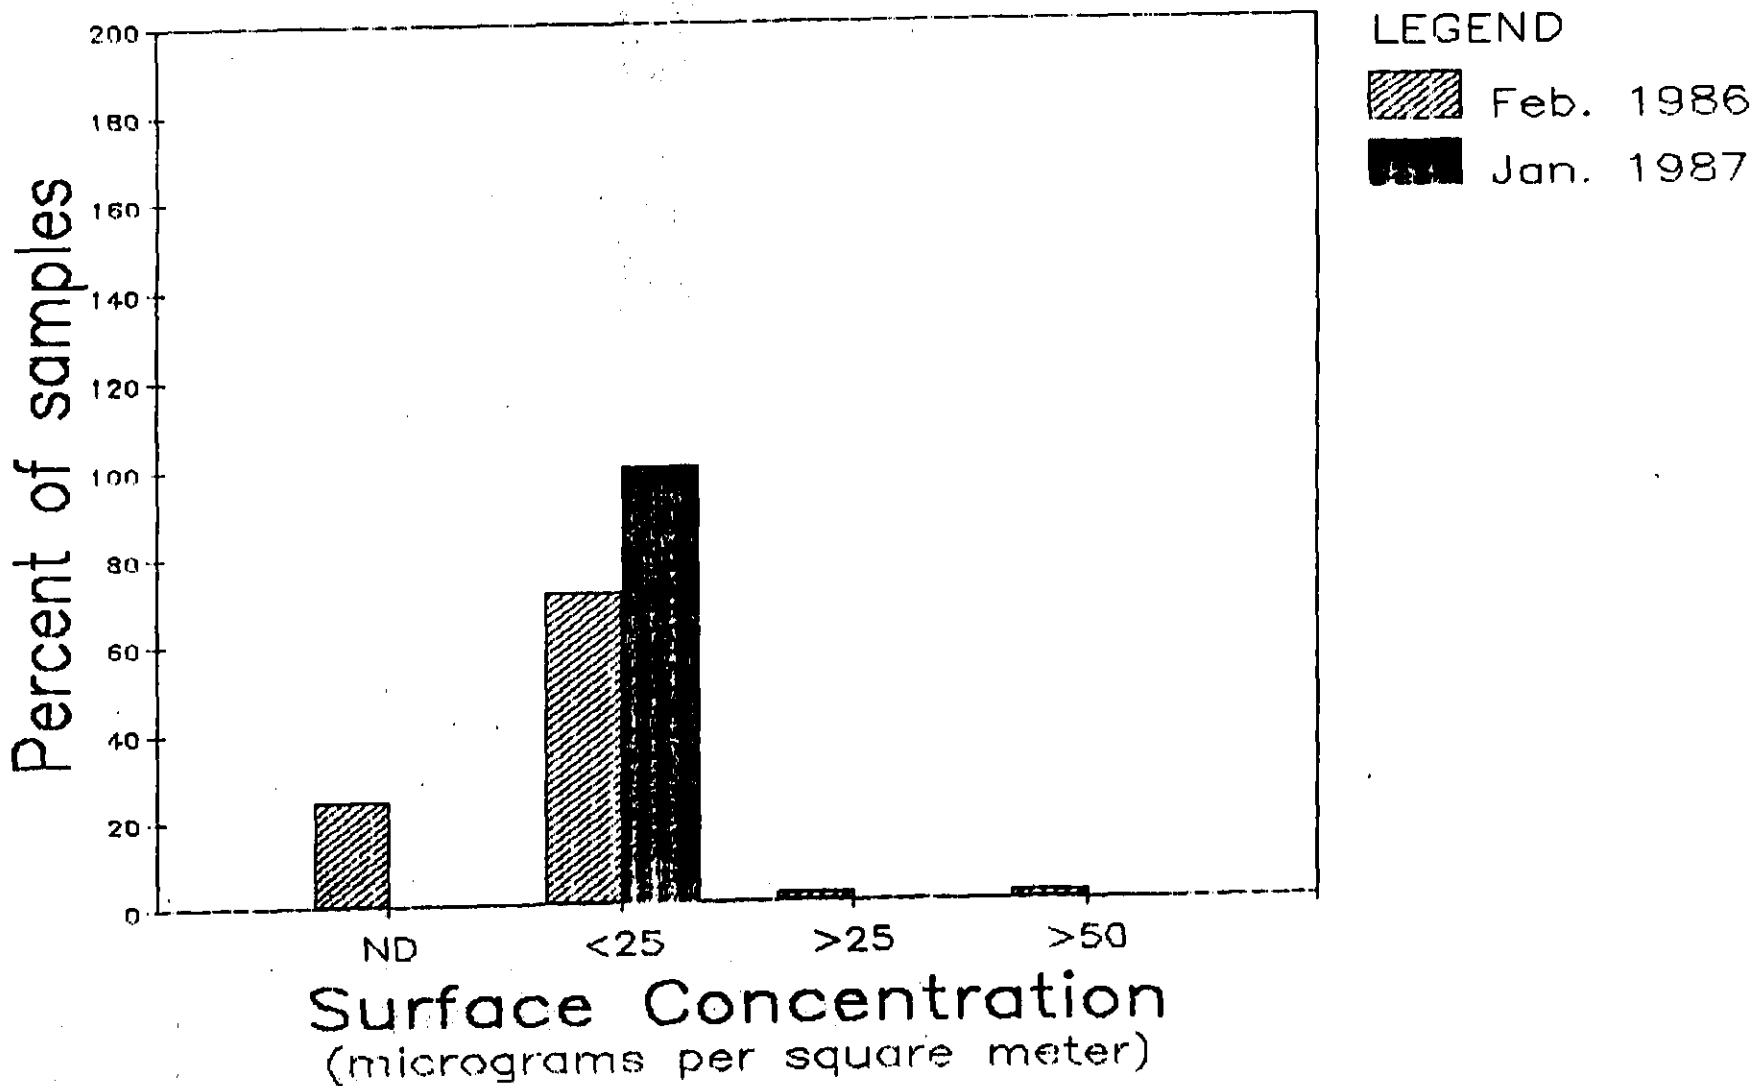
FIGURE 8
PCB Surface Concentration Frequency Distribution
Interior HVAC System Samples
50 Staniford Street Office Building, Boston, MA

A total of 58 wipe samples (Tables 1 and 2) were collected on interior HVAC system surfaces for PCB analysis. The results are summarized in Table 4. Figure 7 shows that approximately 19% (11/58) of the samples were none-detected; 78% (45/58) contained measurable concentrations of <25ug/m²; 2% (1/58) ranged from 25 to <50 ug/m²; and 2% (1/58) exceeded 50 ug/m². All of the samples showed concentrations below the 50 ug/m² guideline, except one. This sample (88 ug/m²) was collected in February 1986 on the exterior fresh air intake louvers above the South entrance to the building. The louvers and supply air ventilation duct were cleaned by the contractor. The followup testing conducted in January 1987 (Table 2 and Figure 8) show that all HVAC system surfaces are within the guidelines.
