HETA 98-0300-2723
Dollar General Store
Prestonsburg, Kentucky

Health Hazard Evaluation Report 98-0300-2723
Dollar General Store
Prestonsburg, Kentucky
February 1999

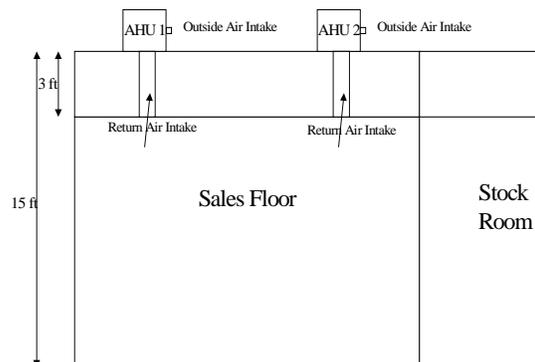
Figure 1: Dollar General Store, Prestonsburg, Kentucky

Ventilation to both the sales area and stock room (Figure 1) is provided by two package rooftop air handling units (AHUs). Supply air (SA) is provided to the sales area and stock room via ceiling level diffusers. OA is obtained from intakes on the side of each AHU. Intake grilles (one per AHU) located in the ceiling of the sales area are connected by ductwork to the AHUs and serve to convey RA back to each unit. The mixed air (RA & OA) passes through filters and then the cooling coils or heaters prior to being distributed to occupied areas. OA dampers are controlled by economizers designed to allow more OA into the system if outside conditions are favorable, and less if conditions are unfavorable.

The interior of the supply ductwork was not accessible and was not inspected. Dollar representatives indicated the interior of the ductwork is not lined. The two rooftop AHUs were clean and the filters had been recently replaced. Condensate pans appeared to be draining properly and there was no standing water in the pans. One of the condensate drain pan PVC pipes was broken, and water was discharging away from the roof drain. There was no obvious source of contaminants near the OA intakes. During the AHU inspection, contract ventilation maintenance was being conducted that included cleaning the coils with an acid-based cleaner followed by treatment with a commercially available encapsulant. (1st Strike MicroCoat®, Controlled Release Technologies). This work was being

1. Continue to work with the HVAC manufacturer and service provider and implement modifications that may impact the odor problem. These include the planned replacement of the existing cooling coil system. Additionally, an experienced ventilation firm should be utilized to conduct a complete inspection of the HVAC system, including the interior of the supply and RA ducts. The integrity of the pressurized components of the system (coils, evaporator) should be verified. Any identified problems should be corrected. Repair the broken condensate drain pipe.
