Evaluation of dampness-associated respiratory symptoms with relocation of staff during remediation of an elementary school

*Rachel Bailey, DO, MPH
Ju-Hyeong Park, ScD, MPH, CIH
Rena Saito, PhD
Kathleen Kreiss, MD
Jean Cox-Ganser, PhD*

Health Hazard Evaluation Report
HETA 2009-0172-3124
North Carolina
March 2011

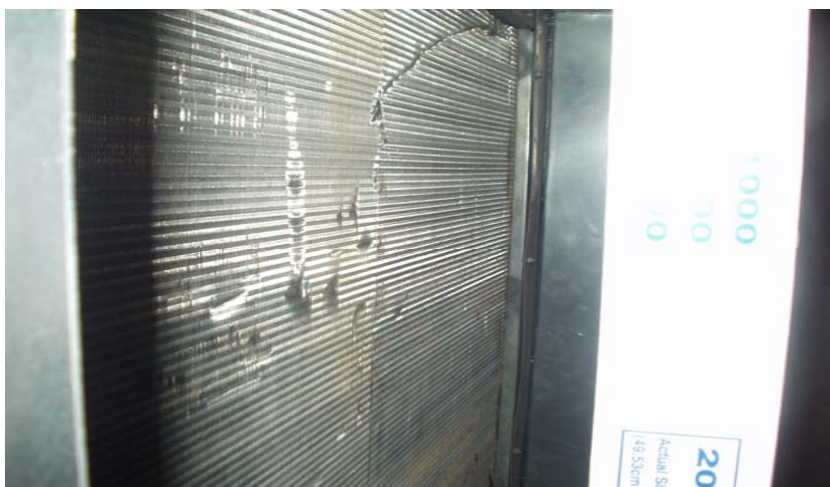
CLEANED COILS
