Evaluation of Environmental Controls at a Homeless Shelter (Trinity Rescue Mission) Associated with a Tuberculosis Outbreak – Florida

Report No. 2012-0265-3183
July 2013

U.S. Department of Health and Human Services
Centers for Disease Control and Prevention
National Institute for Occupational Safety and Health

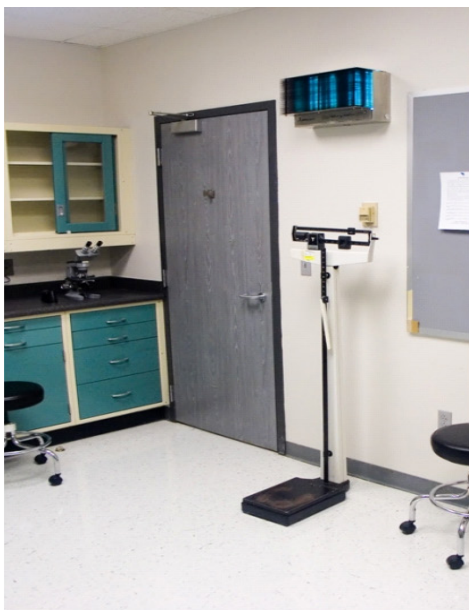
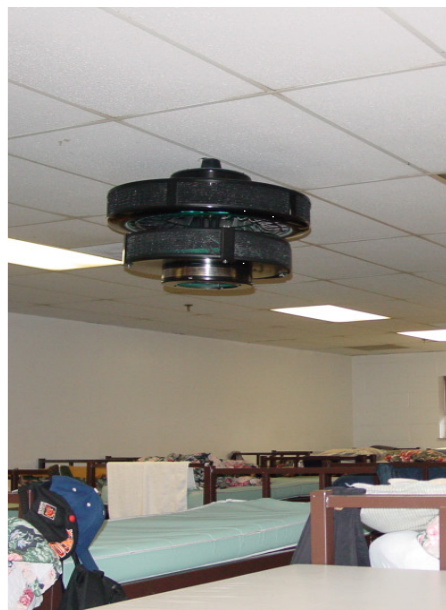
In congregate settings typical in homeless shelters and healthcare facilities, upper-room UVGI systems (often called upper-air systems) are often used to interrupt the transmission of airborne infectious pathogens within the occupied spaces themselves. Upper-room UV lamp fixtures are suspended from the ceiling and/or mounted on walls at a minimum height of 7 feet above the floor (Figure 2) [Riley and Nardell 1989; Brickner et al. 2003; NIOSH 2009; ASHRAE 2011, 2012]. Lamps are shielded to direct radiation upward and outward to create an intense zone of UVC in the upper portion of the room while minimizing UVC levels in the lower occupied spaces. These fixtures inactivate airborne microorganisms by irradiating them as air currents move them into the path of the UV energy. Some upper-room lamp fixtures utilize small fans to enhance air mixing (right photograph in Figure 2) [First et al. 1999a,b; CDC 2005b; NIOSH 2009; ASHRAE 2011, 2012]. The overall effectiveness of upper-room UVGI systems improves significantly when the space is well mixed [Riley and Nardell 1989; Brickner et al. 2003]. Although convection air currents created by occupants and equipment can provide adequate air circulation in some settings, mechanical ventilation systems and/or ceiling fans that maximize air mixing are preferable. Floor fans can also be placed in the room to ensure adequate mixing.

Figure 2. Typical upper-air UVGI installations: Left–Wall-mounted fixture with louvers installed in a health clinic; Right–Ceiling-mounted fixture with a fan installed in a homeless shelter.
