AFFIDAVIT
DESCRIBING UNMONITORED AIRBORN EXPOSURES OF URANIUM
AT
NUCLEAR METALS, INC., WEST CONCORD, MASSACHUSETTS

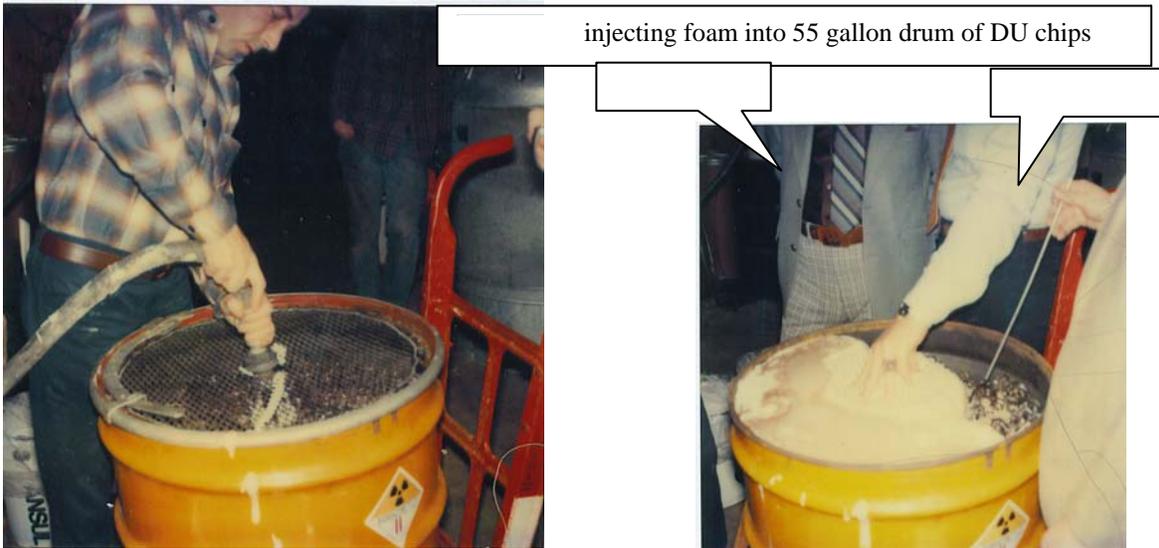
foam, the drums were capped and placed in the heating test rig shown in the photo. This rig would apply a strike anywhere match shipping standard to the package. Specifically, the package would need to withstand an internal temperature of 170-180 °F for eight hours without auto ignition.

passed this standard. However, there were several occasions after power was turned off when the internal temperature of the package continued to rise. At a time of approximately 16-24 hours into the test the package would auto ignite or explode. Explosions were attributed to accumulated hydrogen from water dissociation.

These fires would cause the Type K thermocouples to melt even though they had an upper temperature limit of 1900 °F. In addition, prodigious amounts of smoke were generated. You can see from the photo that there was no provision for ventilation of the test area. The control area where we used recorders to track package temperature was located about 10 feet from the test pit.

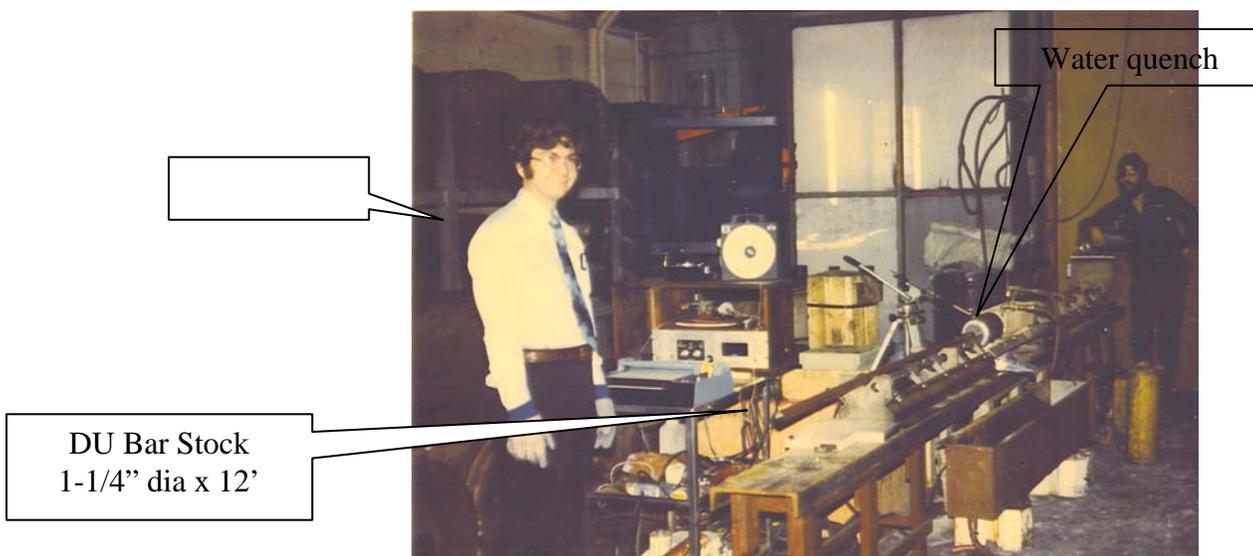
Additional Supporting Documentation: Photograph of heat treatment activity

water quench large diameter uranium bars. This required to feed the rod at a controlled rate of 15-18" per minute through an induction-heating coil that would raise bar temperature to approximately 1550 °F. At this temperature the bar glowed red hot and quickly oxidized on the surface. The rod was continuously rotated and fed into a quenching water can that sprayed water on the bar to quickly cool it to room temperature.

The feed mechanism of this rig would become unstable as the soft rod would bend. Since it was rotating, this bent bar would lift the induction coil and quench can that would short out the induction coil and spray us with water contaminated with uranium oxides.

These experiments were conducted near where the 1400-ton extrusion press abutted the foundry in Building C. This was so we could tap into the power supplies of one of the 100 kW motor generators for our induction coil. This, and other project photos provides further evidence that was a involved in and had first hand knowledge of the exposures reviewed in this petition. was not pleased when would come home all soiled from these experiments.

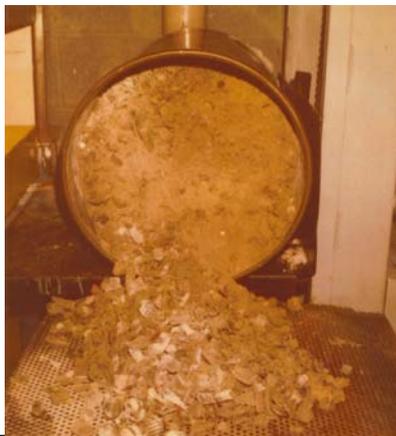
Initial inspection of 55 gallon drum scrap. Waste composed of sand, uranium bullet fragments and aluminum sabots.

There was no significant ventilation of the work area and we did not wear respirators or PAMs. My exposure to uranium dust was unmonitored. From what I recall of this activity I was exposed to unknown quantities of contaminated dust with a high likelihood of inhalation and ingestion. I passed away several years ago.

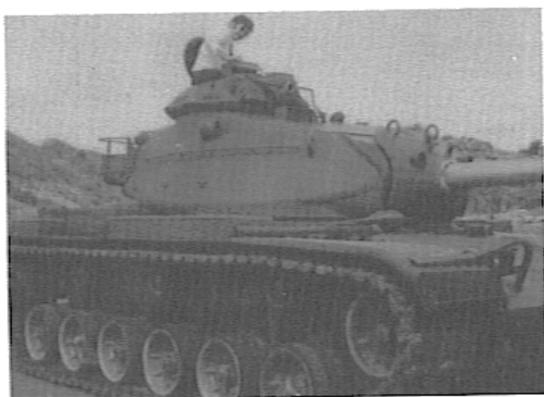
Uranium impact target photo inspection. One of many in my collection.
