**IN-DEPTH SURVEY REPORT OF CARBON MONOXIDE EMISSIONS
AND EXPOSURES ON EXPRESS CRUISERS UNDER VARIOUS
OPERATING CONDITIONS**

January 2006

EPHB 289-11a

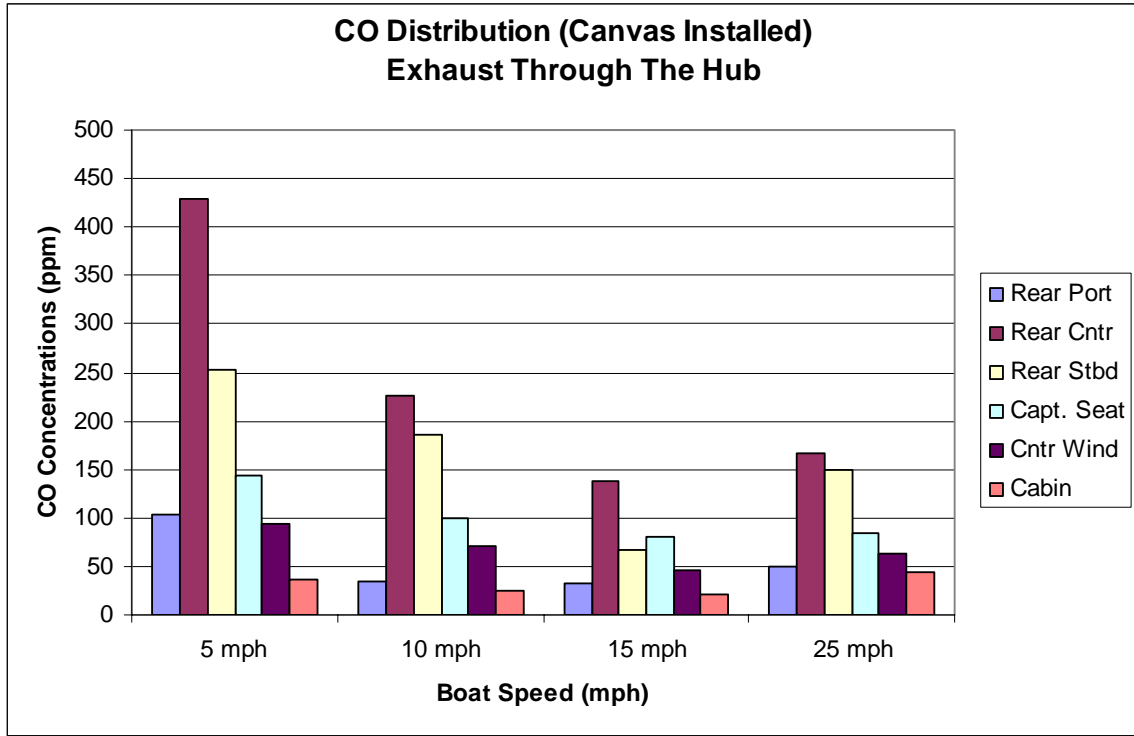
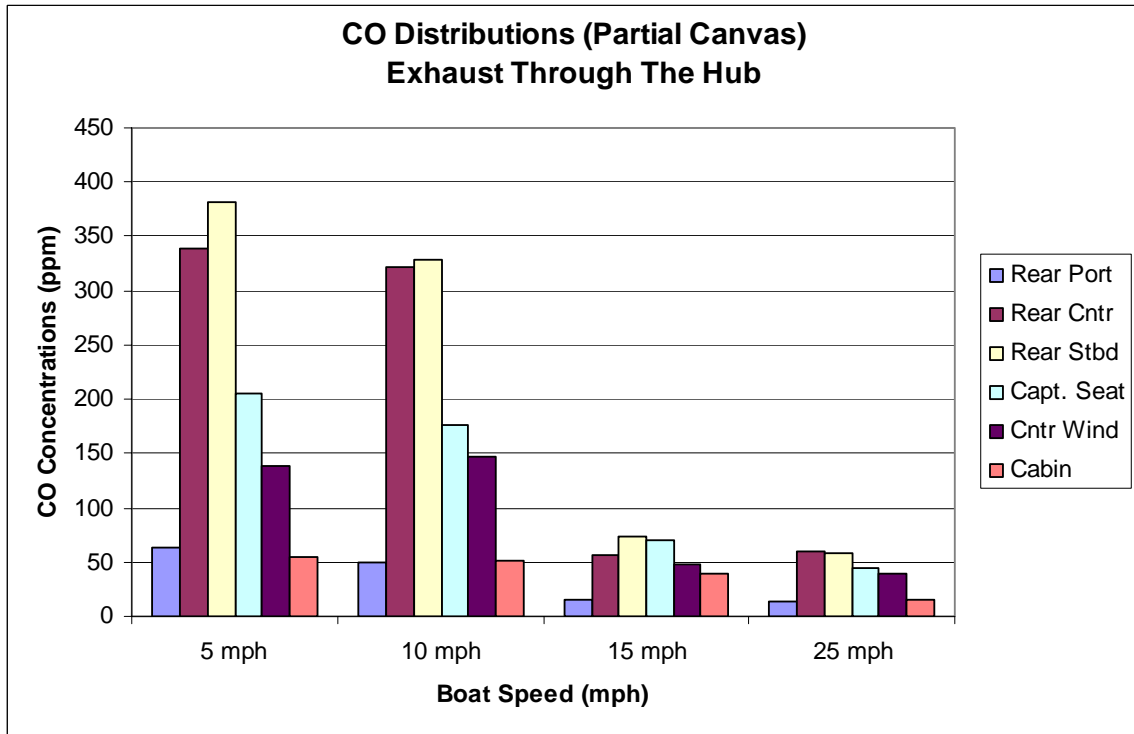
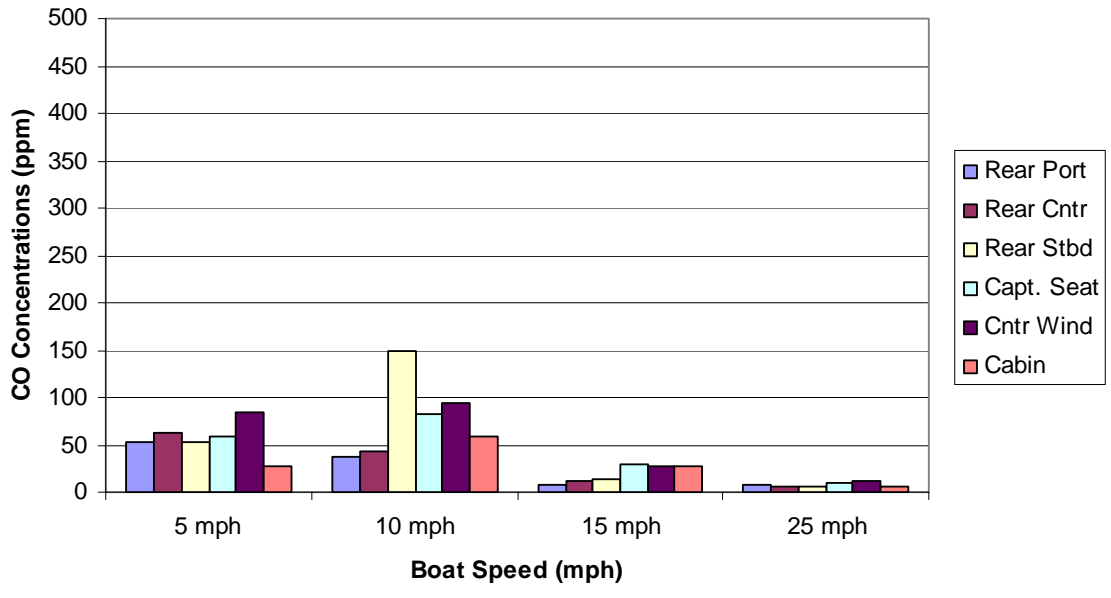
Figure 7: Boat 3 (31') Twin Volvo Penta 8.1L Exhausting Through the Hub.

the stern of the boat, and gradually reduced toward the front of the vessel. Tables 8 and 9 and the graphs in Figure 7 contain additional information for this vessel.

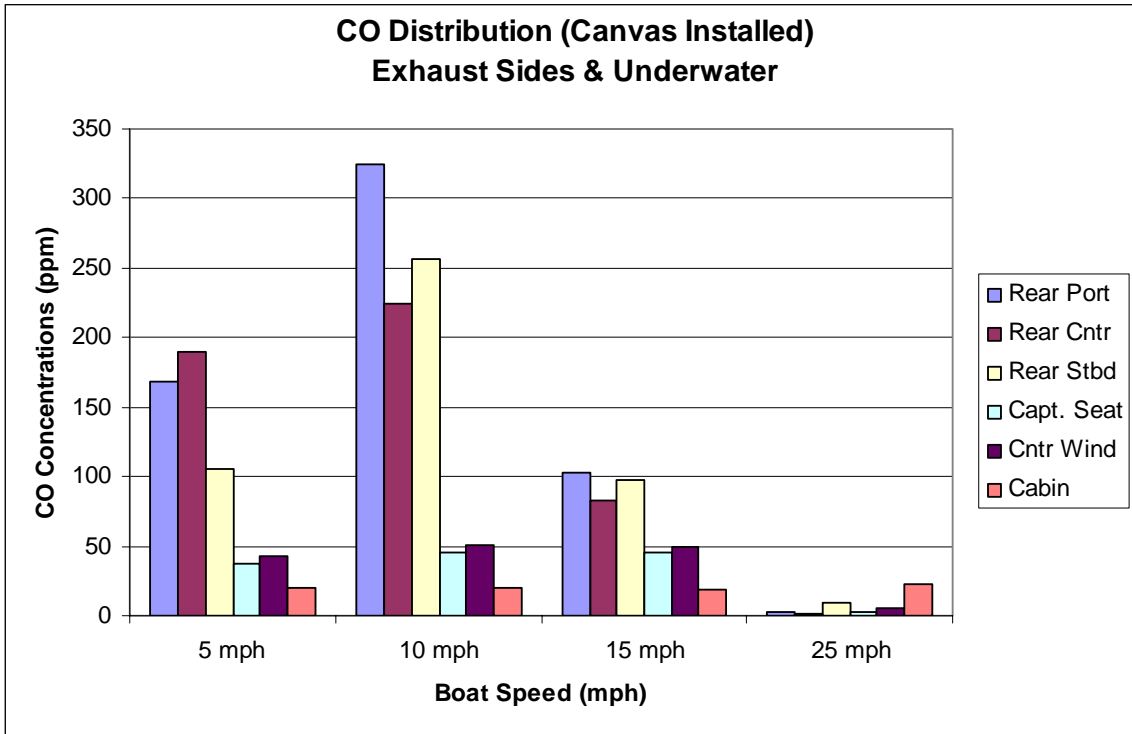
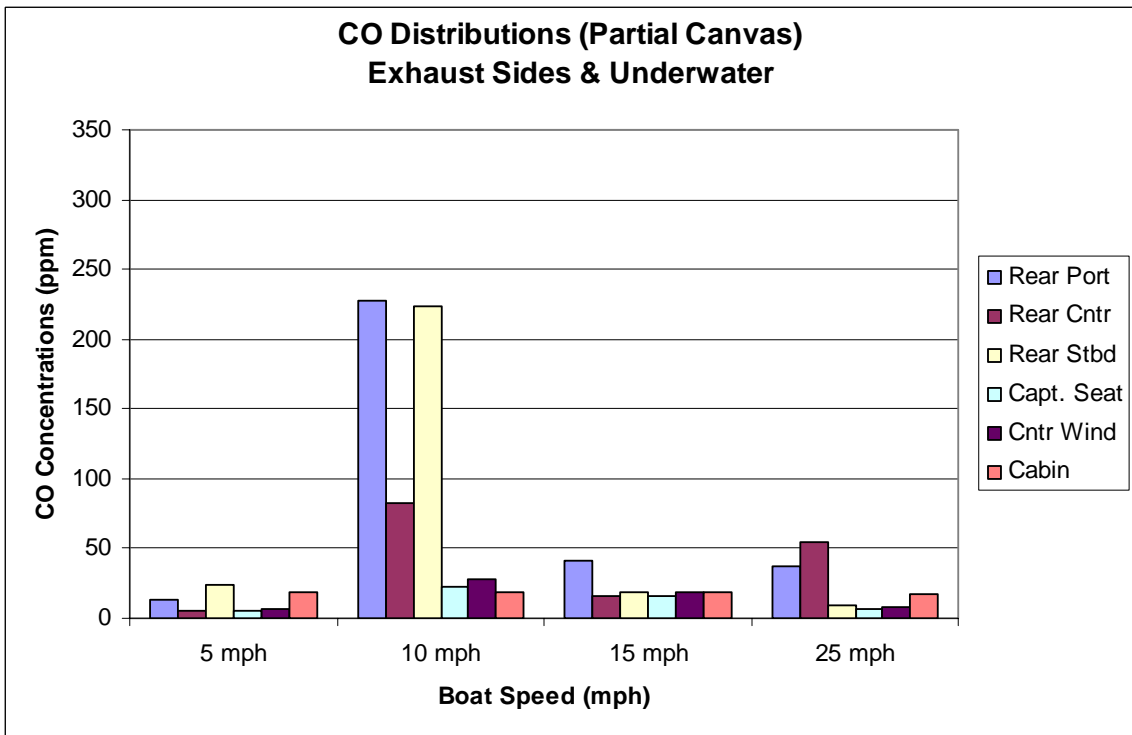
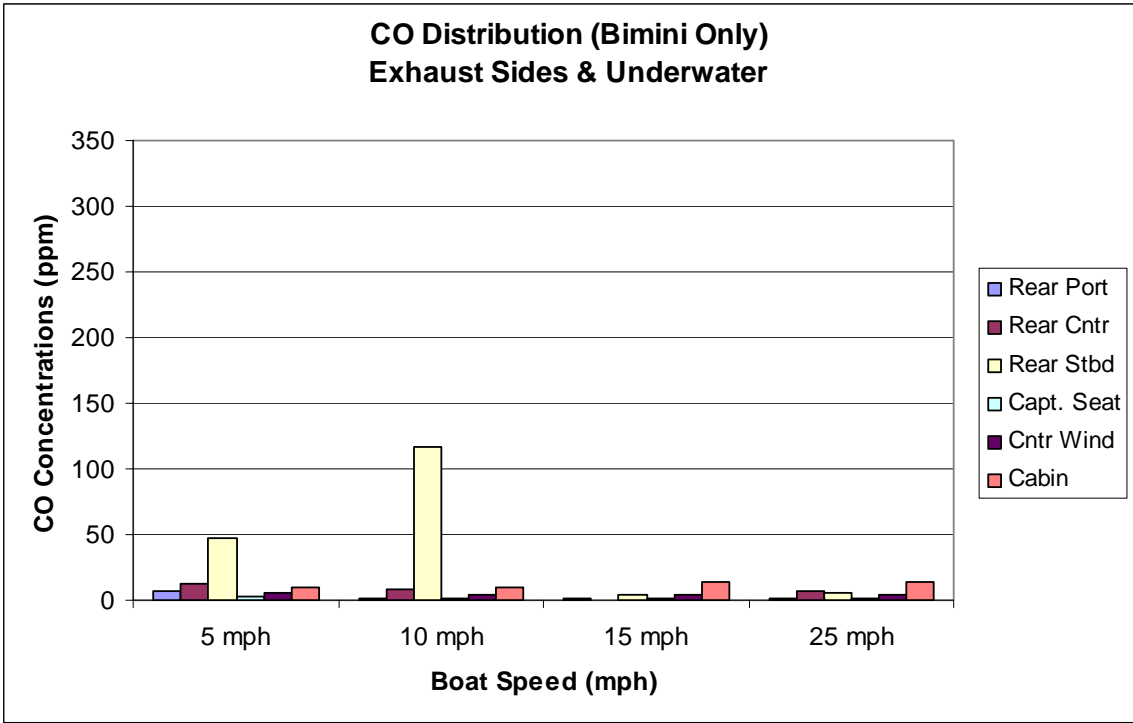
Figure 10: Boat 6 (40') Twin Mercruiser 8.1L Combined Exhaust Through the Sides and Underwater.

Concentrations in the cabin never exceeded 20 ppm even with the canvas fully installed. This indicates a good sealing of the cabin sliding door. Tables 10 and 11 and the graphs in Figure 10 contain additional information for this vessel.

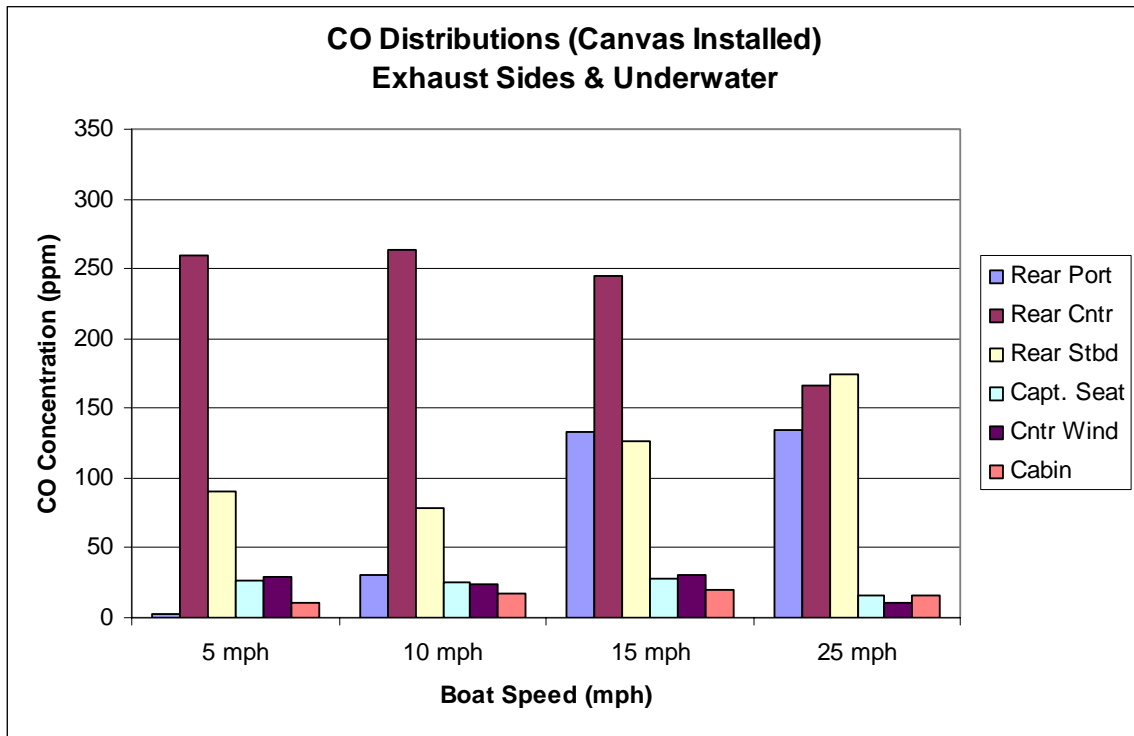
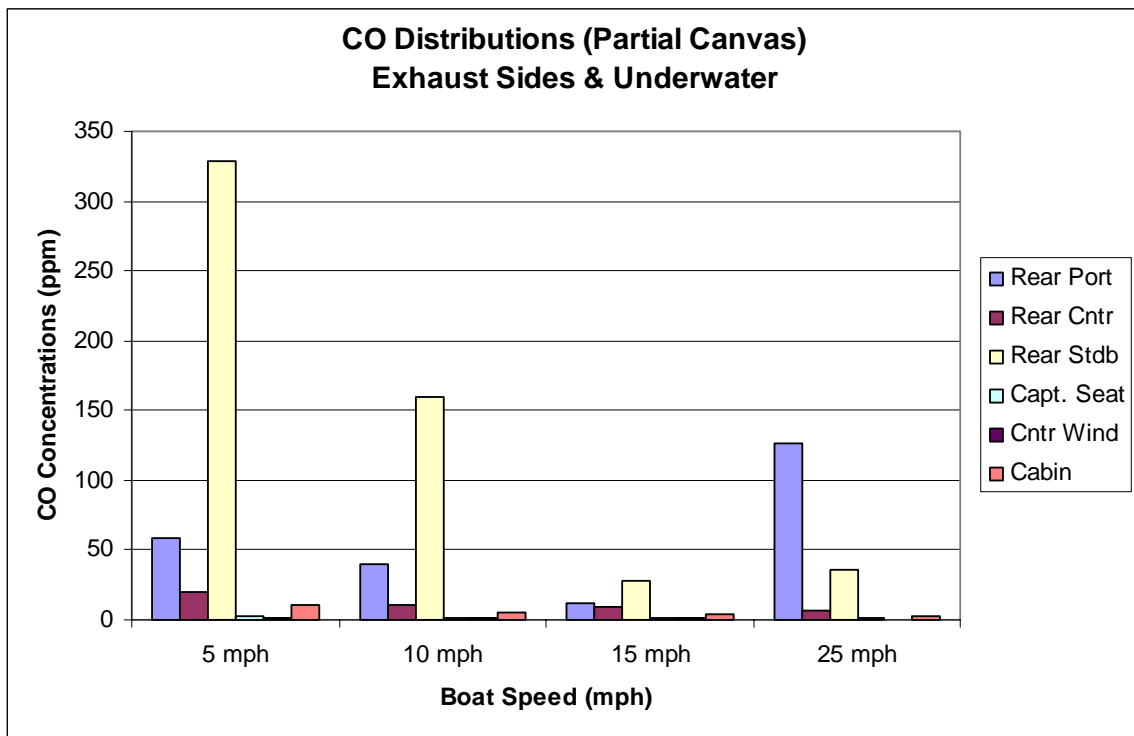
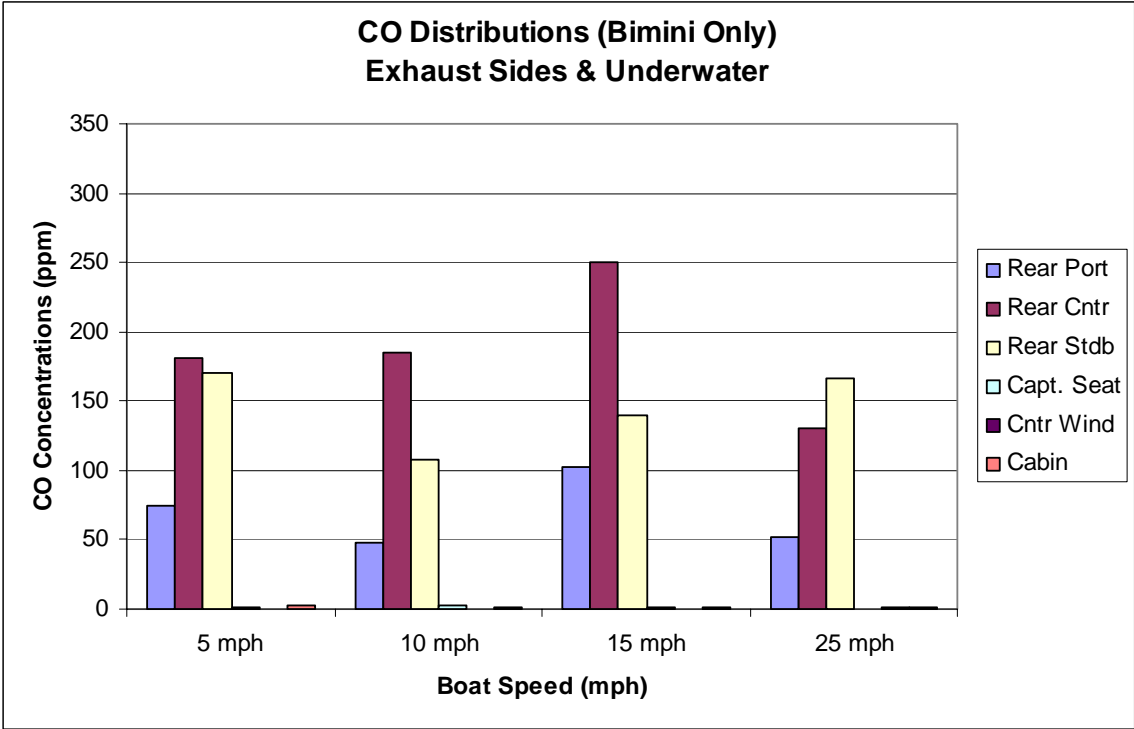
Figure 11: Boat 7 (41') Motor Yacht Twin Mercruiser 8.1L Combined Exhaust Through the Sides and Underwater.

In Figure 11, the CO concentration on the center of the swim platform did not followed the same pattern as the other vessels, in where CO concentrations tended to greatly reduce as speed increased. This unit is considered a Motor Yatch which geometric shape

The cabin door was kept closed at all times, and inside levels never exceeded 17 ppm. This indicates a good sealing of the sliding cabin door and adjacent compartments. CO concentrations in the engine compartment never exceeded 80 ppm when the canvas was installed and 41 ppm when the canvas was fully removed. Cockpit concentrations ranged between 0 and 50 ppm with the canvas fully installed. Refer to Tables 12 and 13 and the graphs in Figure 11 for more details.

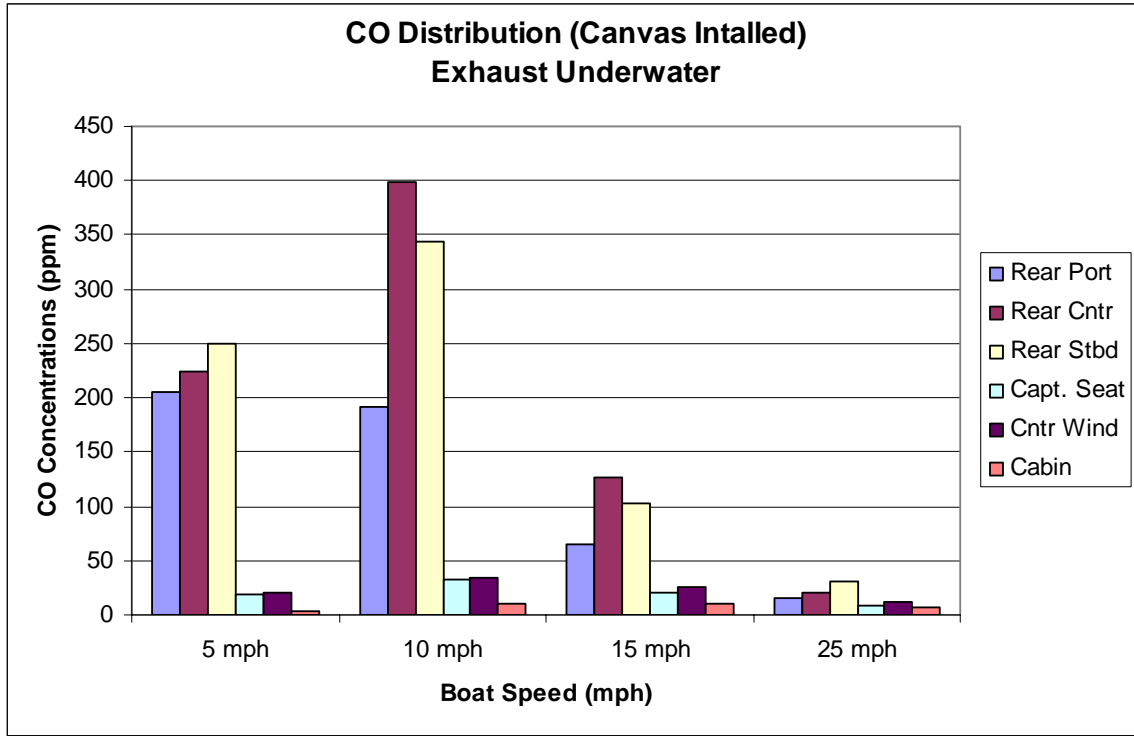
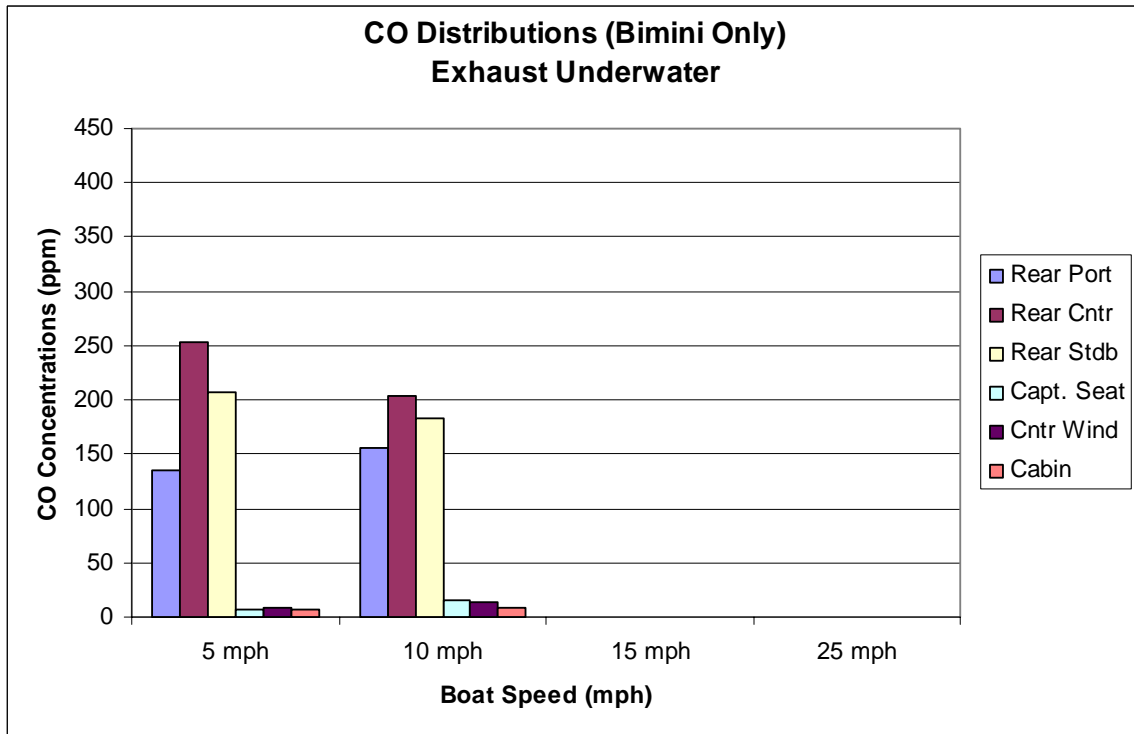
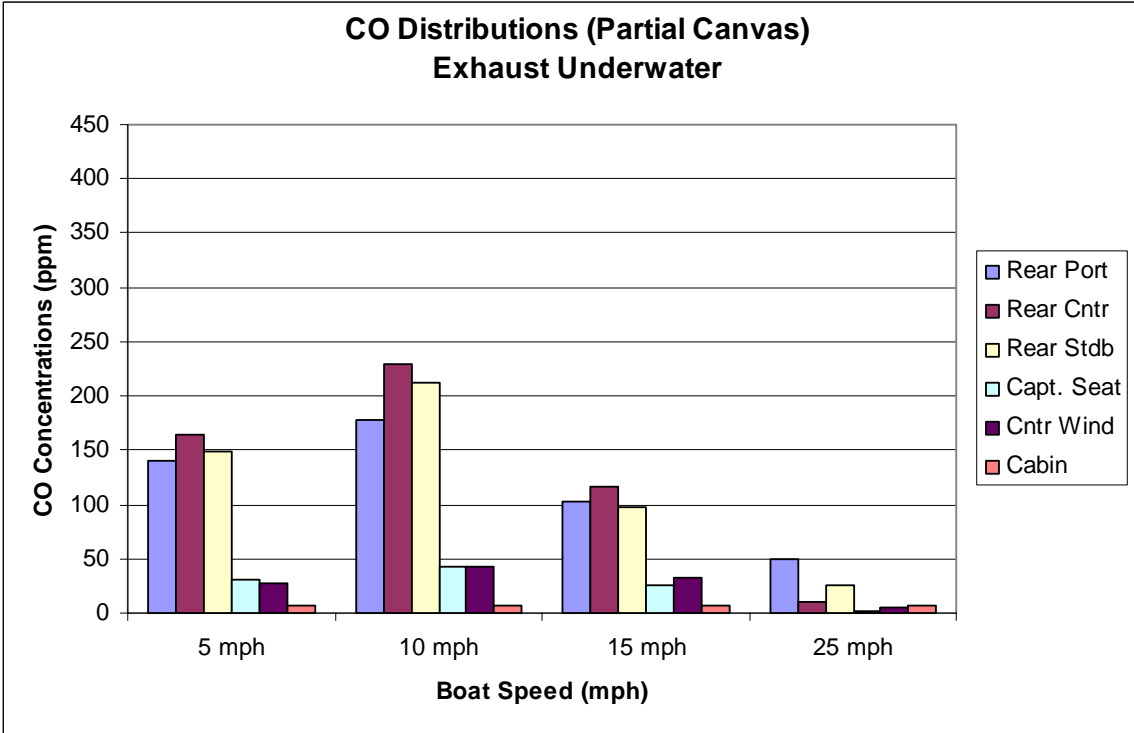
Figure 13: Boat 9 (38') Twin Crusaders 8.1L Exhaust Underwater.

Peak concentration on this vessel exceeded 500 ppm at the stern of the boat when the canvas was fully installed. CO concentrations in the cockpit were below the NIOSH ceiling of 200 ppm at all times, and lower when the canvas was fully removed (bimini top only). Inside the cabin CO concentrations never exceeded 60 ppm. Engine compartment concentrations were well below 120 ppm at all times. As with the other vessels, CO concentrations were consistently higher at the stern of the boat and were gradually reduced toward the front of the vessel. Tables 14 and 15 and the graphs in Figure 13 contain additional information for this vessel.

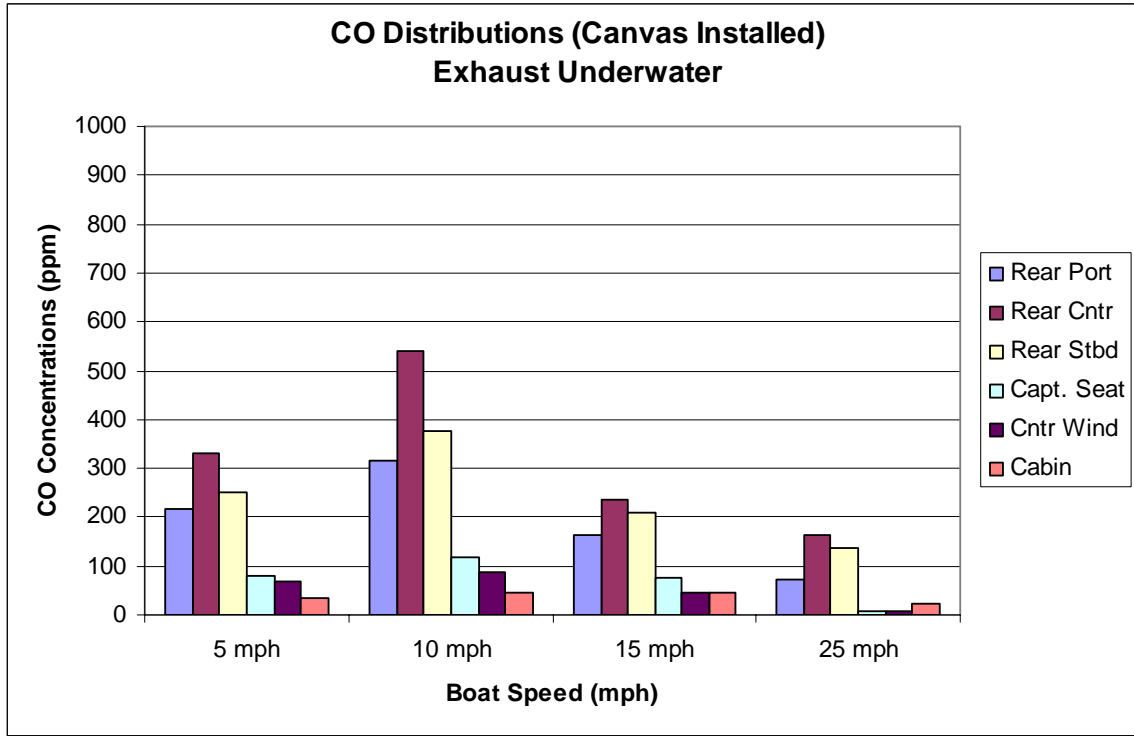
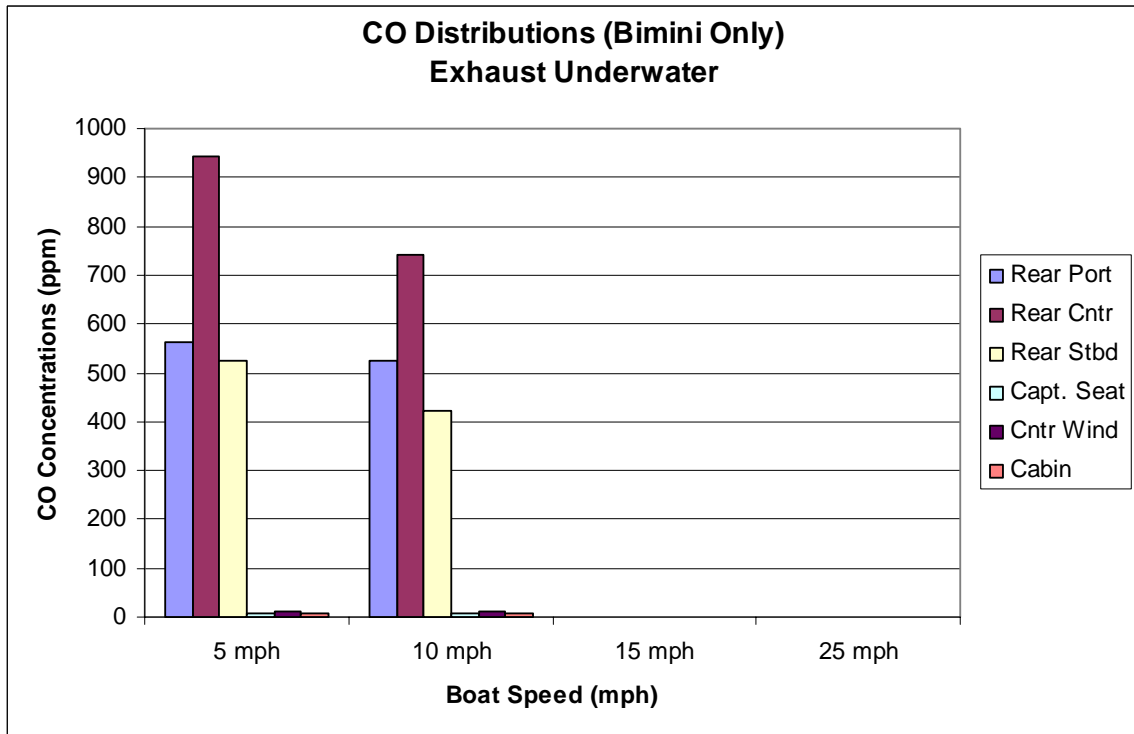
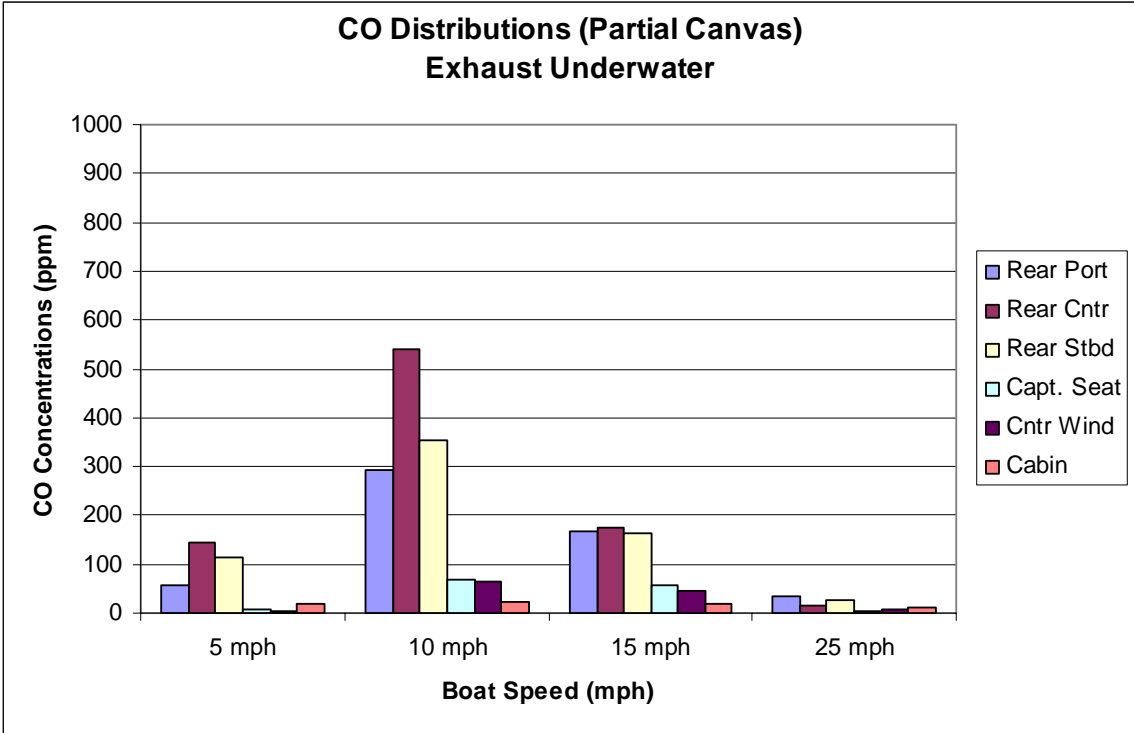
Figure 14: Boat 10 (35') Motor Yacht Twin Crusaders 8.1L Exhaust Underwater.

This boat exhibited CO concentrations that not only exceeded 1000 ppm but also approached the 1200 NIOSH IDLH limit on the center of the stern, with and without the canvas. CO concentrations in the cockpit were below the NIOSH ceiling of 200 ppm at all times, and much lower when the canvas was fully removed (bimini top only). Engine compartment concentrations were well below 200 ppm at all times. In general, CO concentrations were consistently higher at the stern of the boat, and were gradually reduced toward the front of the vessel. Furthermore, CO concentrations tended to decrease at higher speeds. Refer to Tables 14 and 15 and the graphs in Figure 14 for more details.
