REPORT OF INVESTIGATION
(UNDERGROUND COAL MINE)

NONINJURY COAL MINE (BOUNCE) ACCIDENT

Wilberg Mine (I.D. No. 42-00080)
Emery Mining Corporation
Orangeville, Emery County, Utah

June 28, 1983

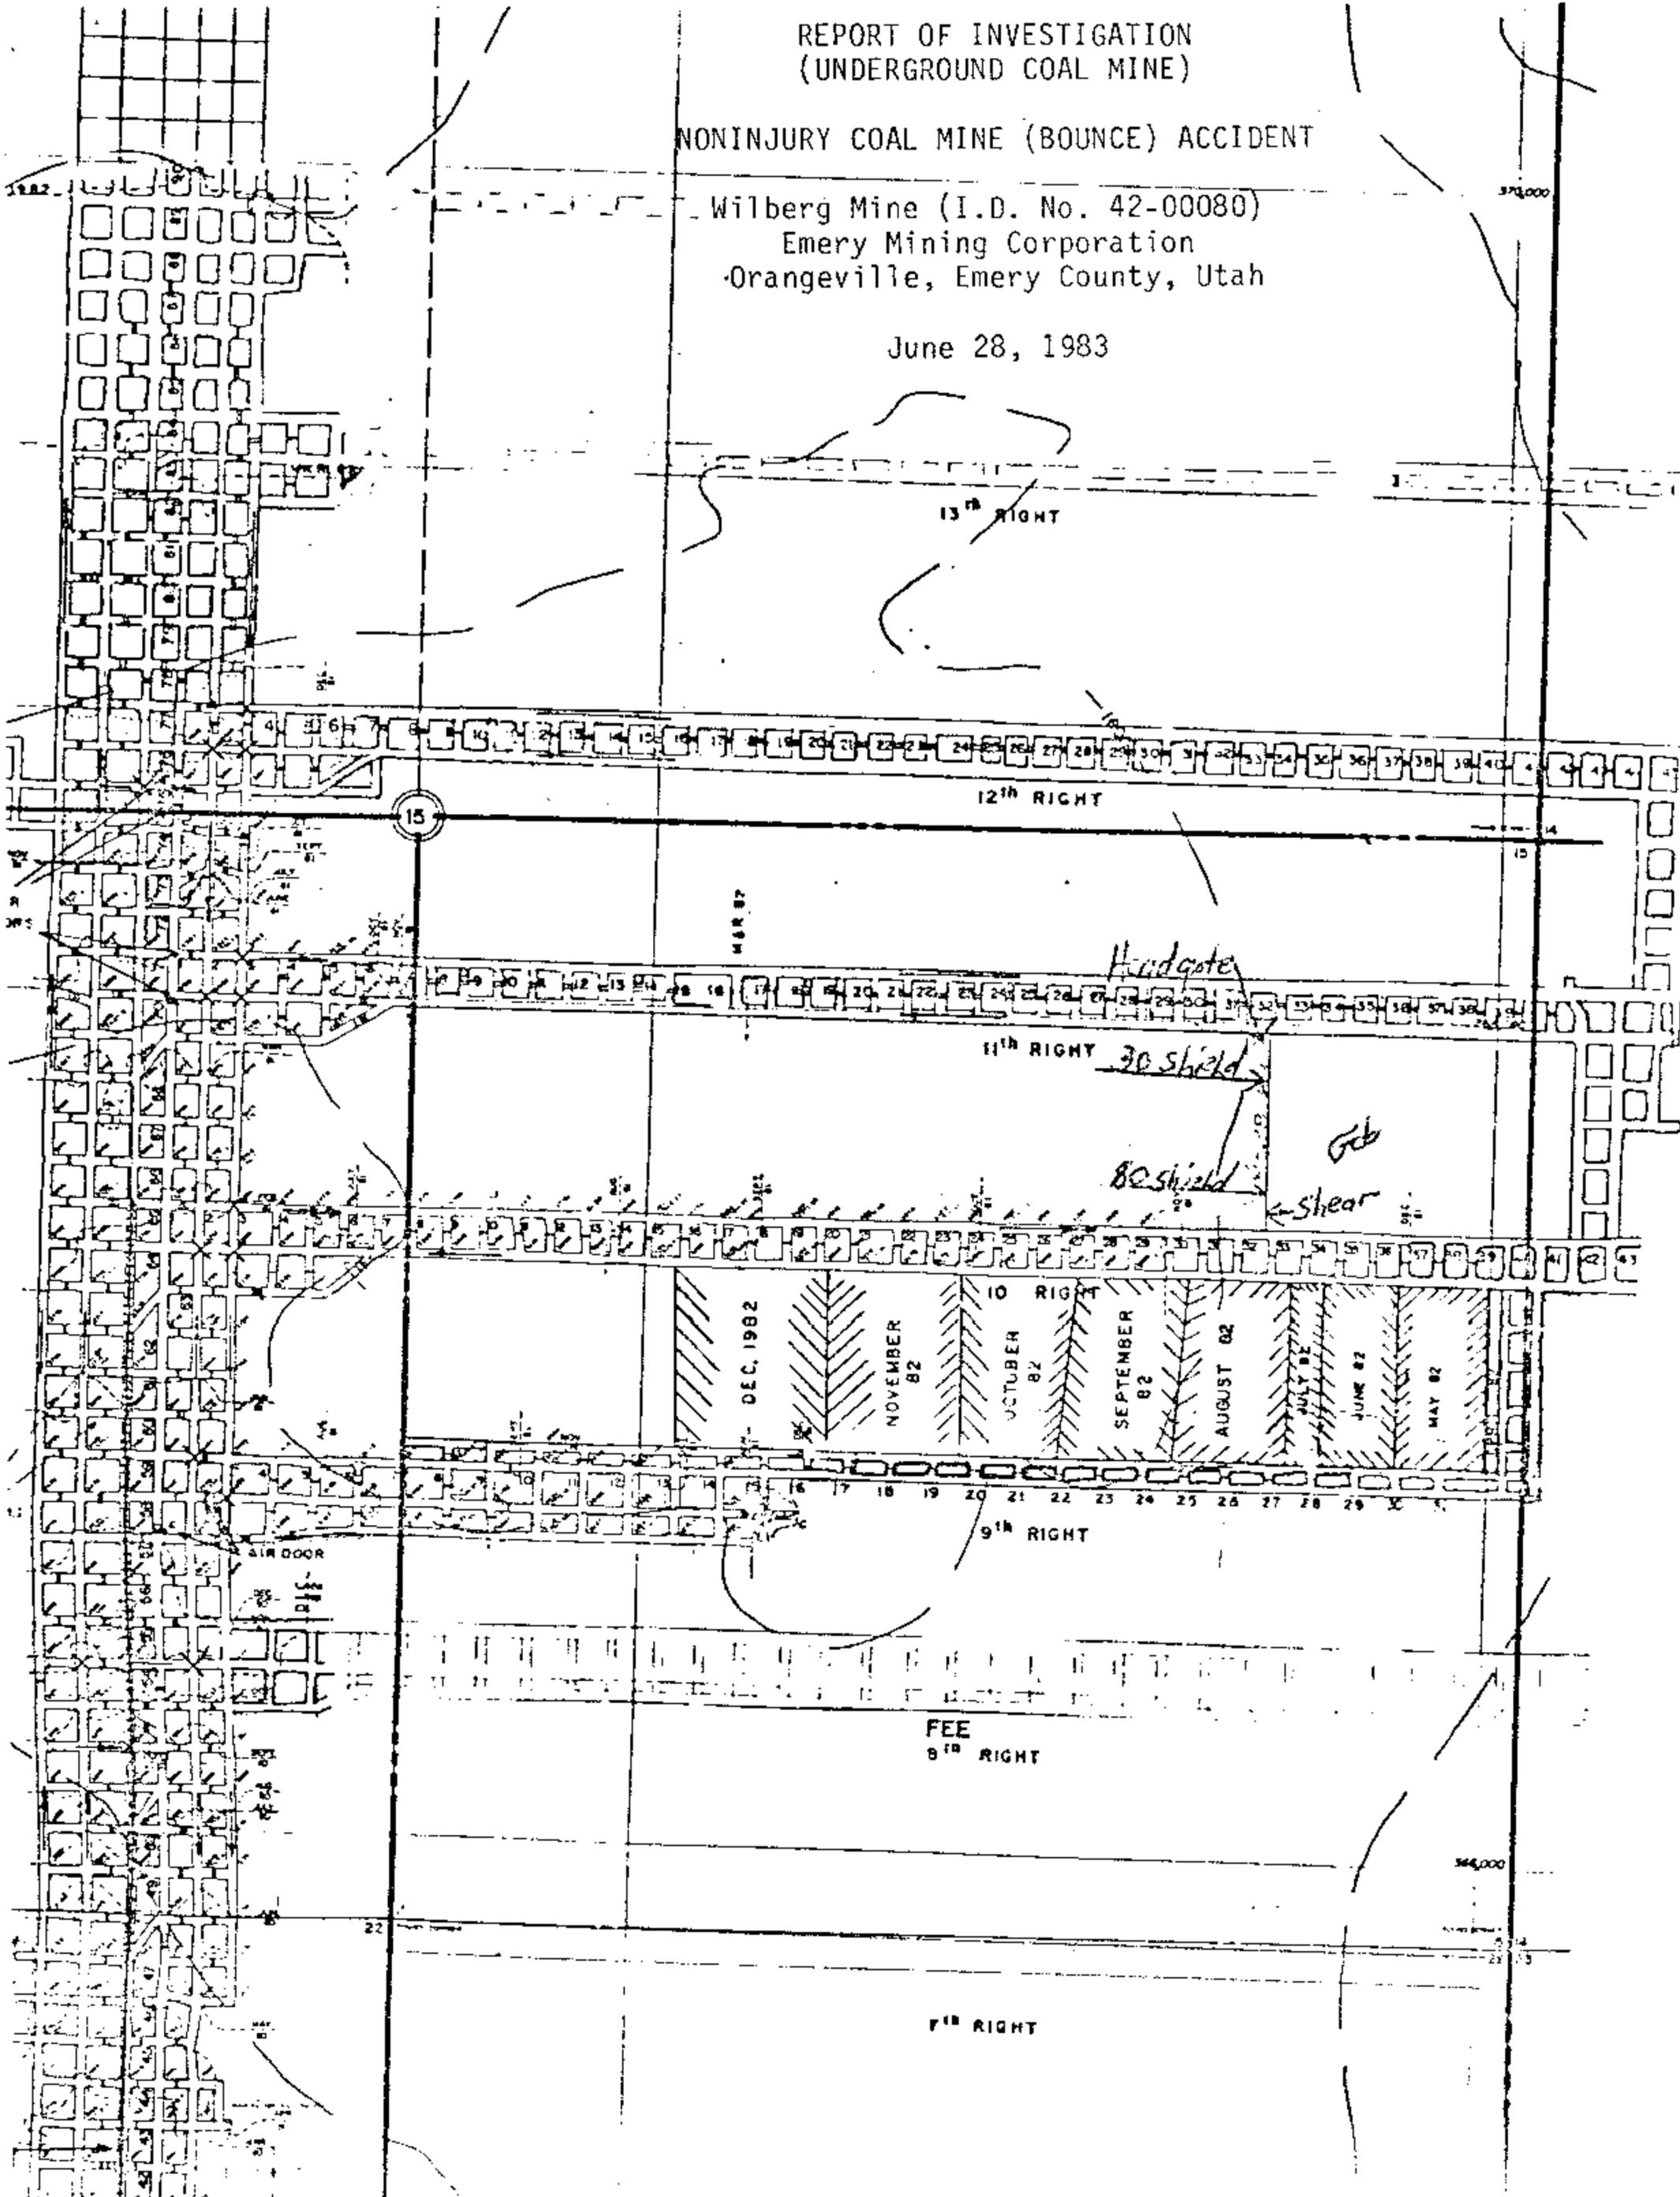
13th RIGHT

11th RIGHT

DEC. 1982

Headgate

30 shield

SECTION FIVE - ABSTRACT	
<p>On Tuesday, June 28, 1983, at 5:30 p.m., a bounce occurred in the face area of the 11th right longwall section. Twenty-five legs on the shields were damaged and four shields collapsed. The accident occurred due to mining in another seam of coal 90 to 100 feet above that left partial pillars and a 50 foot barrier that put pressure on the coal seam below. No injuries were reported.</p>

1. The force of the bounce pushed the mine floor up under the pan line from #30 shield to #80 shield 12 to 15 inches.
2. The force of the bounce damaged 25 legs on the shields causing them to fail.
3. Coal had been extracted from a coal seam 90 to 100 feet above leaving partial pillars and a 50 foot barrier.
4. The bounce did disrupt the miners normal mining cycle for more than one hour due to the damage to the shields.
