Health Hazard Evaluation Report

HETA 87-387-2050
ITHACA COLLEGE
ITHACA, NEW YORK

HETA 87-387-2050
JUNE 1990
ITHACA COLLEGE
ITHACA, NEW YORK

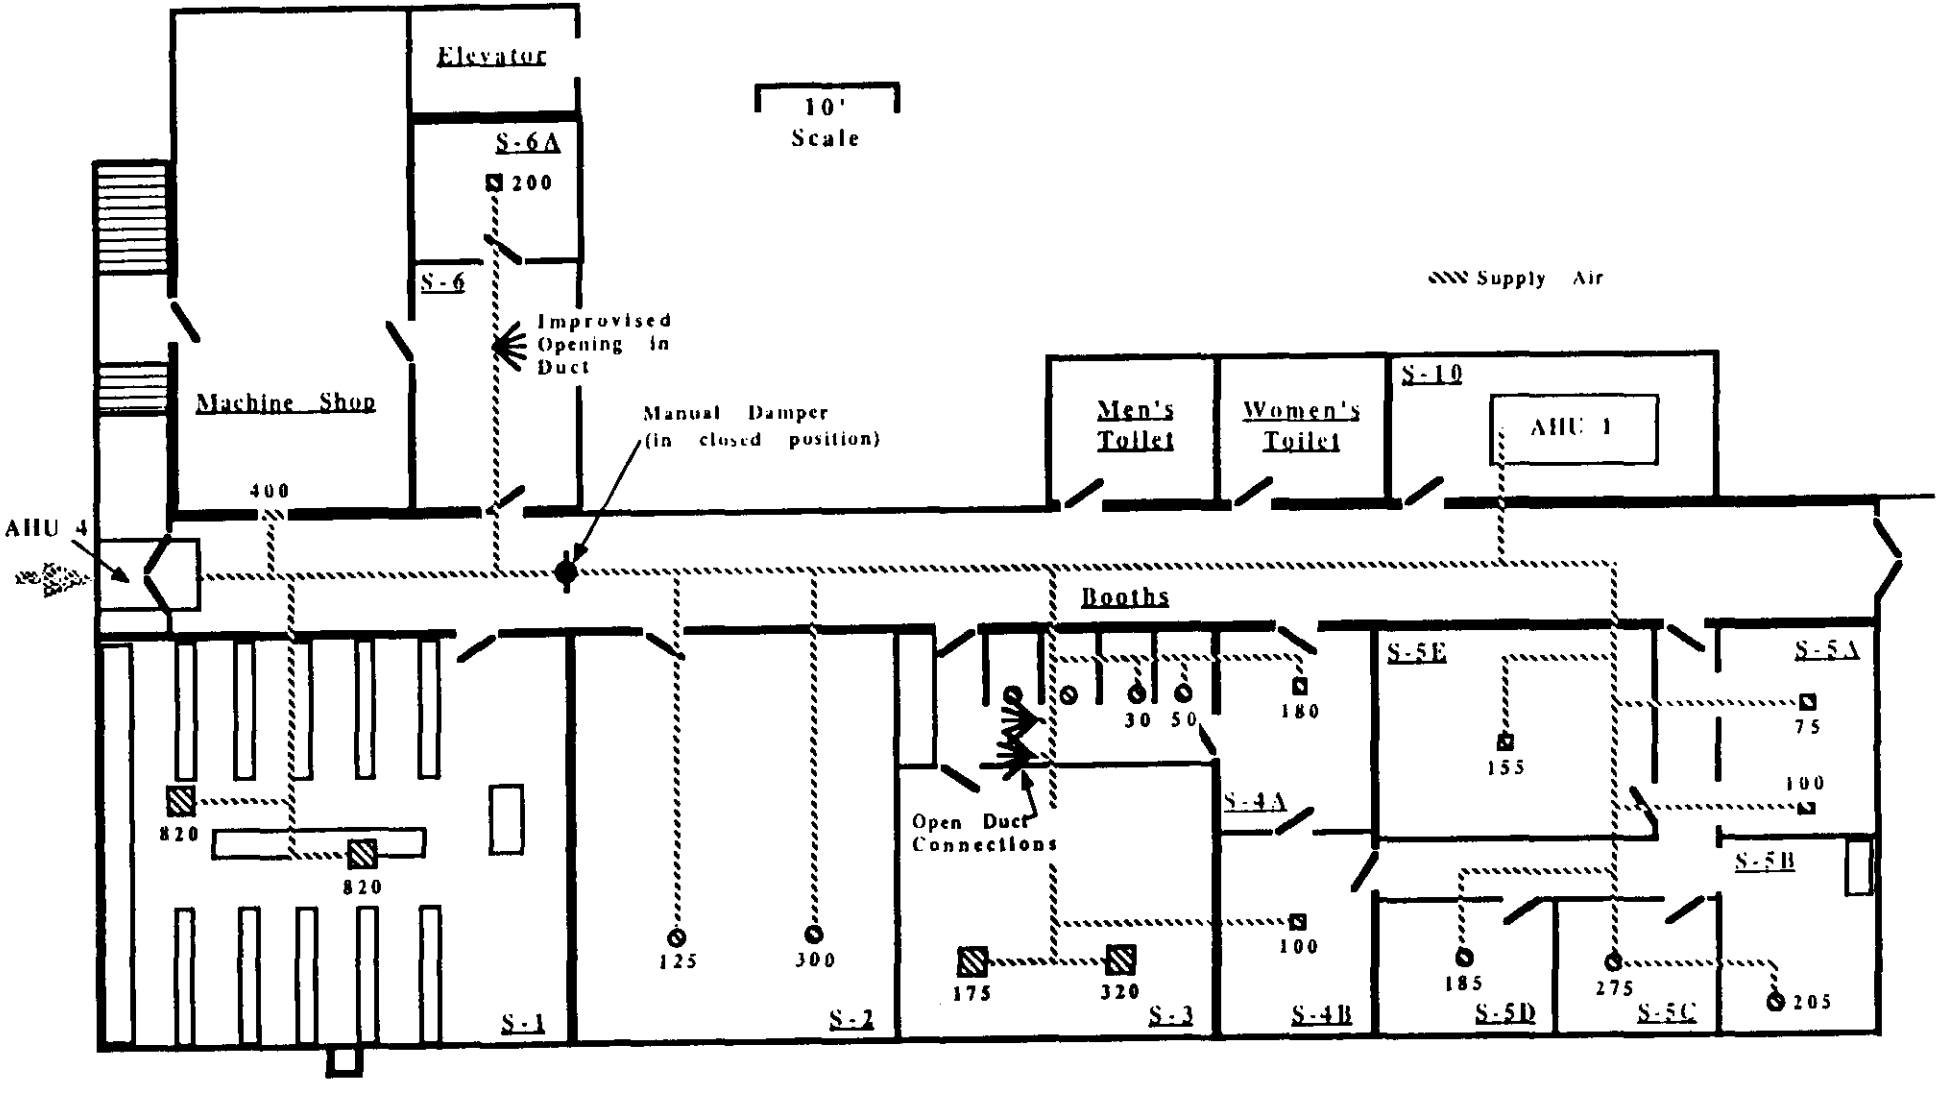
Figure 1. Schematic of supply air system and air flow measurements at supply air diffusers.
Ithaca College
Ithaca, NY
87-387

Two open duct connections were found in the ceiling above Room S-3 (see Figure 1). The connections appeared to be for disconnected diffusers in two booths. Although the connections had manual dampers, neither damper was closed resulting in short-circuiting of the ventilation system.

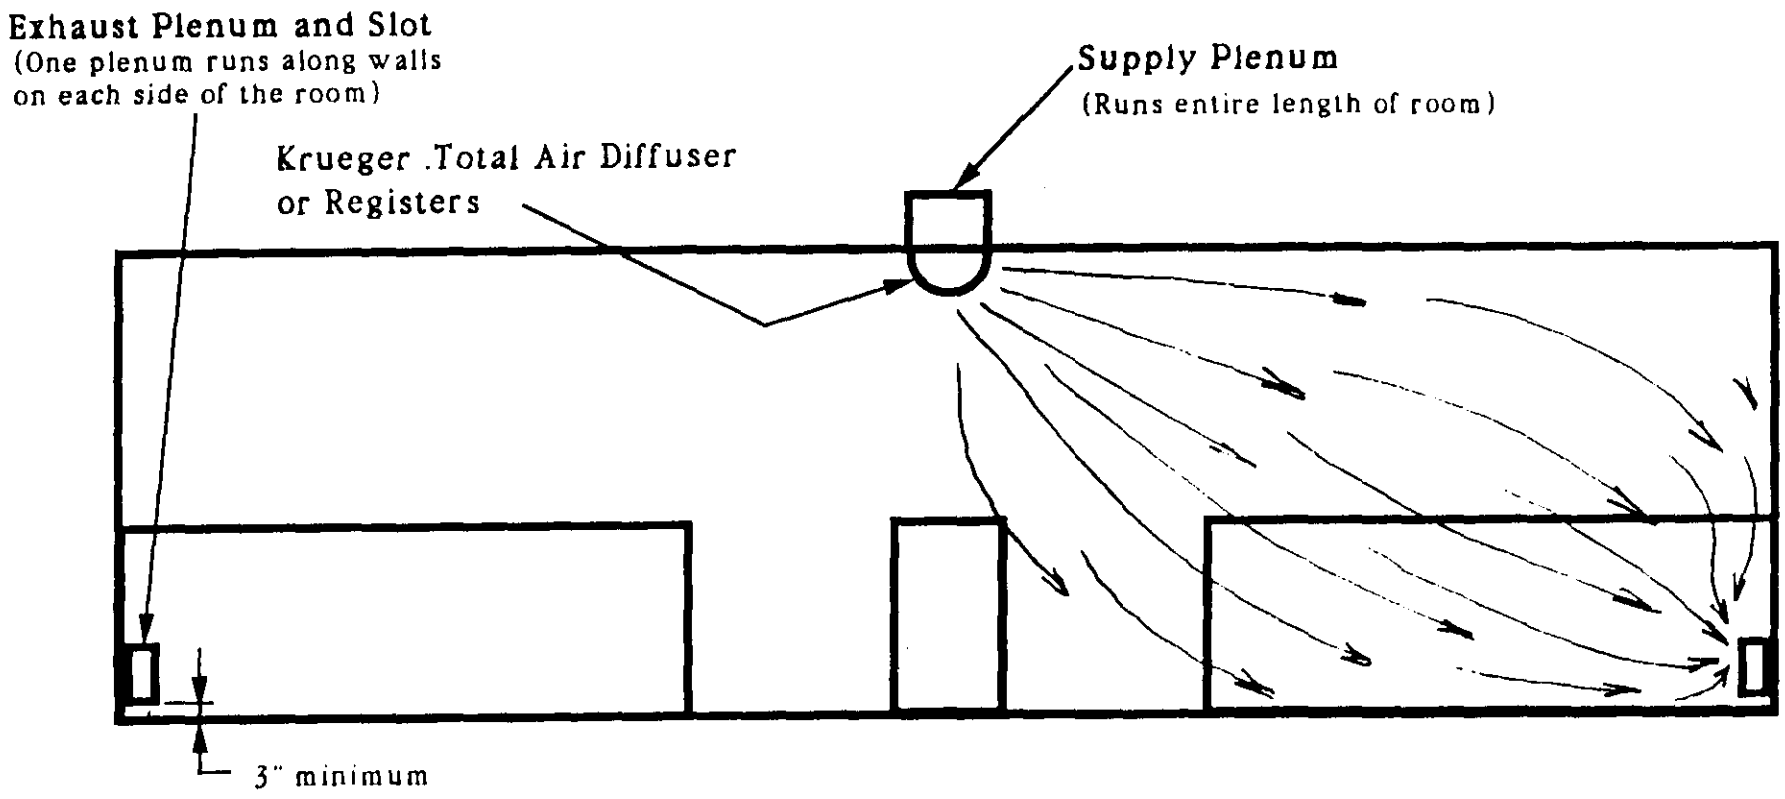
Figure 3. Proposed changes to ventilation system in S-1.
Ithaca College
Ithaca, NY
87-387

The method of supplying air to Room S-1 leads to the dispersion of contaminants throughout the room. Air was supplied at a high velocity causing turbulence and mixing of the supply and room air. Using a low-velocity, widely dispersed air supply reduces turbulence and mixing of air in the space, and thus the dispersion of contaminants. Air supplied at low velocity also maintains the dispersed air pattern and velocity as it flows through the space. One manufacturer was found which has a diffuser that can provide the kind of supply air pattern needed in a dissecting laboratory (Krueger, Tucson, AR). In fact, the applications for the diffusers listed in the company's product literature include laboratories and animal rooms. The application of the diffuser to Room S-1's ventilation system is demonstrated in the "Recommendations" section.

Note: Exhaust plenum should be constructed to stand abuse because of location next to floor.
Each plenum should run the entire length of the room, but may be split into several plenums to cover entire length.
If use, supply air registers should have double deflection louvres and opposed blade dampers.
Louvres should be aimed to get approximate air flow pattern shown on right side of figure.

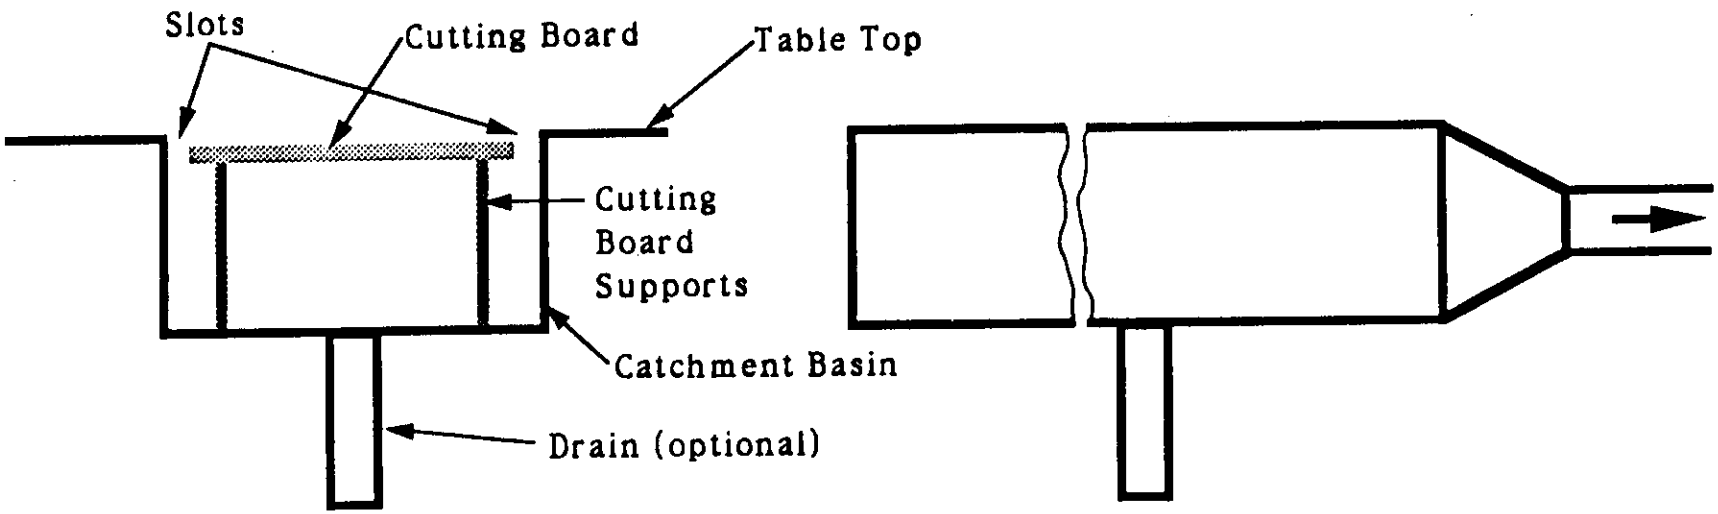
Figure 4. Dissecting Board Hood
Ithaca College
Ithaca, NY
HETA 87-387

Ventilation can be used to affect the path of the contaminants from the source to the person. The best place to affect the path is as near to the source as possible. Degenhardt and Pfost present a design recommendation for a local exhaust hood that can be used for dissecting.[5] Their design has been adapted for the hood discussed further in the Recommendations.

Notes: Minimum slot velocity is 2000 fpm.
Minimum duct velocity is 1000 fpm.
Recess top of cutting board about one inch below the top of the cutting board.
