OIL AND GAS EXTRACTION WORKER FATALITIES 2014

NIOSH Fatalities in Oil and Gas Extraction (FOG) Database

DHHS (NIOSH) Publication No. 2017-193

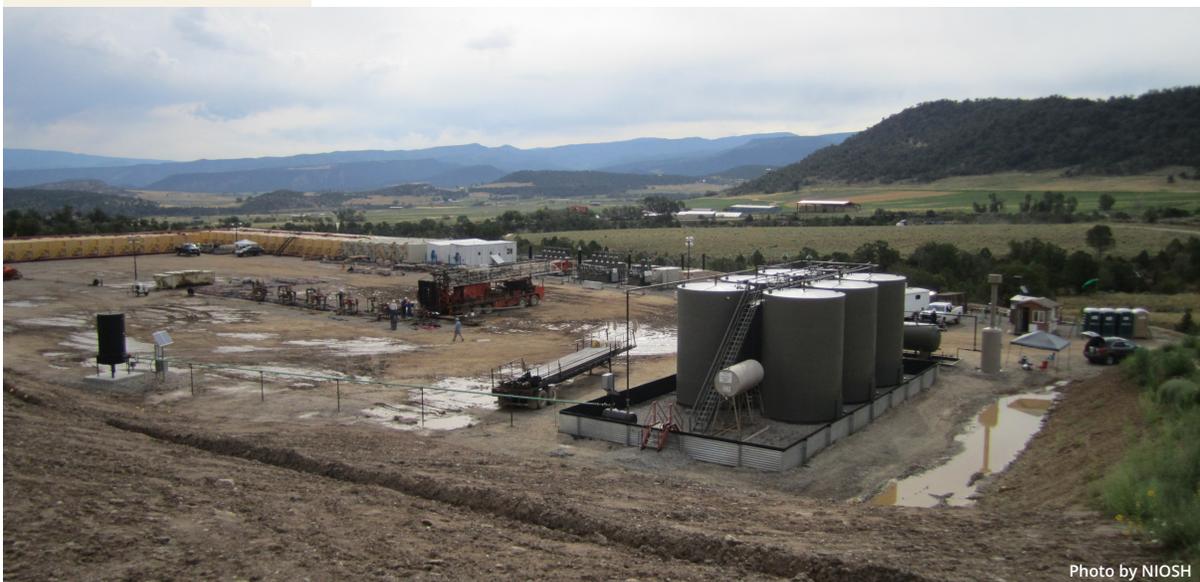
Oil and gas wellsite with multiple wellheads, several flowback tanks, a well servicing rig, and six production fluid tanks.

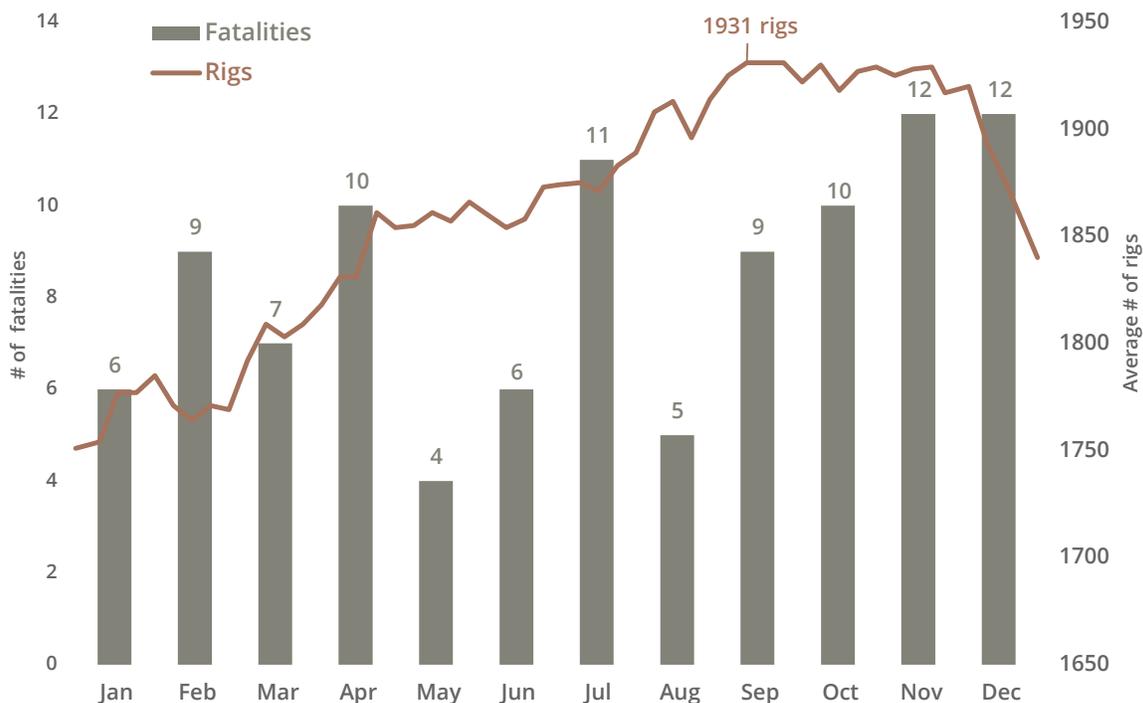
AVERAGE NUMBER OF ACTIVE U.S. ROTARY RIGS AND NUMBER OF FATALITIES IN FOG, 2014

- FOG identified 101 work-related fatalities that occurred in 2014 with an average of eight per month. November and December were the months with the greatest number of fatalities.
- After steadily increasing to a peak of 1,931 rigs in September, rig activity plateaued during the last quarter of 2014.
- There were 621,265 workers employed in the industry in 2014 (NAICS codes 211, 213111, 213112), more than double the workforce that was seen a decade before.

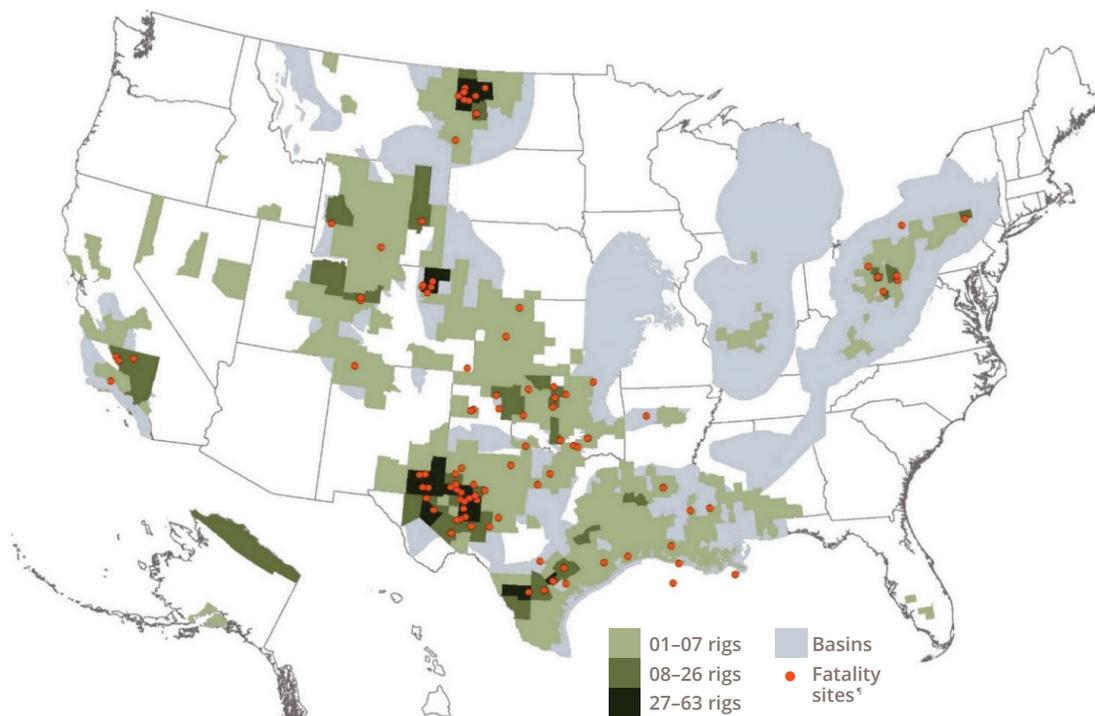
FATALITIES IN FOG BY LOCATION AND AVERAGE NUMBER OF ACTIVE U.S. ROTARY RIGS, 2014*

- Fatalities occurred throughout the U.S., with the largest occurring in states with the greatest amount of rig activity (Texas, Oklahoma, and North Dakota).

STATE	# OF FATALITIES (%)	AVERAGE # OF RIGS (%)
Texas	44 (44%)	882 (47%)
Oklahoma	12 (12%)	199 (11%)
North Dakota	10 (10%)	176 (9%)
Colorado	8 (8%)	68 (4%)
Louisiana	6 (6%)	111 (6%)
New Mexico	6 (6%)	92 (5%)
Pennsylvania	4 (4%)	56 (3%)
Wyoming	3 (3%)	54 (3%)
Ohio	2 (2%)	41 (2%)
California	1 (1%)	42 (2%)
All other states combined†	5 (5%)	145 (8%)
Total	101 (100%‡)	1862§ (100%)

*Basin data source: U.S. Energy Information Administration. Data Projection: Albers Equal Area Conic United States Geological Survey. Datum GCS WGS 1984.

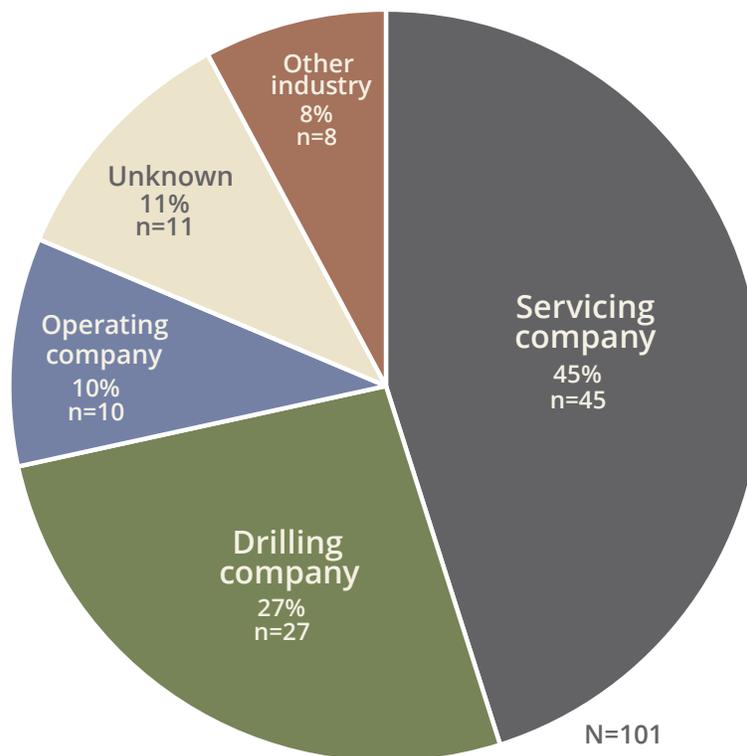
FATALITIES IN FOG BY INDUSTRY GROUP*, 2014

*Percentages do not total due to rounding

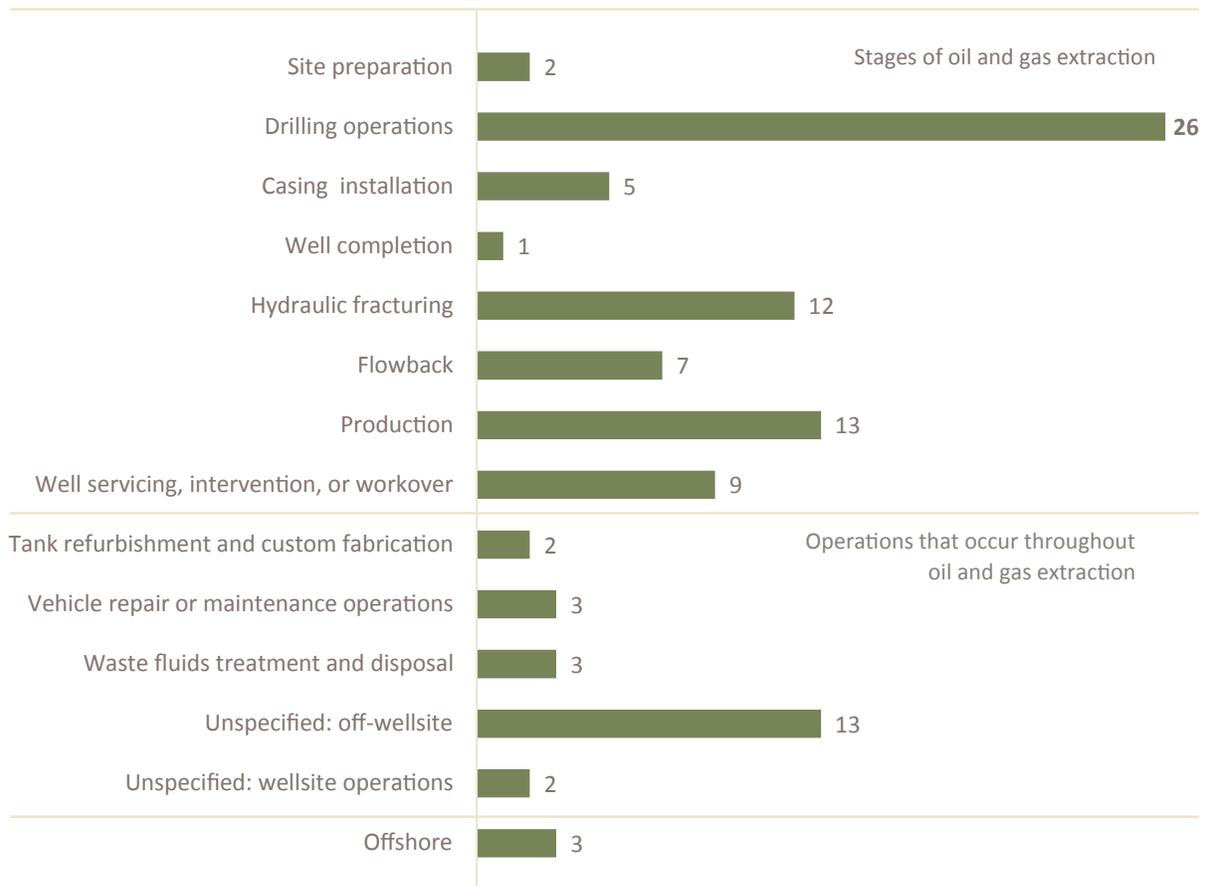
FATALITIES IN FOG BY OPERATION, 2014

- The operation could be determined in 75 (85%) of the 88 incidents. Where operation is unspecified, the incidents were categorized into off-wellsite and on-wellsite operations (13 incidents accounting for 15 fatalities)
- The largest number of fatalities occurred during drilling operations (26 fatalities).
- Twenty worker fatalities occurred during completions (well completion, hydraulic fracturing, and flowback).

Operations are distinct stages or processes in oil and gas extraction. Each incident is assigned one operation.

N=101

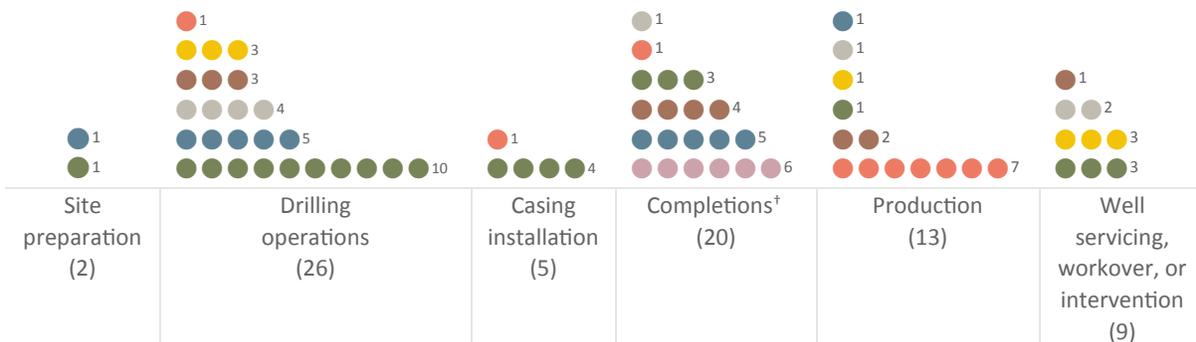
Operations by stages in the oil and gas extraction process

- Contact injury
- Electrocutation
- Explosion (combustion) or fire
- Explosion (pressure)
- Exposure
- Fall
- Vehicle incident

Operations that occur throughout the oil and gas extraction process

Tank refurbishment and custom fabrication (2)	● ●
Vehicle repair or maintenance operations (3)	● ● ●
Waste fluids treatment and disposal (3)	● ● ●

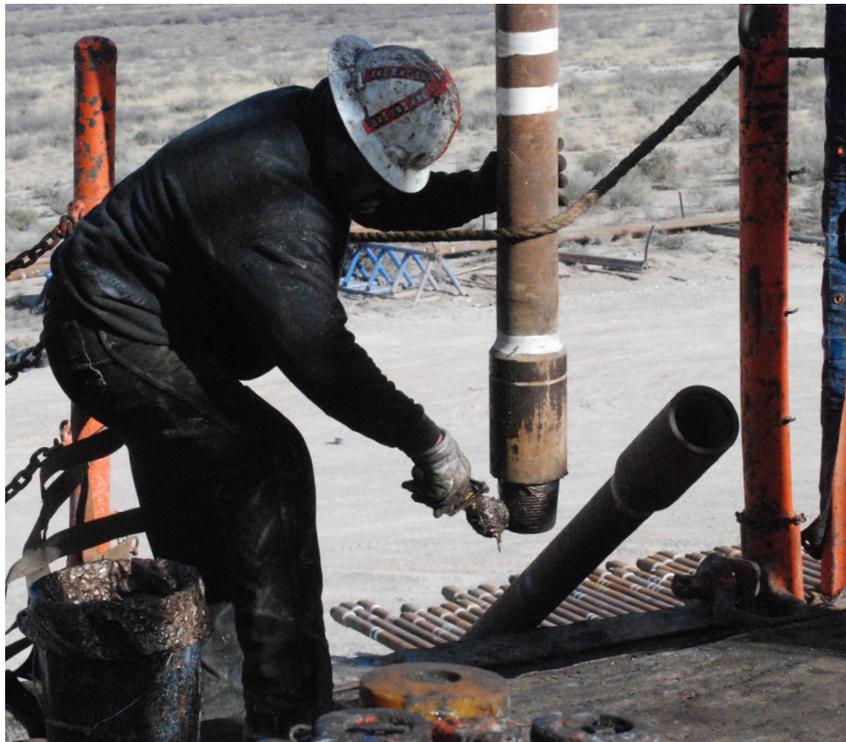
A worker applies lubricant to the end of a tubular that is being picked up into a drilling rig.
