# Two Masons Electrocuted after Contact with an Overhead Power Line

**Incident Number: 13KY010**

**Kentucky Fatality Assessment and Control Evaluation (FACE) Program**  
**Incident Number: 13KY010**  
**Release Date: February 11, 2015**  
**Subject: Two Masonry Workers Electrocuted after Contact with an Overhead Power Line**

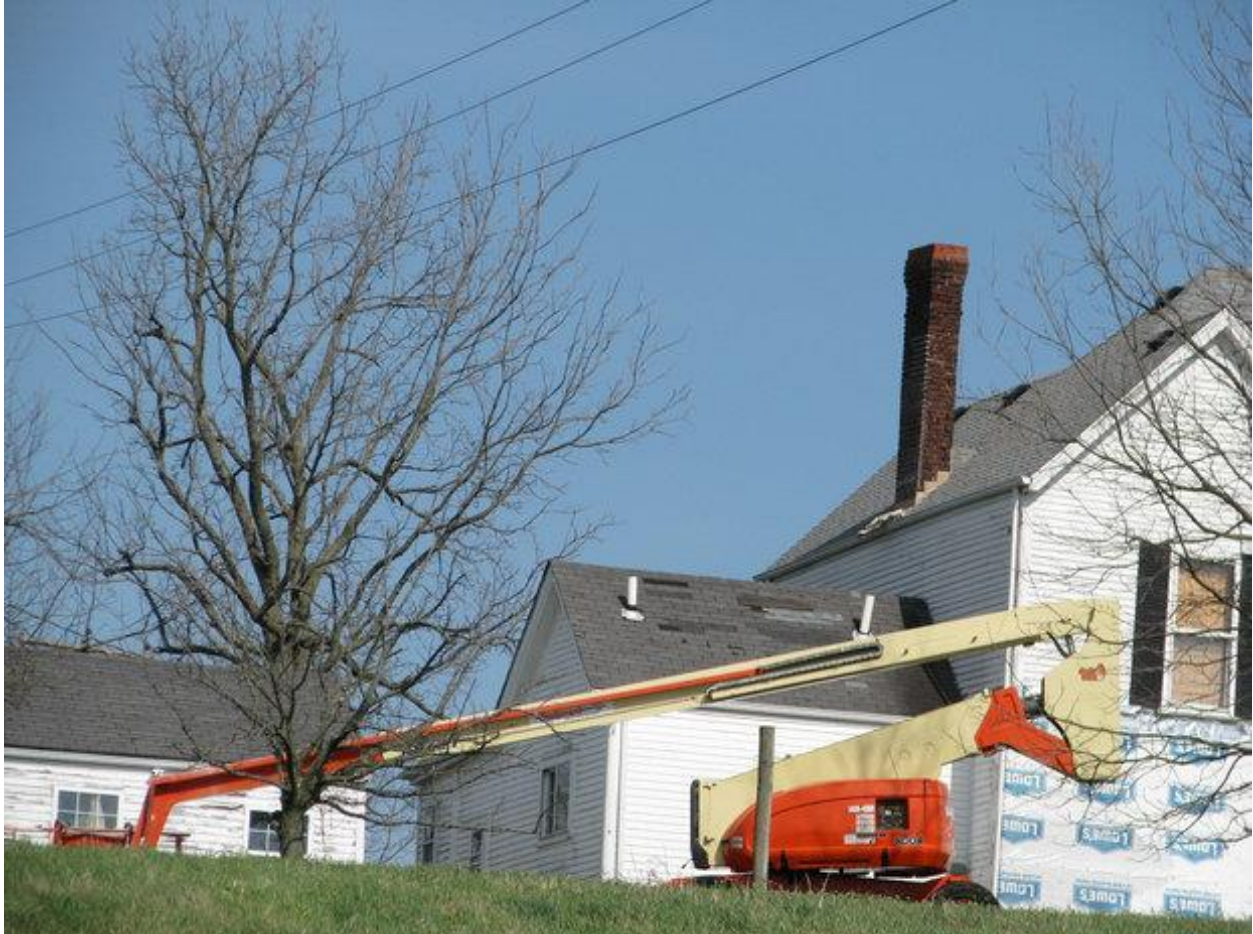
Photo courtesy of Lexington Herald Leader

The masons controlled the bucket steering from inside the bucket itself and swung it away from the house to lower it back to the ground. As they swung the bucket around, the bucket came into contact with the overhead power lines that were located behind the house. There was a distance of approximately 30 feet between the back of the house and the overhead power lines. The bucket hit the 7,200 volt line and the two masons were electrocuted immediately. The power line came down, burning on the ground and knocking out power to residents in the surrounding area. The force of the electric current was so strong that the tires on the aerial lift burned and were reduced to a pile of scorched rubber. There was also a fire around the downed power line on the ground.
