FATALITY INVESTIGATION REPORT

Maintenance Mechanic Crushed Working Inside of a Vertical Storage Machine

REPORT#: 2017-22-1

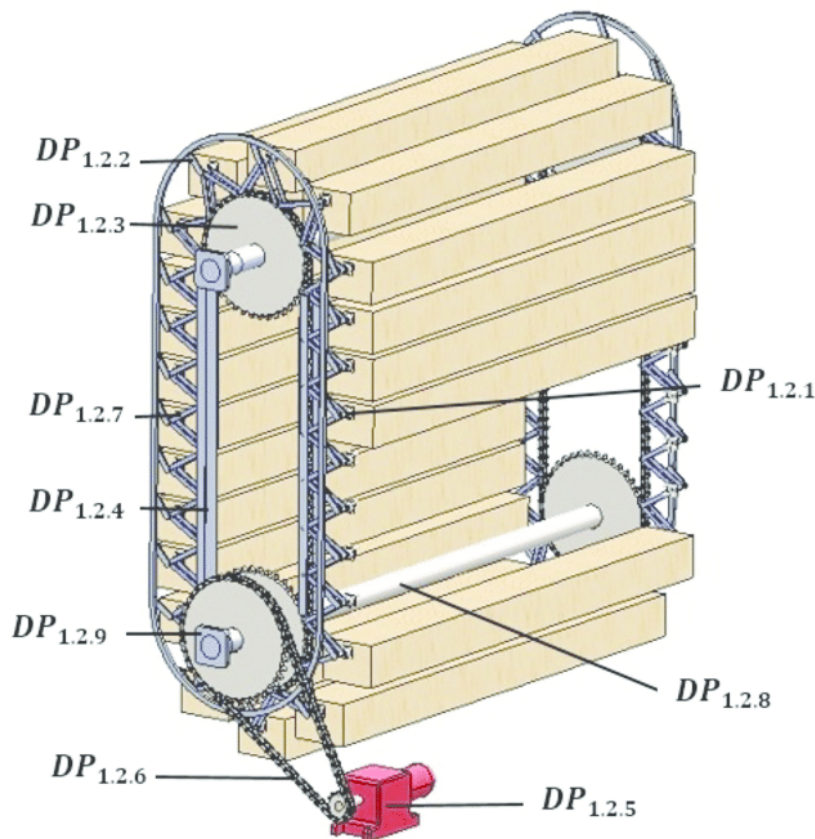
Example vertical storage unit design. *The unit involved in the incident was 12 feet high, 8 feet wide, and 11 feet deep. The machine exterior was a sheet metal housing with front and back access panels, but with only the front panel accessible. A hand crank was available to rotate carriers while the machine was powered off.*

(Image from "The Rational Footsteps for the Design of the Mechanism of a Vertical Carousel-type Storage Device", used with permission from Alberto Martinho)

Importantly, in addition to the ability to move carriers with electrical power, the machine possessed a hand crank that could be used to rotate the carousel manually while the machine was de-energized. This alternative procedure would have allowed the unit to have been de-energized and LOTO procedures used. The employee could be moved as needed by the hand crank.

The cause of death was reported as a crushing injury. The OR-OSHA Compliance Office's notes stated that the movement of the carrier over the top of the carousel resulted in the employee being squeezed into and over the top of the machine with less than a 2 inch clearance from the top of carriers going over the top.
