IC 9466
INFORMATION CIRCULAR 2003

Geologic Hazards and Roof Stability in Coal Mines

By Gregory M. Molinda

October 2003

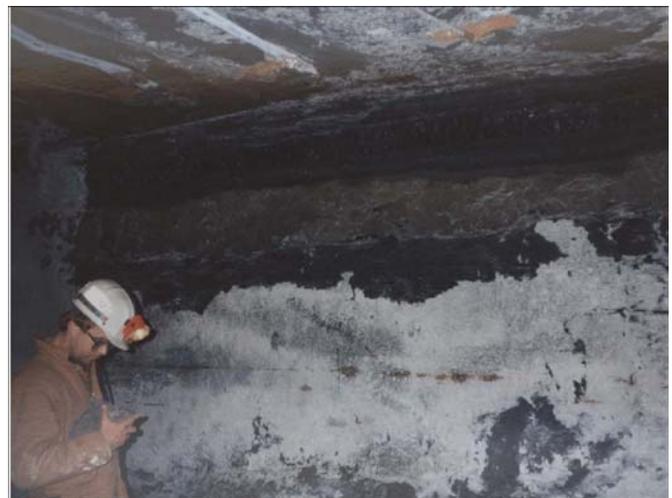
Figure 10.—As a weak seat earth thickens in a southern West Virginia mine roof, it causes roof bolts to miss anchorage in a strong sandstone.

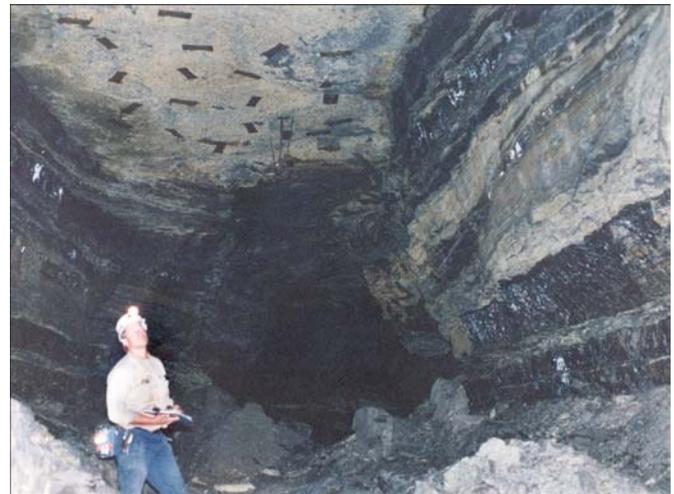
Figure 14.—Rider coalbeds above the main bench of the Pittsburgh Seam.

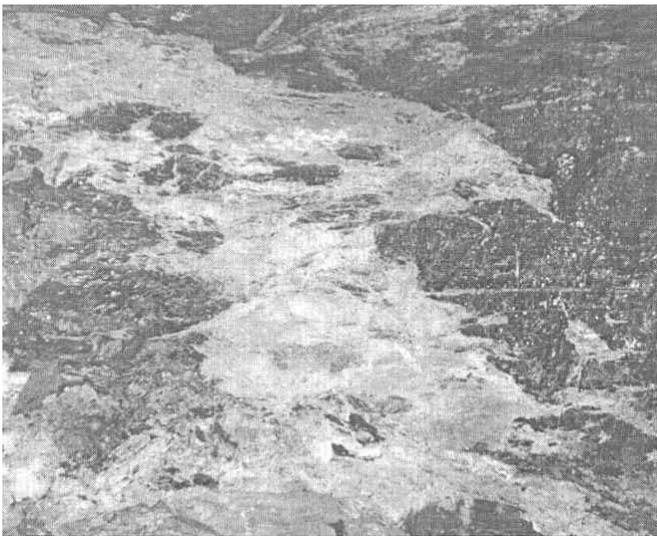
Figure 15.—Clay vein injected into the coalbed. Note inclusion of “floating” coal pieces.

Clay veins or clay dikes occur when soft, ductile roof or floor mudrocks are squeezed into tension fractures in the coalbed. They can also be injected parallel to bedding, or they may occur as a combination feature as in a stairstepping pattern (figure 15). Clay veins and their associated mining problems (water and gas barriers, roof damage) have been well documented [Chase and Ulery 1987; Hill 1986]. On a smaller scale, clay veins have squeezed into existing joint systems. The clay-filled tension features can then form the boundaries of roof falls. Clay veins can range in thickness from millimeters to tens of feet, and the dikes can occur from a single one to one every 10 ft or more often. Roof damage can be severe (figures 16-17). Roof rock dissected by clay veins is already failed upon exposure by mining and can fall out before bolting, covering the continuous miner and limiting cuts to only a few feet before cleanup and bolting. When a clay vein cuts through a pillar corner, large rib rolls can occur. When excess horizontal stress is added to a clay vein-broken roof, mining can be a nightmare. Conversely, there is some indication that clay veins can act as shock absorbers for horizontal stress. They can soften roof enough to prevent some massive roof falls that may have occurred in stiffer roof.

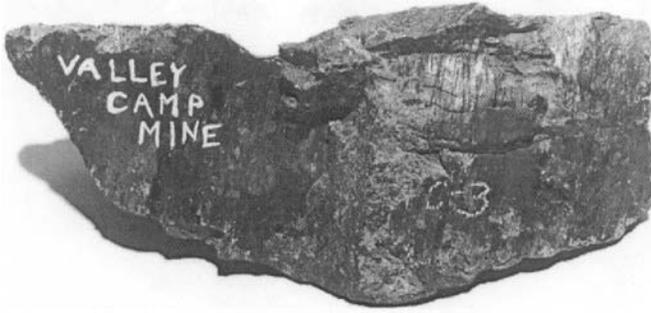
Figure 26.—Slickensides on a rock fallen from a coal mine roof.

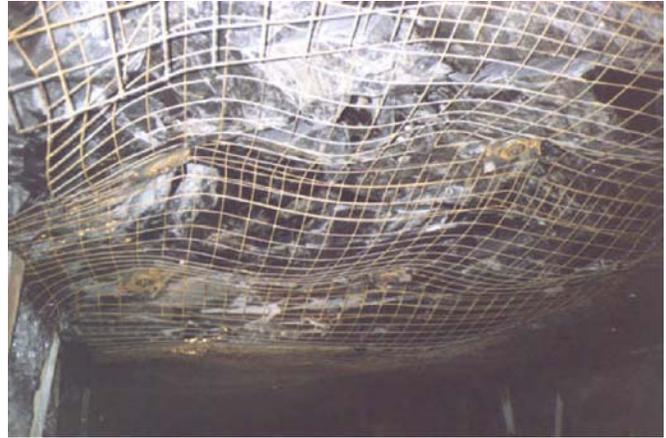
Figure 29.—Metal screen supporting roof scale formed in highly slickensided shale.

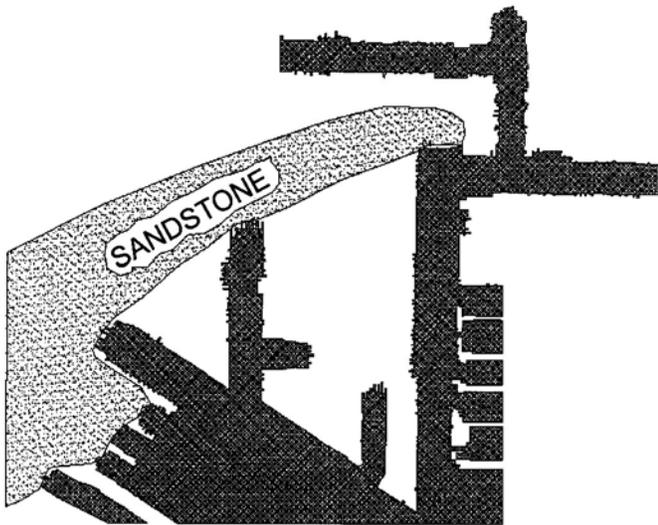
Figure 33.—Complete washout of the coal by a paleochannel in a West Virginia mine terminated numerous headings.

Some disruption occurs during the deposition of the peat swamp. As the channel scours the peat, slumping occurs on the cut bank and crossbedding occurs on the point bar side of the channel. Both features can cause hazards in the future roof strata. Slump surfaces become slickensided by loading. The resulting disrupted, rotated blocks fall between bolts. After burial, even more disruption of the paleochannel and surrounding rocks occurs because of differential compaction. The channel fill acts to point load the soft peat, which flows away from the base of the paleochannel. The result is thick coal sequences and highly sheared and friable rocks on the margin of the paleochannel. Figure 33 shows the effect of a paleochannel system on mining in a mine in the Upper

Freeport Seam in Preston County, WV. At least seven separate developments were prematurely terminated due to complete seam washout or poor roof quality and difficult mining conditions (rolls and splits).

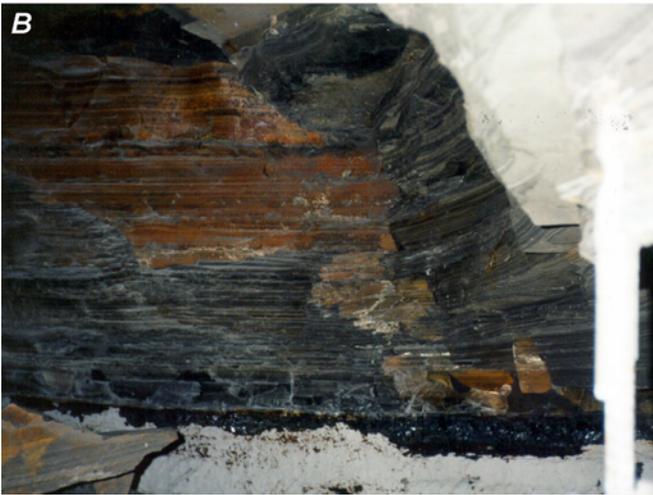
Figure 36.—Roof fall terminating against a large joint face. A, Diagram; B, photograph.

joints may be persistent, extending through numerous roof strata, effectively severing the roof beam. At one western Pennsylvania mine, joints formed the severed termination of a number of roof falls (figure 36). The fall pictured in the intersection had two turnouts, contributing to its oversized intersection span of 74 ft and likely triggering the fall (figure 37).

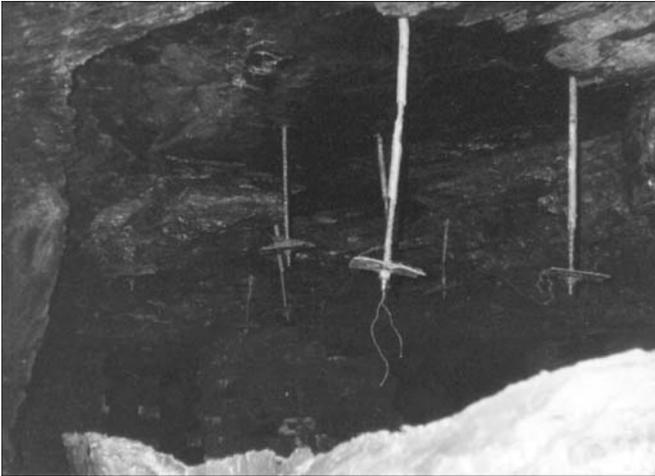
Figure 45.—Roof fall caused by broken rock falling between bolts.

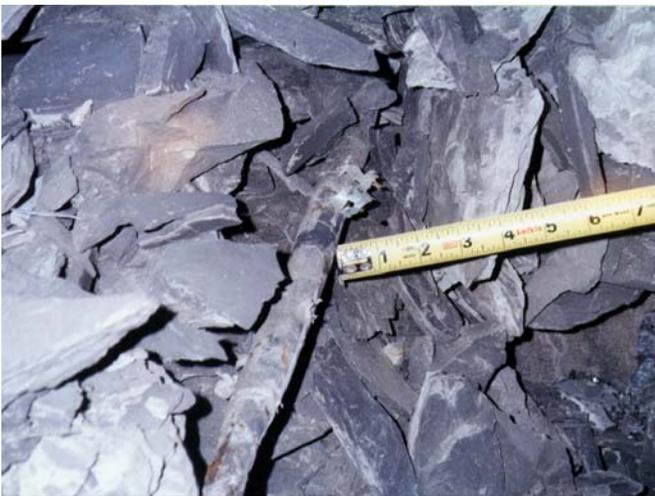
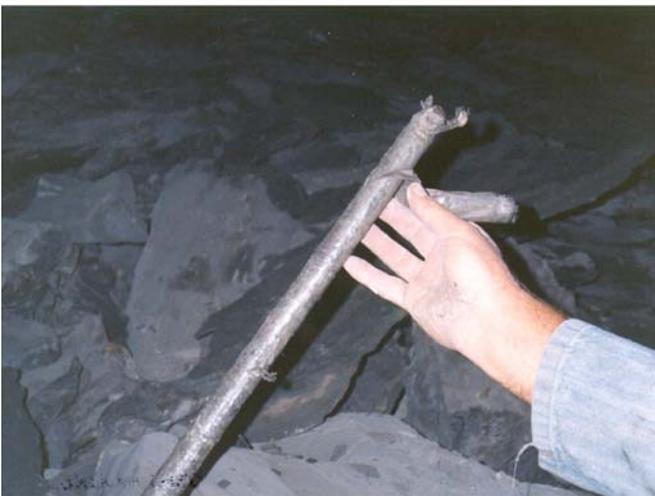
Figure 46.—Two views of "glove-fingered" bolts that provide little mechanical interlock to support strata.

Defective bolts may be the cause of more roof falls than is widely believed. Although sometimes hard to document, it is worth the effort to examine roof bolts in roof fall debris. Poor roof bolt installation can result from a number of practices [Mazzoni 1996]. "Glove-fingered" bolts occur when the bolt spins within the resin cartridge, failing to break the bag and preventing resin contact with the wall of the roof bolt hole (figure 46). At one mine in southern Illinois, nearly all of the bolts observed ($n = 10$) in several roof falls were "glove-fingered." "Glove-fingered" bolts can be eliminated by reducing the resin annulus and spinning the bolt as it is inserted. This can be done by drilling a smaller diameter hole or installing a larger bolt in the hole. One support manufacturer has developed a rebar that has a serrated surface, which ensures complete resin tube penetration during initial inserts of bolt in hole. If mechanically anchored bolts are undertensioned, roof failure can result. If the same bolts
