Injuries associated with continuous miners, shuttle cars, load–haul–dump and personnel transport in New South Wales underground coal mines

Keywords: Underground coal, Injury, Ergonomics, Development equipment

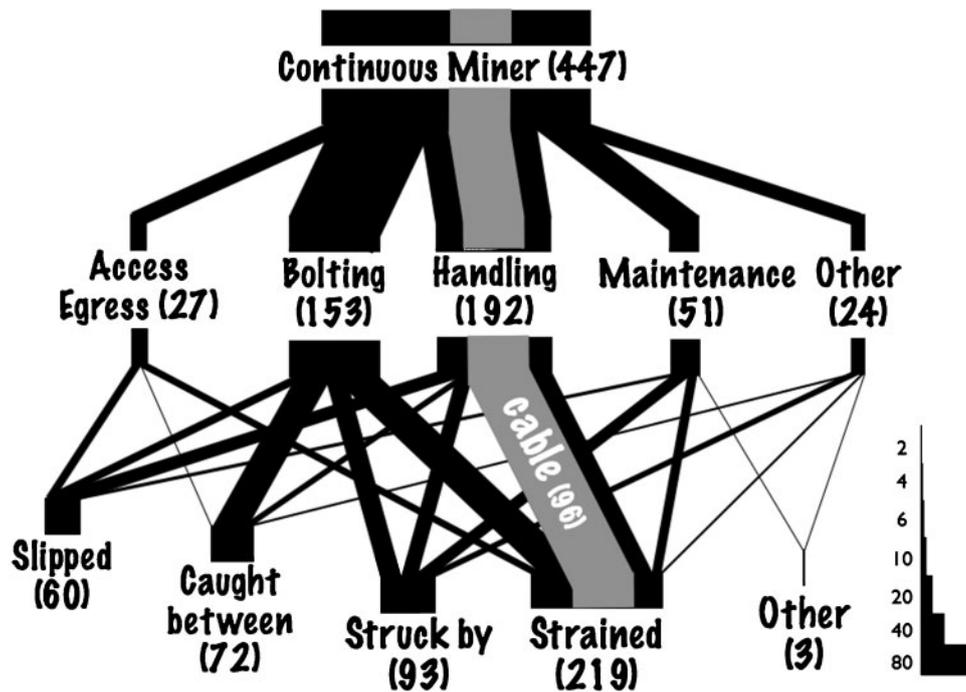
1 Combinations of activity and injury mechanism codes for injuries reported by NSW coal mines involving CMs for three years to June 2005

The data provided in Table 3 and illustrated in Fig. 1 highlight a number of opportunities for controlling injury risks associated with CMs. Strains while handling was the most frequent cause of injury associated with CMs. The majority of these injuries involved handling CM cable. Strains (typically of the shoulder) while bolting were also relatively common and are likely a consequence of handling drill steels and bolts at a distance from the body. Slipping off the CM platform, whether during access or egress, or during operation on the platform, accounted for 60 injuries in the three year period.

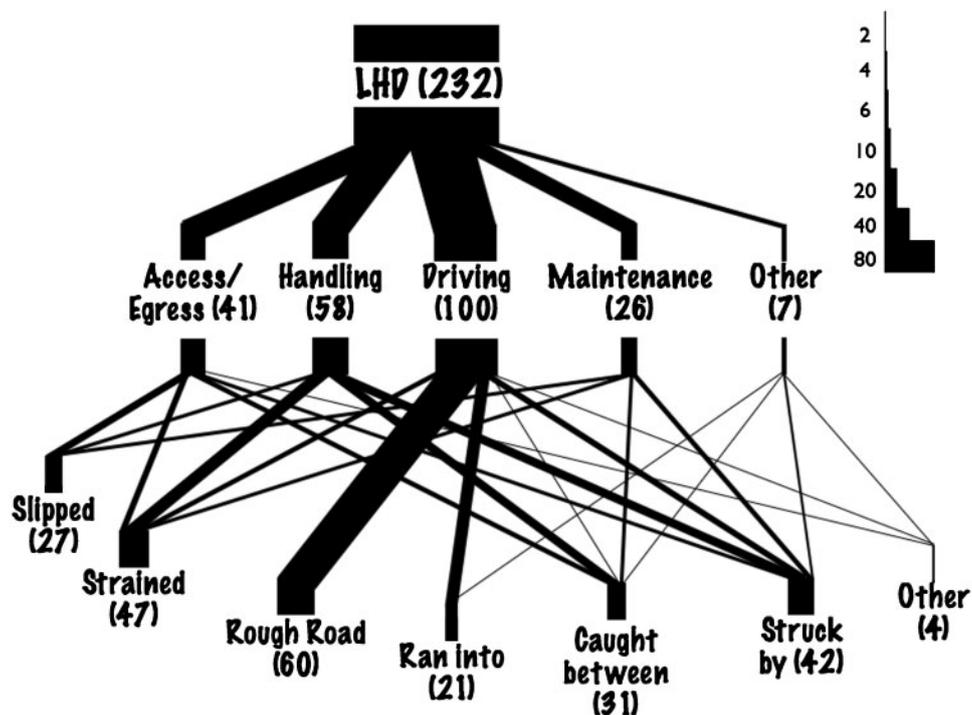
2 Combinations of activity and injury mechanism codes for injuries reported by NSW coal mines involving LHD vehicles for three years to June 2005

The consideration of Figs. 2-4 reveals that the most common cause of injuries associated with LHD, SC and

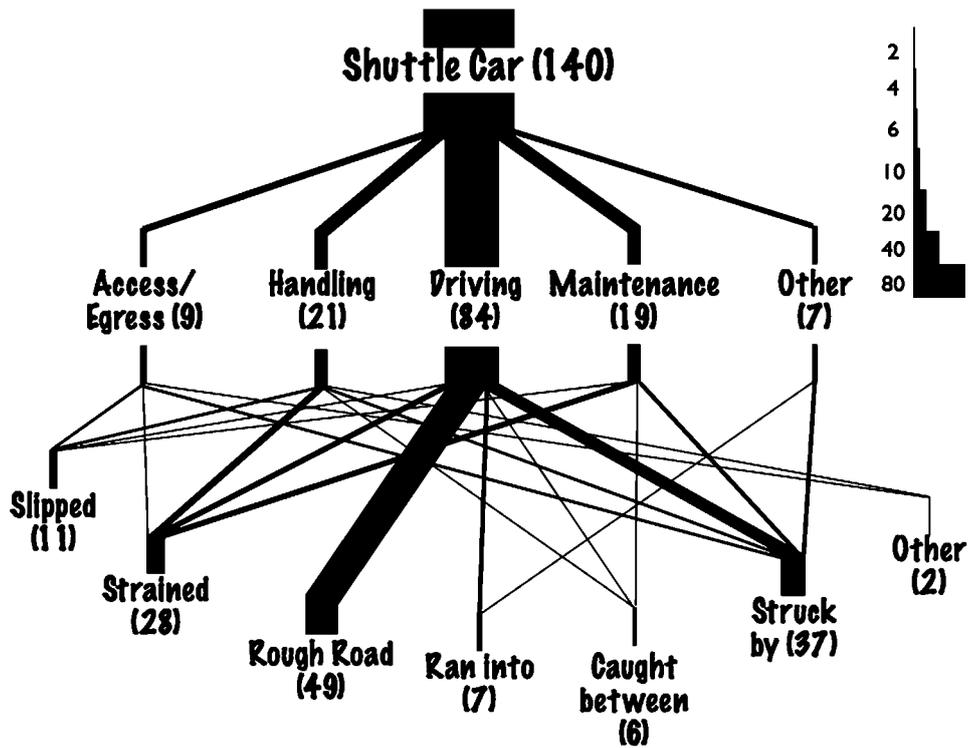
3 Combinations of activity and injury mechanism codes for injuries reported by NSW coal mines involving SCs for three years to June 2005

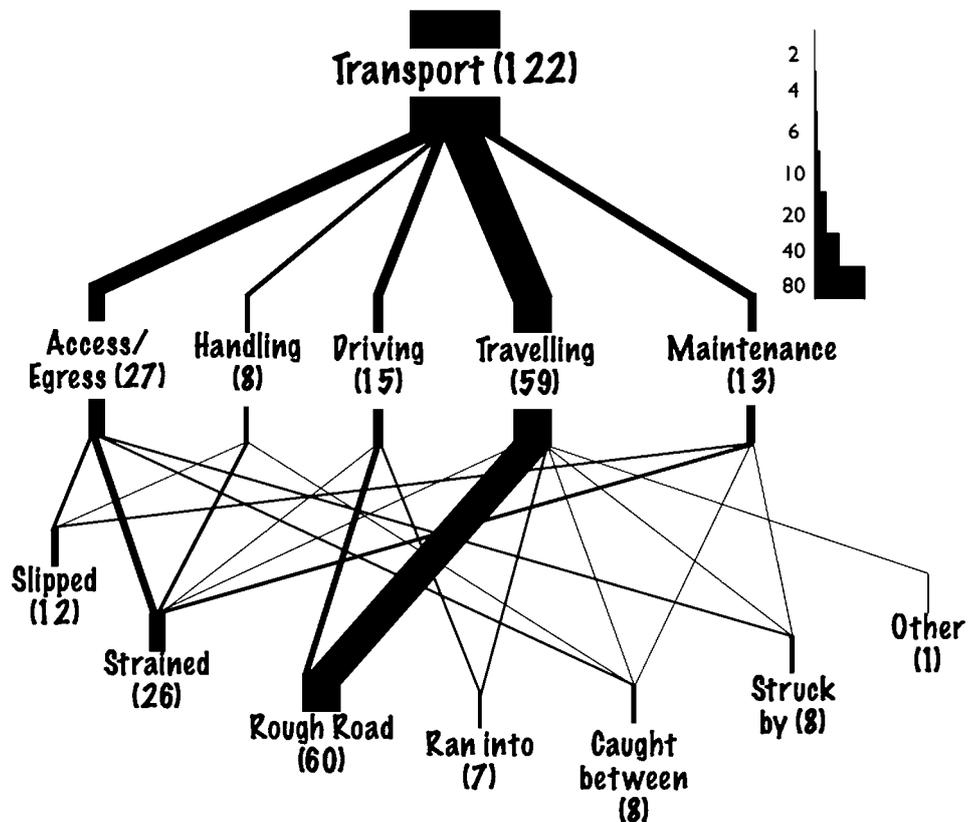
4 Combinations of activity and injury mechanism codes for injuries reported by NSW coal mines involving PT for three years to June 2005

PT vehicles occurred when the vehicle was driven over a pot hole or other roadway abnormality. This mechanism typically causes the driver and/or passengers to strike their head on an internal structure resulting in neck, back or shoulder injuries. An injury mechanism of particular concern because of the potential severity of consequences is 'ran into' while driving (or travelling) LHD, SC or PT (35 injuries).
