SHEAR MECHANISM FOR MINING-INDUCED FRACTURES
APPLIED TO ROCK MECHANICS OF COAL MINES

Brian G. White

Spokane Research Laboratory, National Institute for Occupational Safety and Health, Spokane, WA, USA

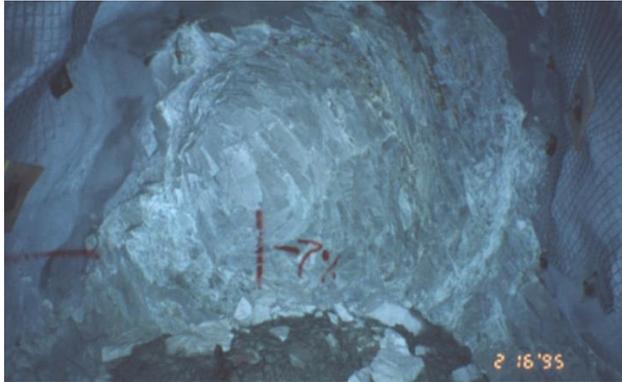
Figure 1. Cavity created by a face-strain rock burst in a development heading of a hard-rock mine.

A rock burst in an Idaho silver mine took place in the face of a development heading that was being driven normal to vertically dipping, massive quartzite beds (figure 1), creating a bowl-shaped cavity centered in the face. Inspection showed that the quartzite had been thinly split on the edges of the cavity (figure 2), but much of the broken rock ejected from the cavity was thicker than the quartzite at the edge of the cavity. Inspection of the walls after the next advance showed no evidence of splitting. Thus, the splitting was confined to the edge of the cavity and evidently represented

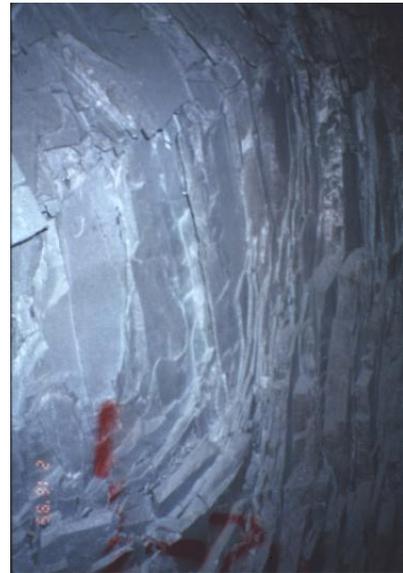
Figure 2. Edge of burst cavity shown in Figure 1. Note closely spaced fractures.

many individual fractures that were progressively offset with depth along the cavity edge toward the center of the face (figure 3*A*). This contrasts with a classic view presented by Fairhurst and Cook (1) that mining-induced fractures extend all the way across a face or surface.

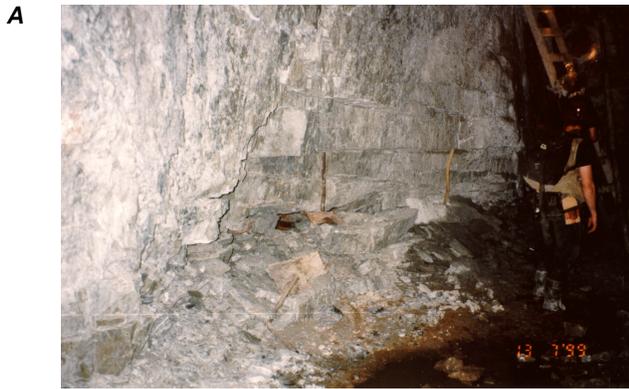
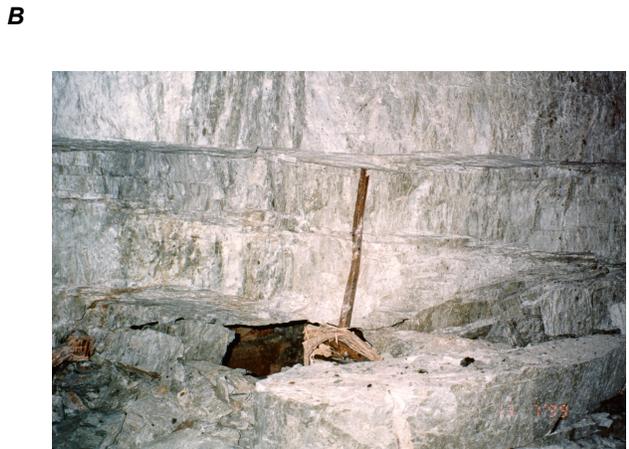
Figure 4. Cut (or drift) in a steeply dipping hard-rock vein. A, View along wall. Photo taken while standing on sandfill from previous cut. Note mining-induced fractures and temporary friction rock bolts from roof of previous cut exposed in wall. B, View of wall showing bent rock bolt offset by shear displacement along an echelon fracture zone.

This example (figure 4) is in a steeply dipping, narrow vein. The vein is mined by the overhand method, which involves mining the vein in a horizontal cut or drift, filling the cut with sand, and then driving a new cut on top of the sand. Thus, mining advances along a longwall front in an ore body that stands on end.

Split-Set¹ rock bolts provide temporary support during the mining of each cut. Since the vein was not quite vertical, each cut was slightly offset from the one preceding, so that bolts installed in the roof of the previous cut were sometimes exposed in the next cut above (figure 4). High stress around the ends of the mined portion created horizontal fractures that became exposed in the walls and face of each new cut (figure 4B). In figure 4B, a rock bolt from the previous cut intersects fractures that were induced by mining, as shown by shearing offset of the bolt. It is also evident that the fractures involved are not continuous, but form a zone of systematically offset, or en echelon, fractures. Such fracture zones have been found to be common in the deep hard rock mines of Idaho.

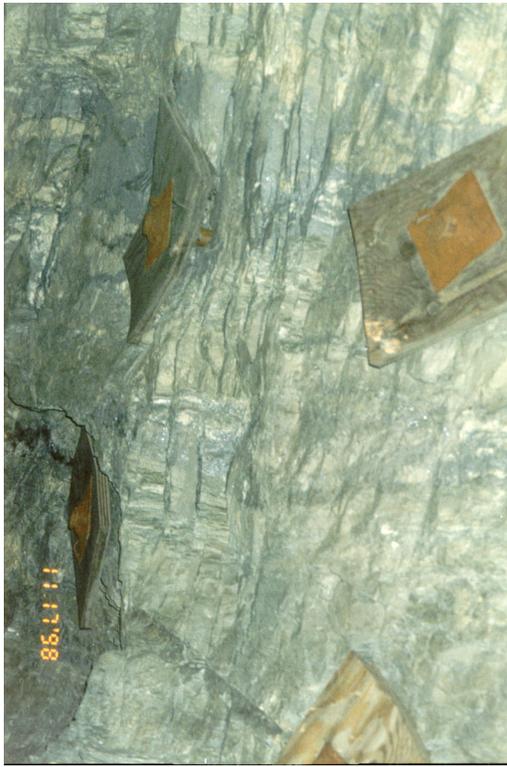
Figure 8. Mining-induced fractures parallel to the face in longwall mines. A, Hard-rock mine, vertical vein (photo rotated 90° to approximate geometry of flat-dipping coal); B, proposed origin of fractures in coal mines as result of shear displacement along angle of draw.

A familiar fracture type seen in longwall coal mines, as well as in South African longwall gold mines and Idaho silver mines, is one that forms parallel to the face. This type is instrumental to cave development (figure 8). These fractures apparently form in the region of high, nearly vertical stress that is concentrated ahead of the face (figure 8B).

Longwall mines are also characterized by subsidence that extends beyond the face a distance partially defined by the draw angle ϕ (figure 8B). In addition, horizontal stress changes associated with subsidence increase compressive stress over the longwall panel and create tension adjacent to the edge of the draw (4).

The opportunities for shear as a result of the high vertical stress near the face are limited. A direction describing gravitationally assisted movement toward the gob is strongly favored. Thus, a preferred direction of shearing extends upward along the angle of draw. As the face advances, the fractures are pressed closed along the upper edge of the active shear zone and opened below.
