MIFACE Investigation Report: #13MI019

Subject: Bus Driver Died While Attempting To Open Bus Doors While Bus Was Moving

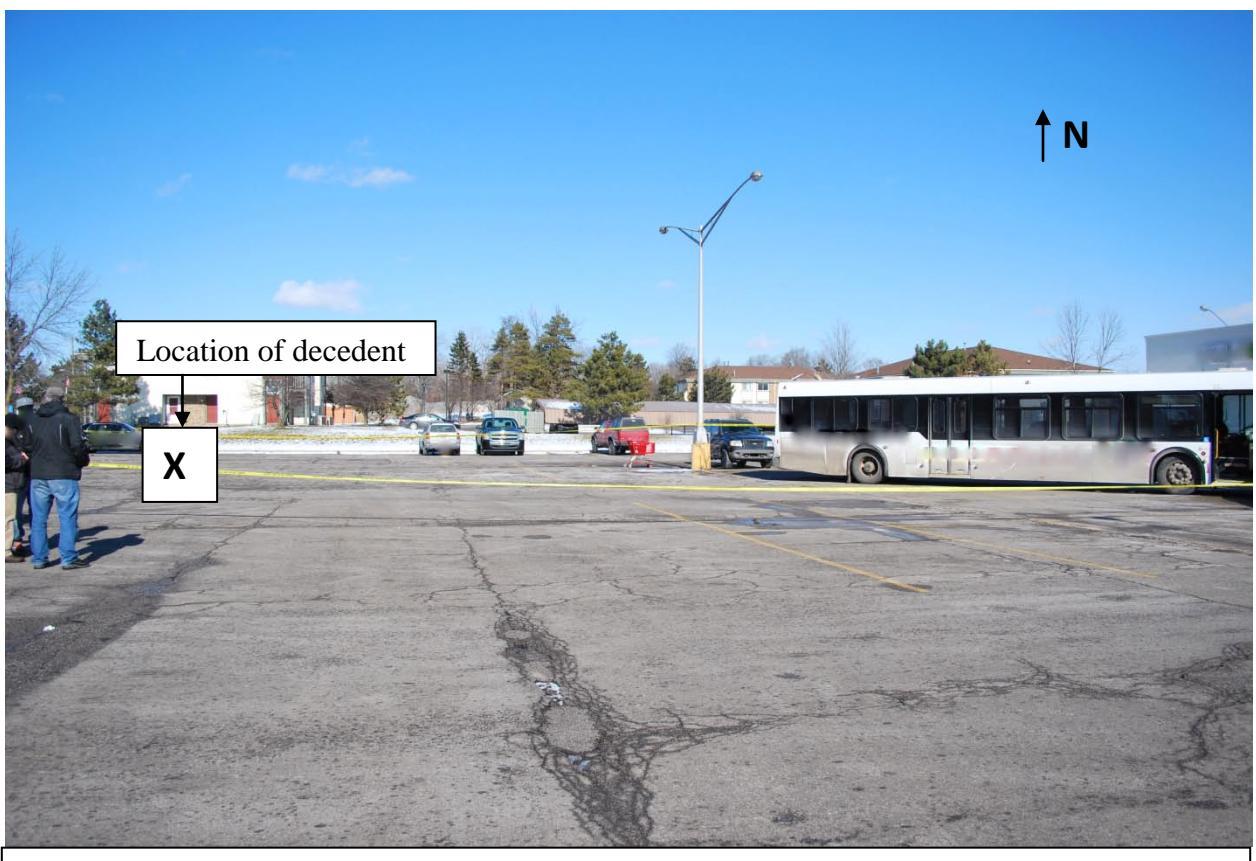
Figure 1. Overview of Incident Scene

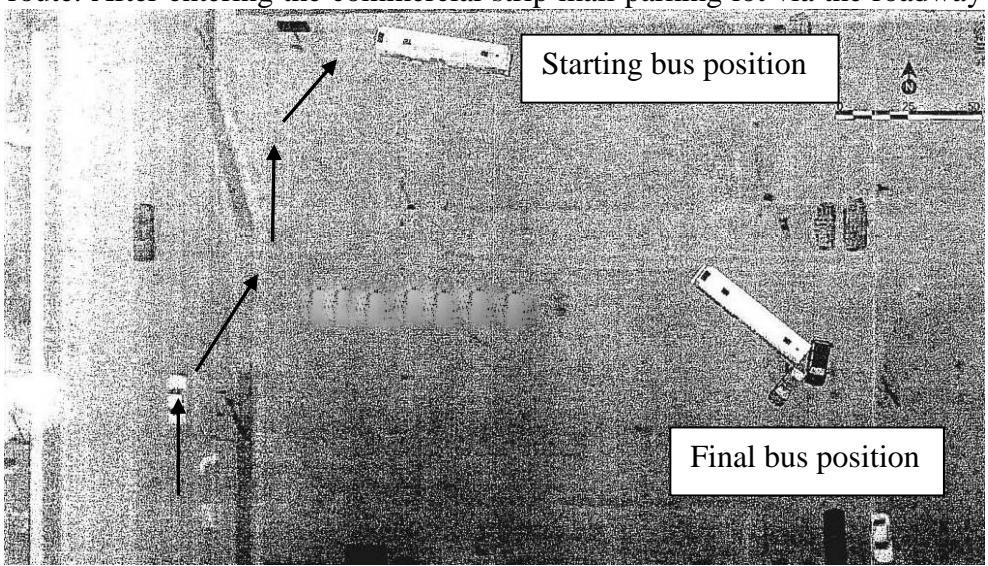
Figure 2. Police report overhead of incident scene

The bus was situated so it faced east and was positioned near the top of a slight downward slope in the parking lot. The bus wheels were turned slightly to the right, toward the center of the parking lot.

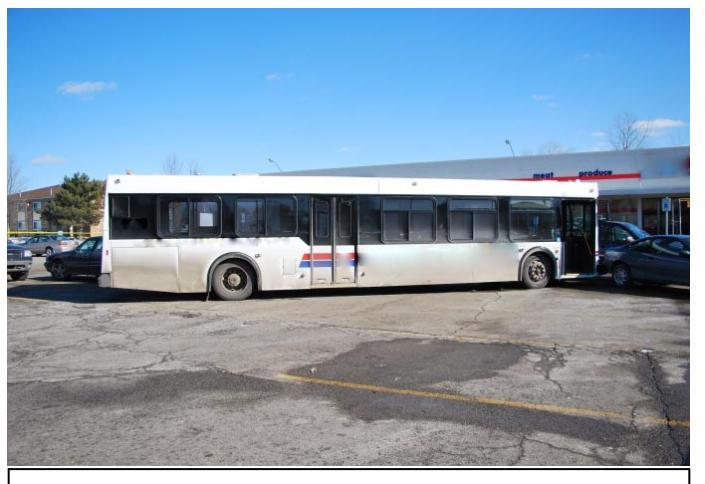
Emergency response was called. The bus continued across the parking lot and collided with two unoccupied parked vehicles, stopping its forward momentum. The police department was first on

Figure 3. Final resting position of bus against parked cars
