# Death in the line of duty...

#### Two Volunteer Fire Fighters Die in a Tanker Rollover – North Carolina

Fatality Assessment and Control Evaluation Investigation Report # F2007-25

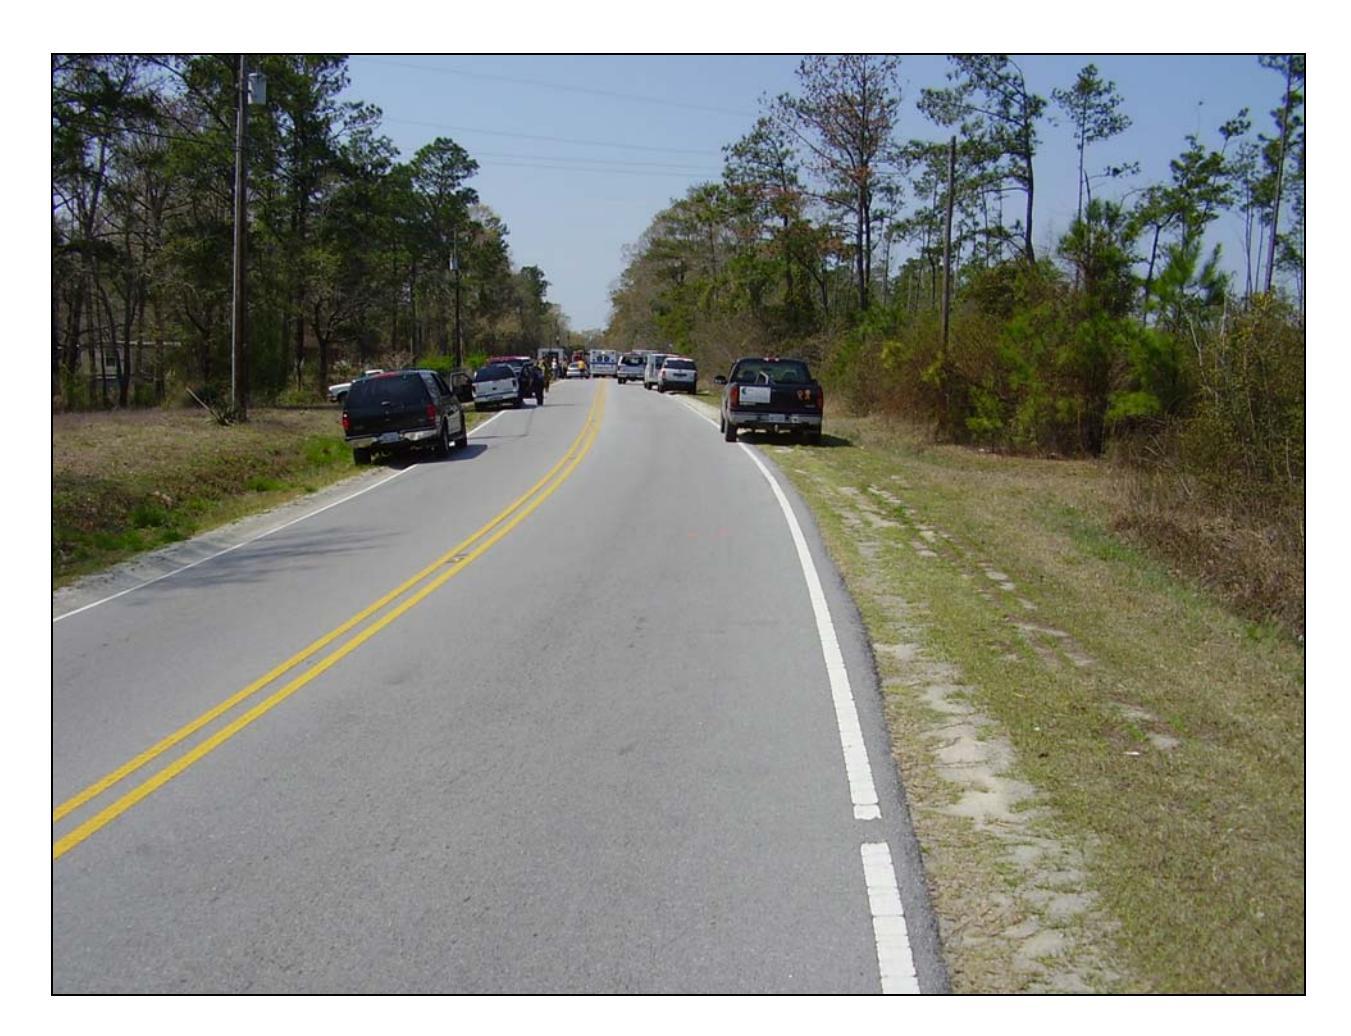
At approximately 1146 hours, the department was dispatched to a structure fire for an automatic aid call. At approximately 1150 hours, the tanker departed the station with victim #1 driving and victim #2 riding as a passenger, with the lights and siren activated. Two fire fighters and a junior fire fighter riding in a privately owned vehicle (POV) responded behind the tanker. The route to the fire was a two-lane state road, with a posted speed limit of 45 mph (Photo 1). The tanker was travelling westbound.

Photo 1. Westbound view of the road the tanker was traveling. (Photo courtesy of the NC State Highway Patrol)

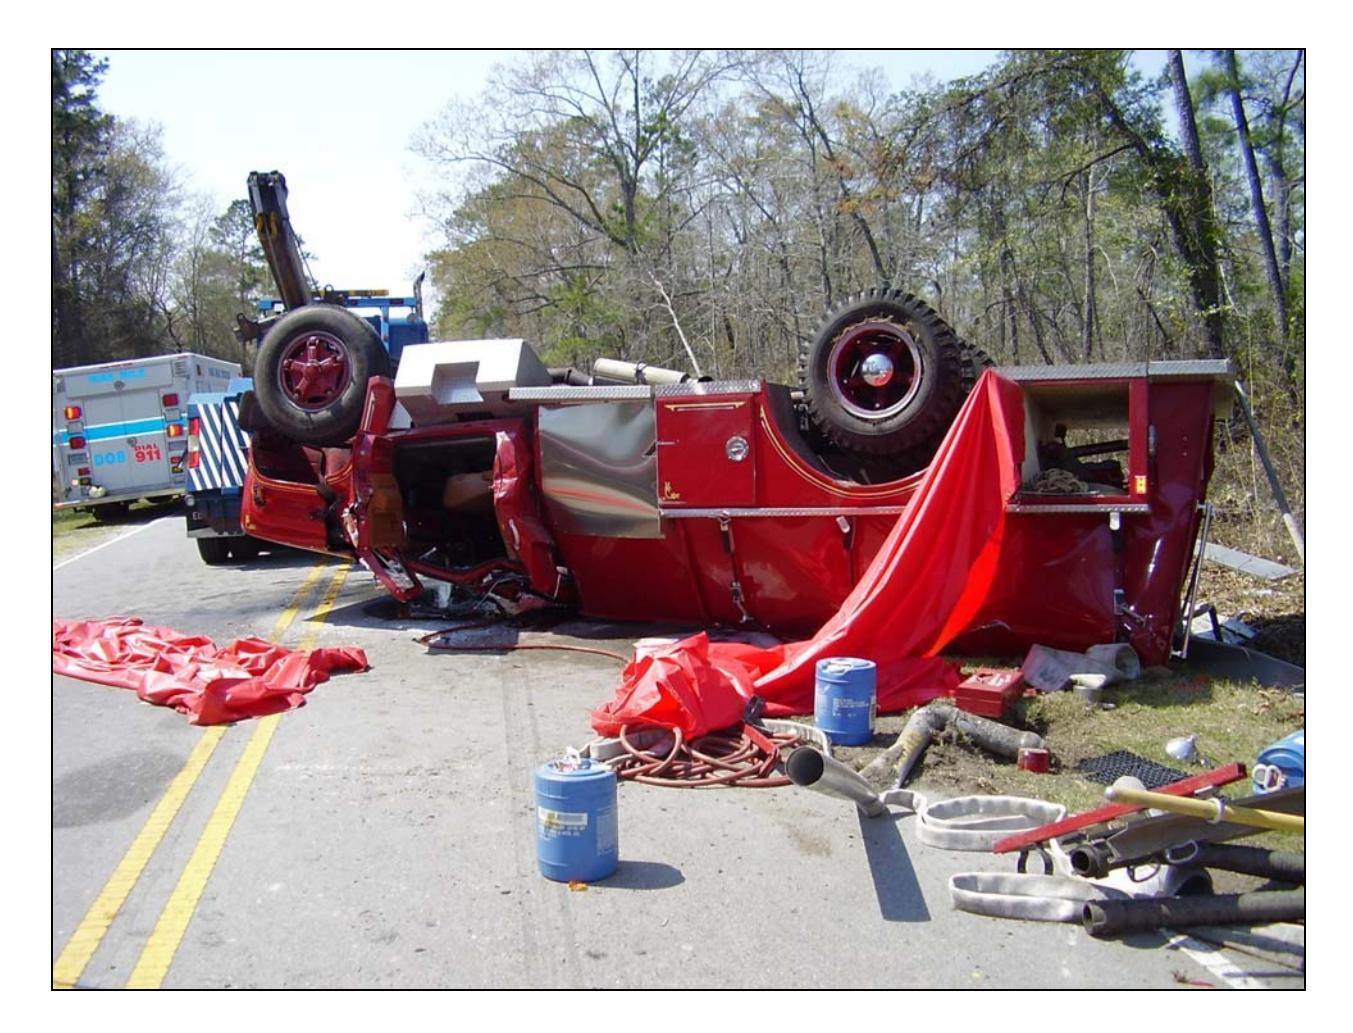
After traveling approximately two miles and completing a slight right curve, victim #1 braked and steered the tanker towards the left side of the roadway. The tanker crossed over the double yellow center-line, and victim #1 attempted to steer the tanker back towards the right side of the road. According to the state highway patrol, victim #1 overcorrected and the tanker began to skid sideways across the roadway. The tanker temporally ran off the right-side of the roadway, then proceeded to skid back onto the road and began overturning. According to witness statements, the tanker rolled over three to four times onto the roadway.

The state highway patrol estimated that the tanker continued to travel 55 feet before it came to rest sitting upside-down and lying across the roadway and partially on the westbound shoulder of the road (Photo 2). The state highway patrol estimated that the tanker was traveling approximately 50 mph at the time of the incident, and concluded that neither of the victims were wearing a seat belt.

Photo 2. Incident scene (Photo courtesy of the NC State Highway Patrol)
