A summary of a NIOSH fire fighter fatality investigation

### Career Fire Fighter/Paramedic Dies 2 Days After Being Ejected During an Ambulance Rollover Incident – Georgia

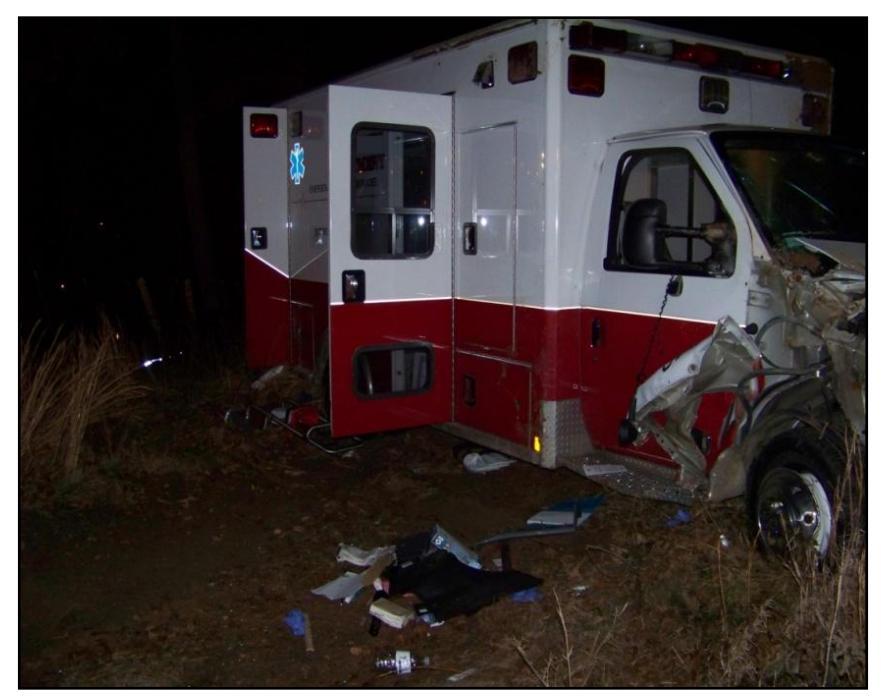
Front view of ambulance after the incident. (Photo courtesy of fire department.)

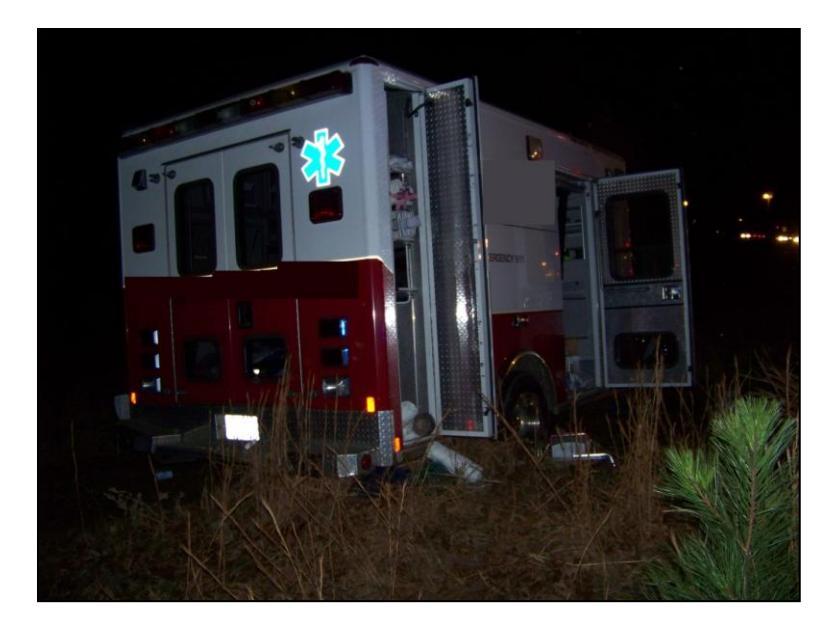
Rear view of ambulance after the incident. (Photo courtesy of fire department.)

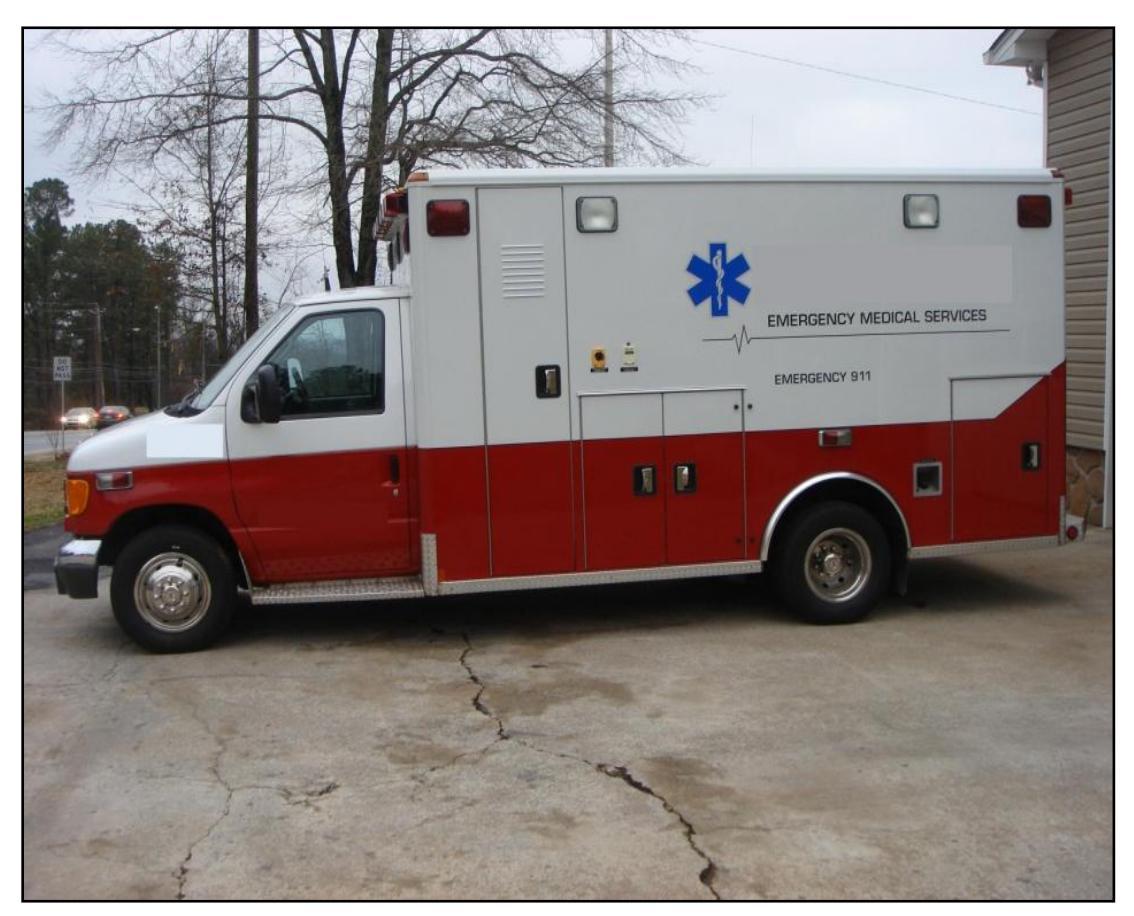
The incident involved an ambulance with a fire fighter/emergency medical technician (EMT) driver and a fire fighter/paramedic attendant (the victim). The ambulance involved in this incident was a 2006 Type III<sup>a</sup> Class 1 (4x2) with a diesel engine, automatic transmission, and anti-lock brakes. The vehicle was also equipped with three-point lap and shoulder belts in the front compartment. The patient compartment of the ambulance was configured with five seating positions, each equipped with a two-point lap belt. These riding positions included a bench seat accommodating three individuals; a rear-facing, high-backed attendant's seat; and a cardiopulmonary resuscitation chair. The cot provided patient restraint belts for the shoulders, pelvis, and lower legs. The incident ambulance was one of three identical ambulances purchased in 2006 by the fire department (see Photo 1).

Photo 1. An identical ambulance purchased by the fire department. *(NIOSH photo.)*

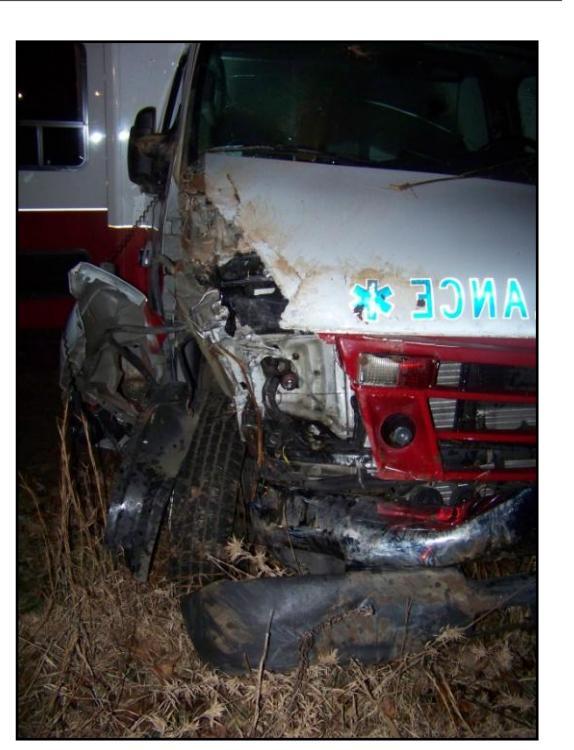
The state of Georgia traffic crash report stated that the front passenger side of R5 struck the POV on the driver side door (see Photo 2). The airbags did not deploy, and it was undetermined whether the victim was wearing his seat belt.

Photo 2. Vehicle damage to ambulance after impact with POV. (*Photo courtesy of fire department.*)

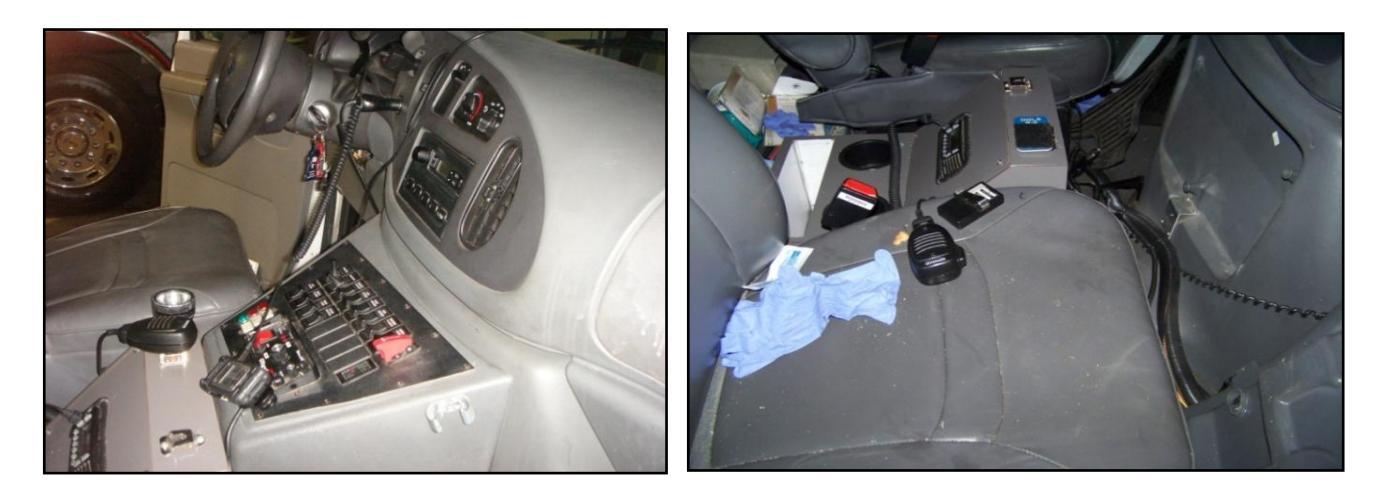
Within the front compartment, the master console broke away from the floor and dash mounts and other dashboard covers came off (see Photo 3 and Photo 4). The front compartment space remained intact and did not show damage past the A-pillar, and the patient compartment remained intact during the rollover incident (see Photo 5). Fire department officials stated that the ground was soft and wet from several days of rain, which may have cushioned the ambulance as it rolled.

Photos 3 and 4. Driver compartment of an identical ambulance (left photo) and driver compartment of the involved ambulance following the rollover incident (right photo). (NIOSH photo at left; right photo courtesy of fire department.)

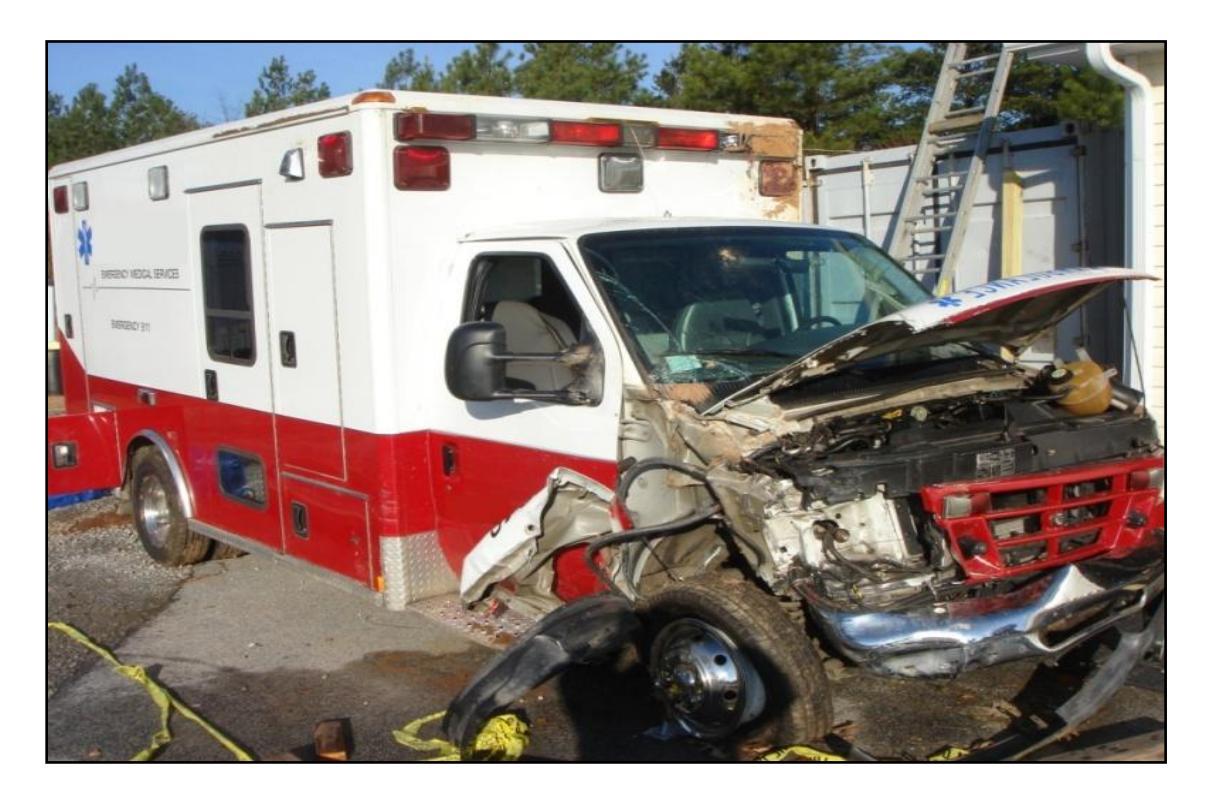
Photo 5. Exterior of the involved ambulance showing no obvious intrusion into the front and patient compartments. (NIOSH photo.)

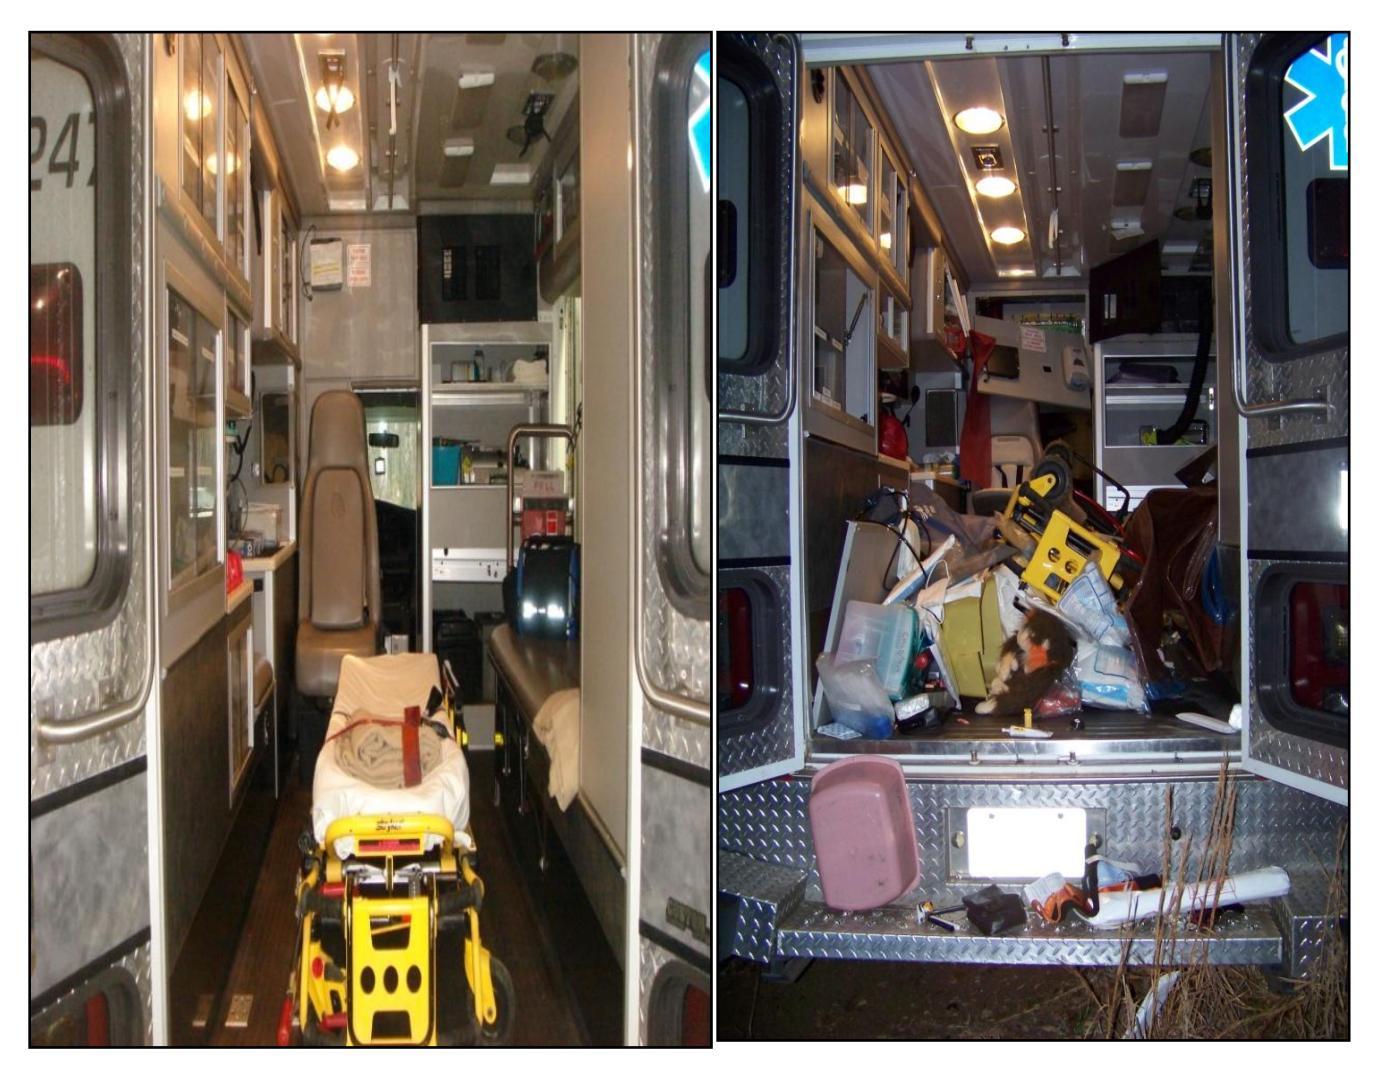
Fire department photos reviewed by the NIOSH investigator showed the potential for injuries if there had been a patient or attendant in the back of the ambulance. When the ambulance rolled, the cabinets opened up spilling their contents into the patient compartment, the bench seat and support rail came apart, the cot came undone from the floor locking mechanism, and EMS equipment (e.g., oxygen cylinders, medical bags, automated external defibrillator) were thrown throughout the compartment (see Photos 6-9). All these objects became projectiles, which had the potential to injure anyone riding in the patient or driver compartments.

Photos 6 and 7. Typical fire department patient compartment (left photo) and patient compartment of the involved ambulance after the rollover incident (right photo). (NIOSH photo at left, right photo courtesy of fire department.)

Discussion: Although there is no evidence that the following recommendation would have prevented this fatality, it is being provided based on inspection of the ambulance patient compartment which showed the potential for injuries if a patient or attendant had been in the patient compartment. During this incident, the oxygen cylinder came out of its housing device, cabinets opened up dumping equipment and material, equipment stored on countertops was displaced, the cot came loose from its floor mount and flipped upside down, and coverings for mechanical and electrical compartments came off. Although the patient compartment was unoccupied during this incident, these items became projectiles that may have posed an injury risk to patients and care providers had they been present in the compartment.

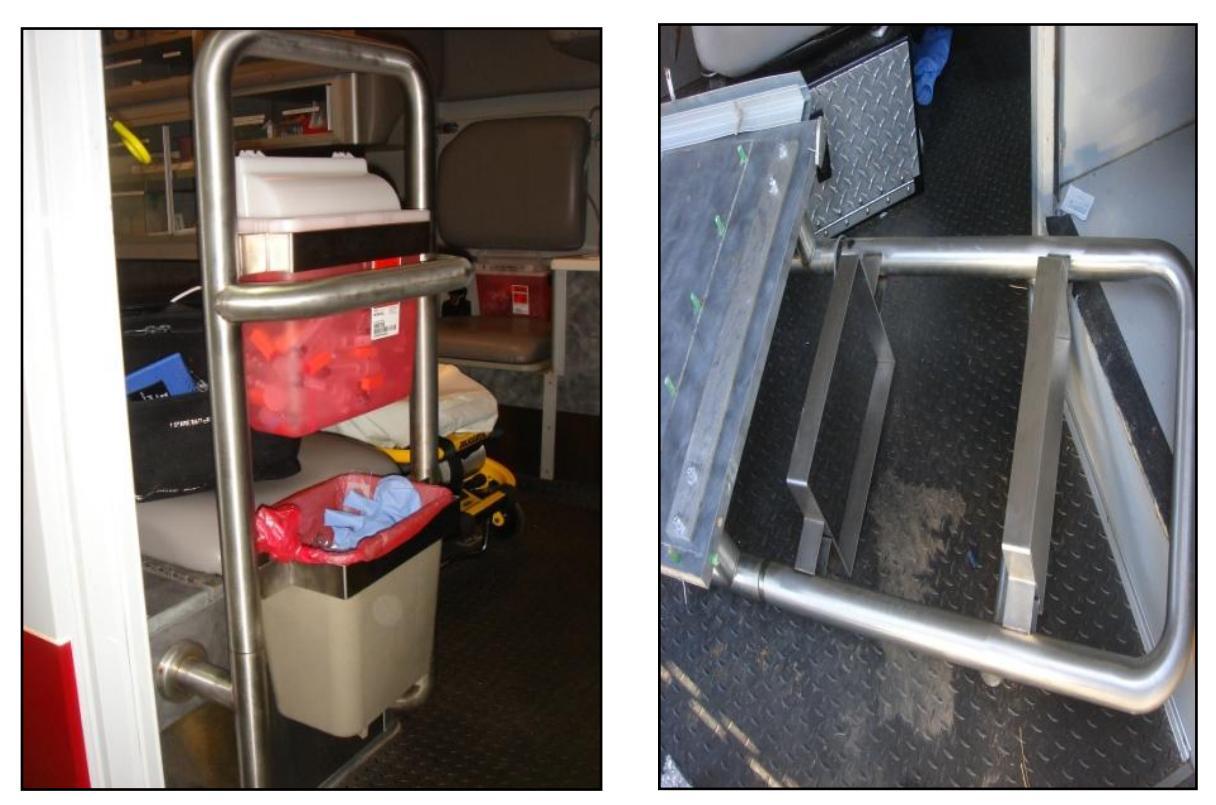
Photos 8 and 9. Typical fire department bench seat support rail (left photo) and bench seat support rail of the involved ambulance after the rollover incident (right photo). (NIOSH photo.)

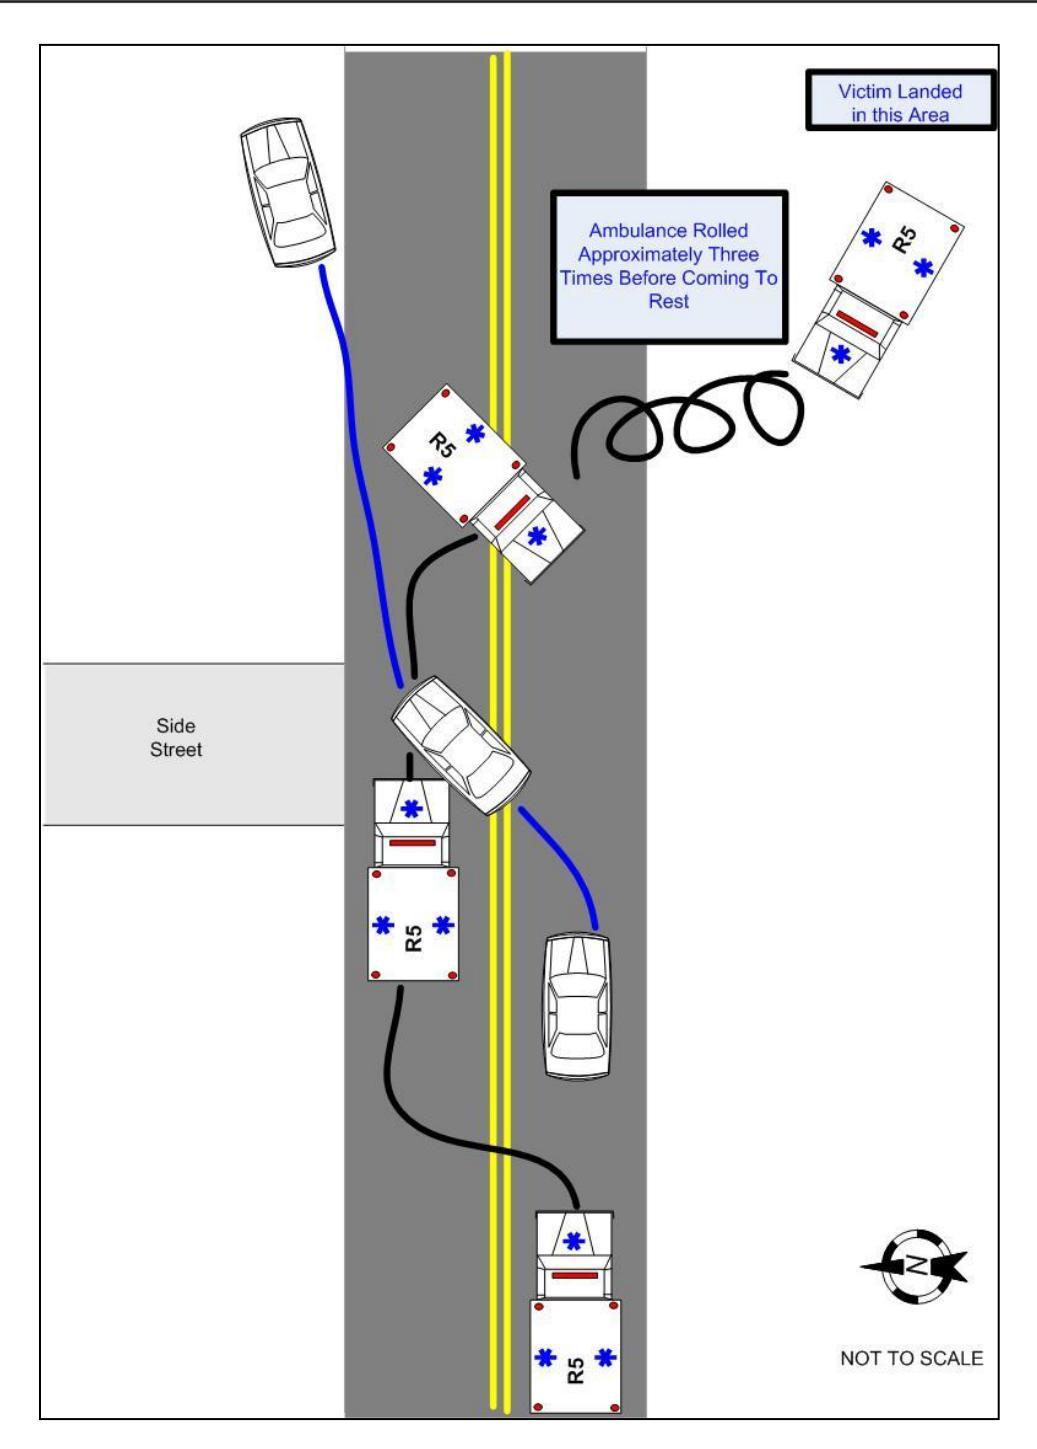
Diagram of the incident scene.
