A summary of a NIOSH fire fighter fatality investigation

February 28, 2011

Volunteer Chief and Fire Fighter Die After Being Ejected During a Rollover Crash—Virginia

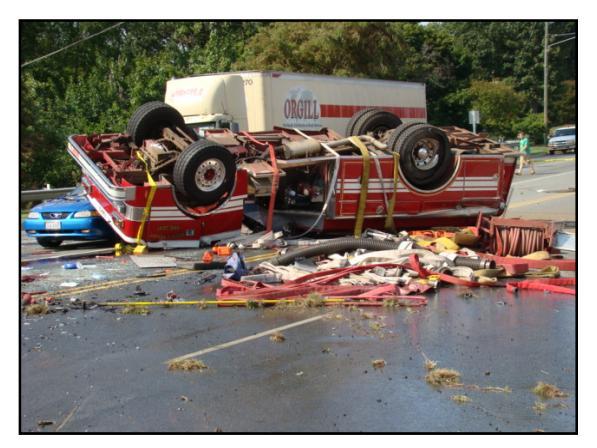
Crash photo. (Courtesy of the Franklin News Post.)

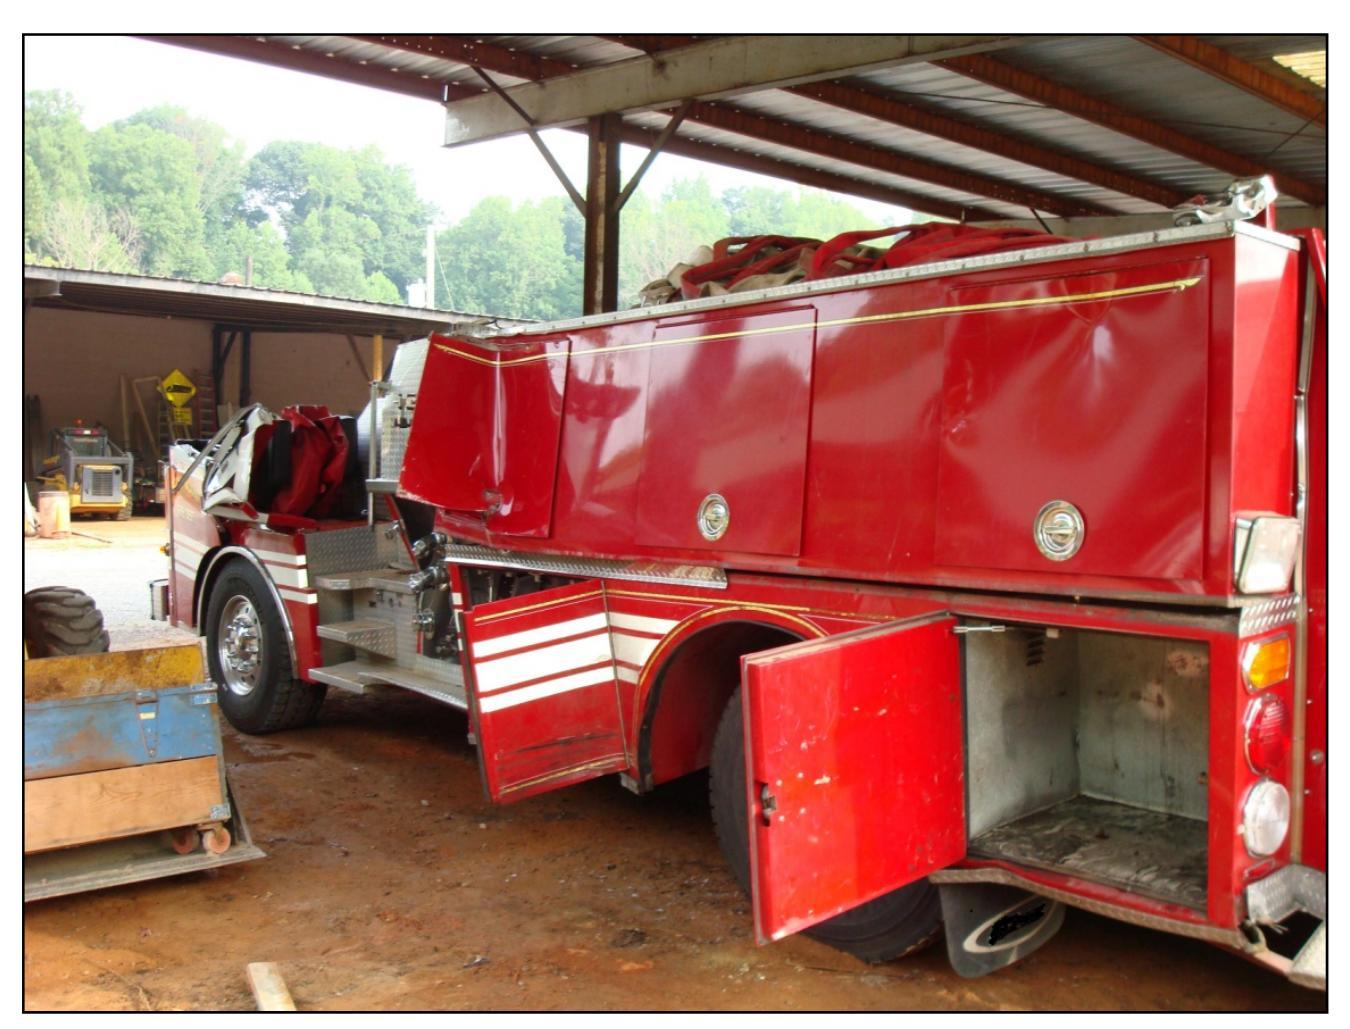
The engine involved in this incident was a 1988, 1,250-gpm custom engine with a 1,000-gallon water tank (see Photo 1 and Photo 2). The fire department purchased this pumper as a used vehicle from another department approximately 10 years prior to the incident. The gross vehicle weight rating of the engine was 37,180 lbs. The engine had an automatic transmission, diesel engine, air-actuated drum brakes with no auxiliary braking devices, and two axles with six wheels (two in the front and four in the rear). The engine had an electronic siren, air horns, and emergency lights. The engine had seat belts for the driver and passenger. The water tank was inspected at the town's storage facility and appeared intact, although the configuration of the tank baffles could not be verified at the time of the inspection. The two victims were the only personnel on board the engine at the time of the crash.

Photo 1. Side view of the apparatus, post incident at the storage facility. (NIOSH photo.)

In this incident, the fire truck was a 1988, two-door, open jump-seat custom chassis that met all the minimum requirements for fire truck safety standards and design in effect on the date of manufacture.

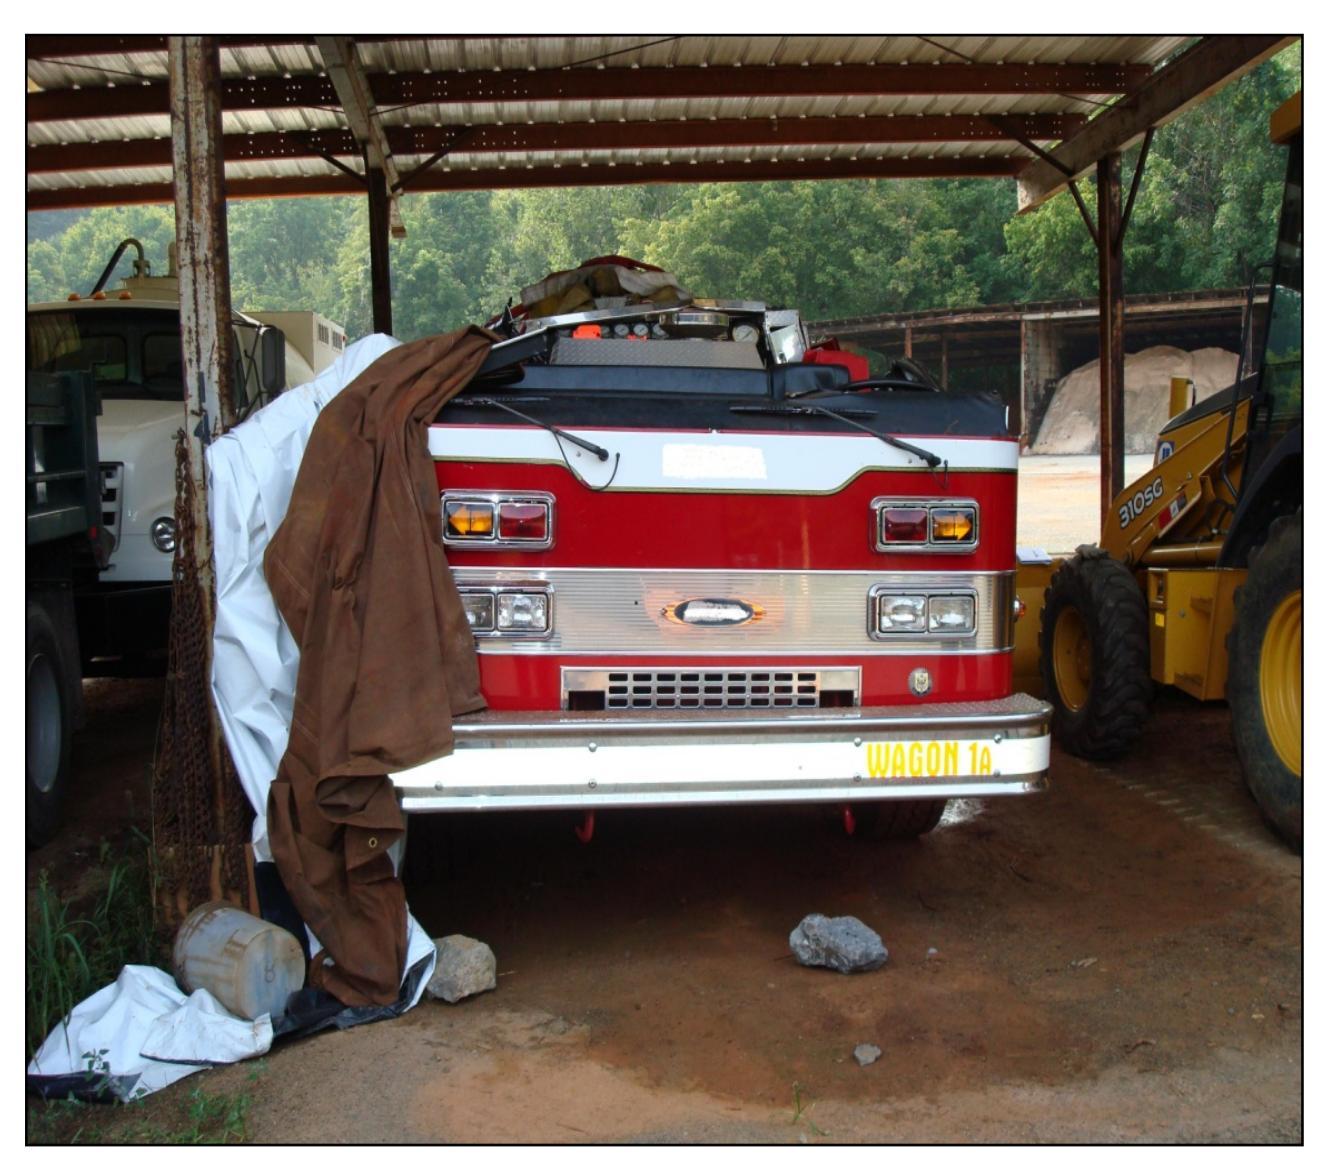
Photo 2. Front view of apparatus post incident with top of cab sheared off by crash impact. (NIOSH photo.)

In this incident, the driver and the passenger were not wearing seat belts and were ejected. The roof of the cab was crushed down significantly (see Photo 2 and Photo 4). The driver's seat and passenger seat lacked a mechanism to automatically retract the seats down, and the cab roof was not strong enough to prevent the intrusion into the driver and passenger's compartment.

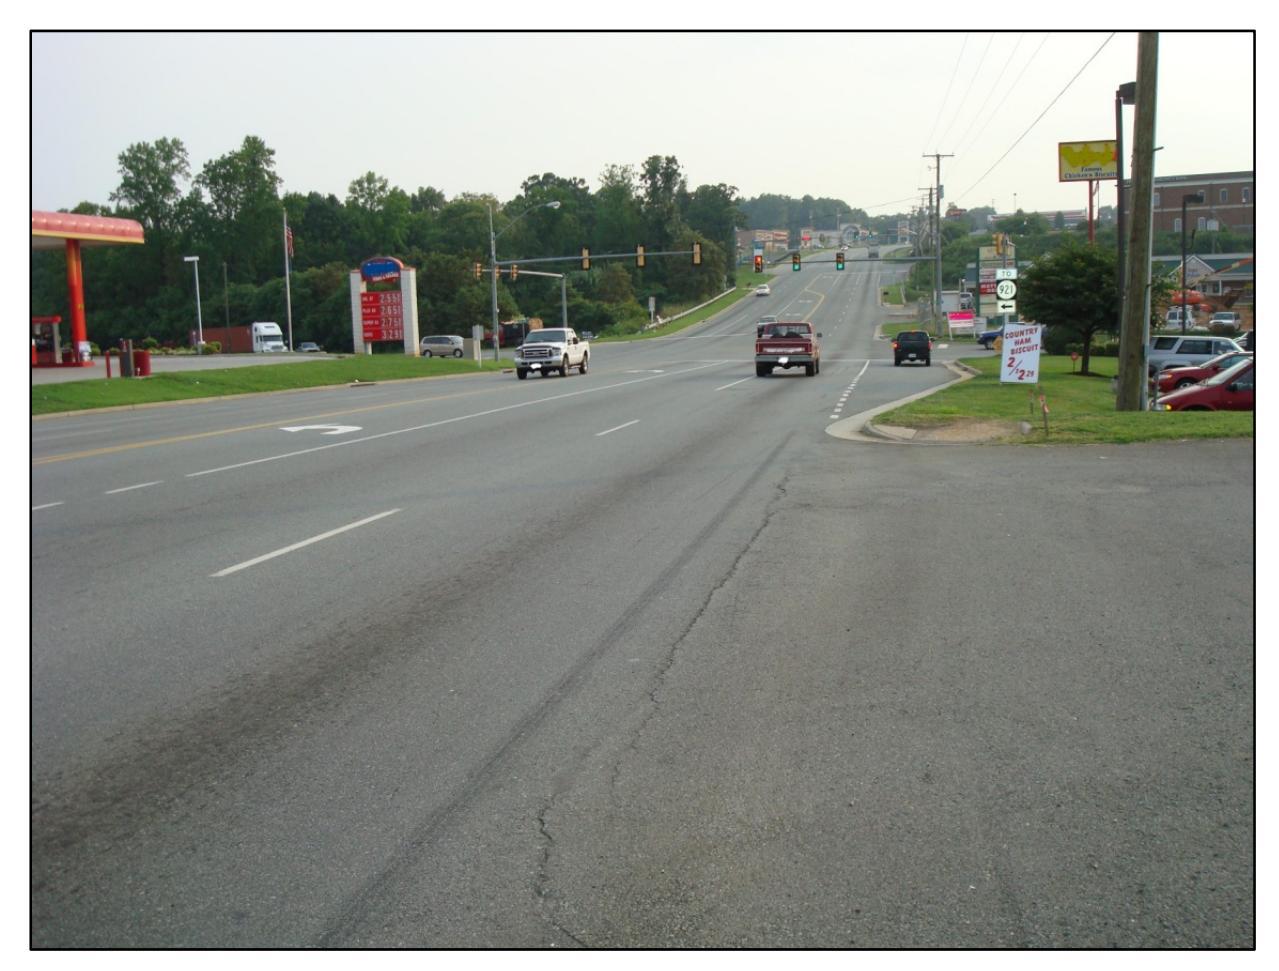
Photo 3. Intersection where crash occurred (same direction of travel as incident apparatus, eastbound). (NIOSH photo.)

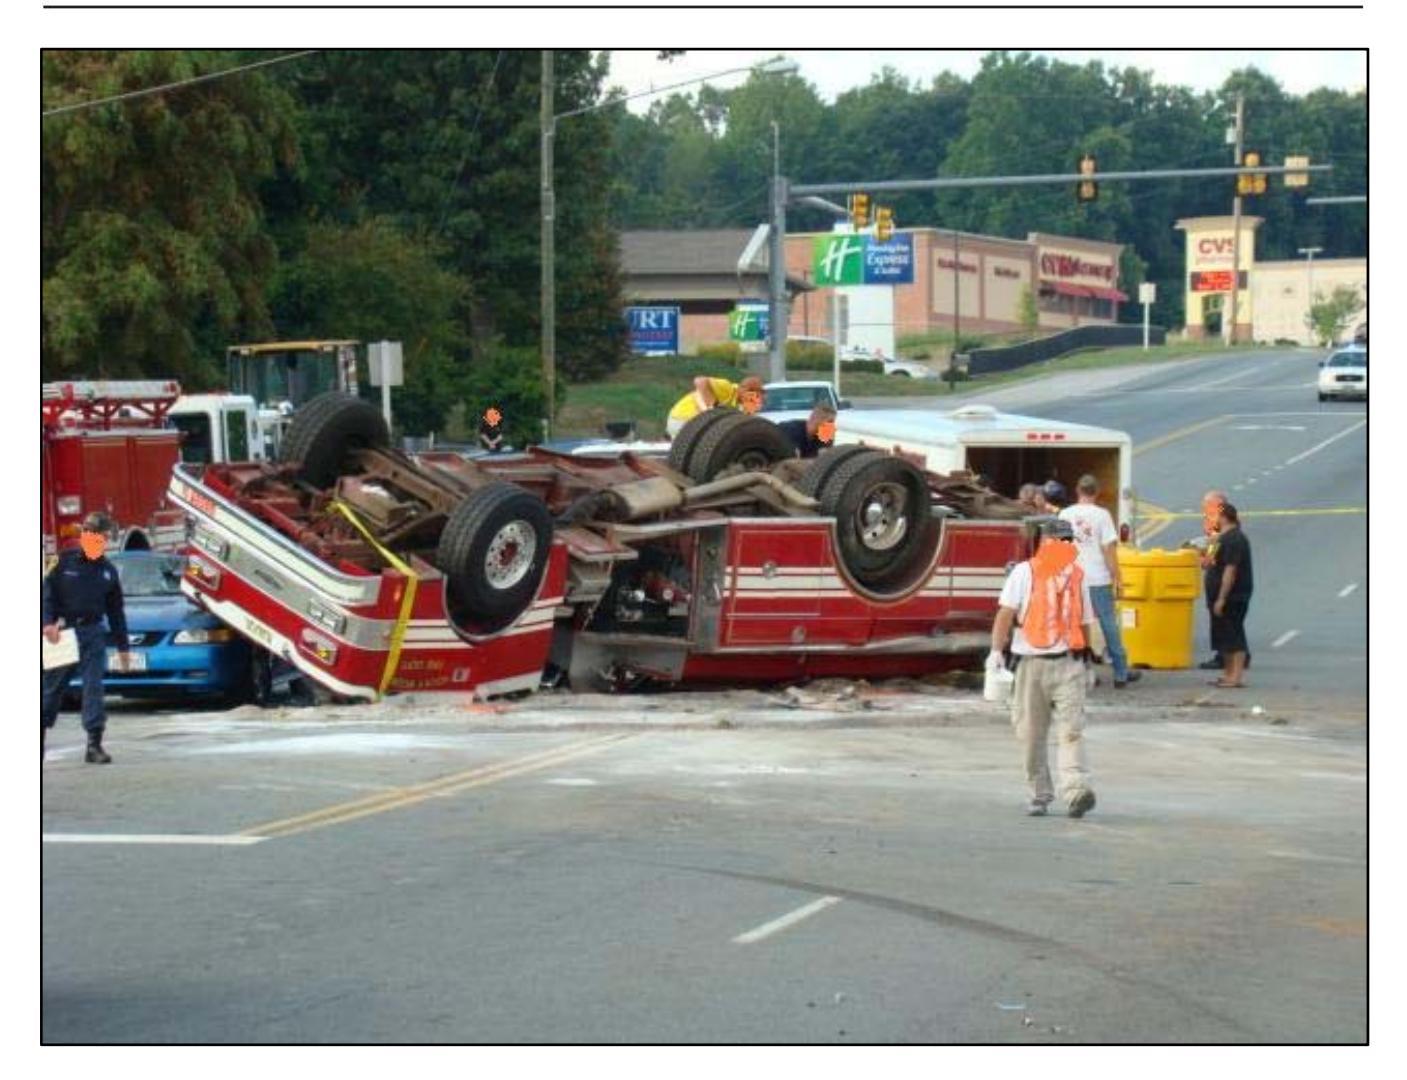
The engine had traveled approximately 1.8 miles when it encountered the red light at the intersection. The engine entered the intersection and was struck on its left rear side by an SUV that was entering from the north (left) side of the intersection. The engine struck the curb on the south (right) side and then rolled over; both victims were ejected. The engine rested on its top facing northwest and impacted a car in the opposing lane (see Photo 4).

Photo 4. Crash scene. (Photo courtesy of the Franklin News Post.)
