A summary of a NIOSH fire fighter injury investigation

August 1, 2011

Seven Career Fire Fighters Injured at a Metal Recycling Facility Fire - California

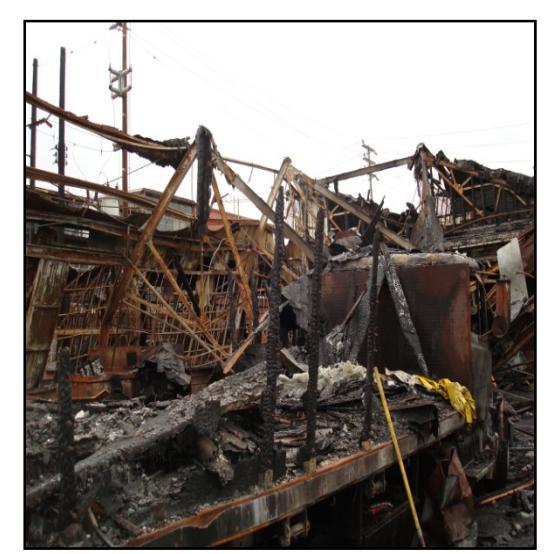
Large commercial structure containing combustible metals for recycling (NIOSH Photo)

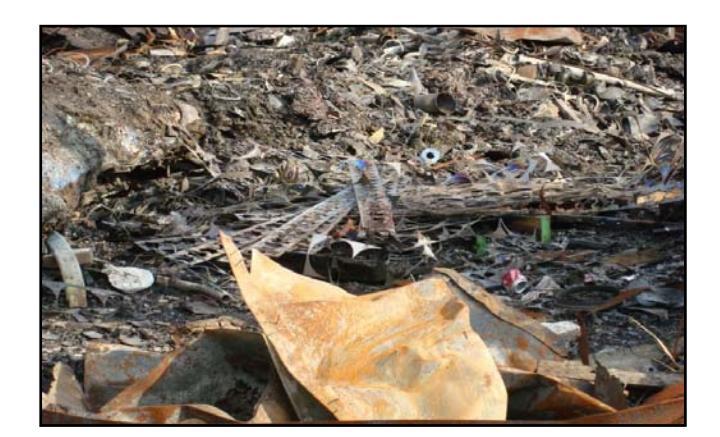
An example of the variety of recyclable combustible metals in the fire structure (NIOSH Photo)

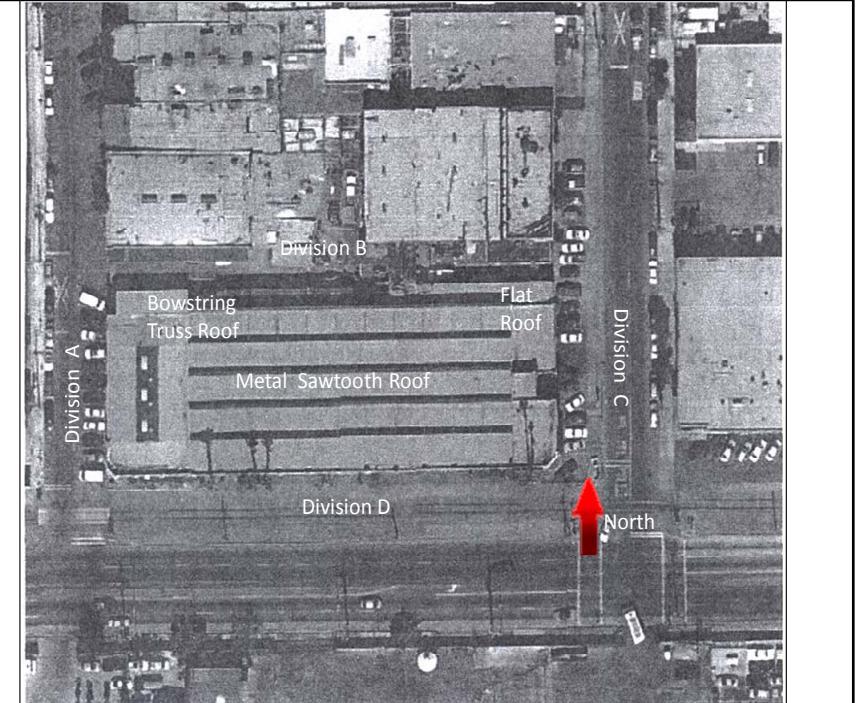
Photo 1: Aerial view of commercial structure prior to fire. (Courtesy of Fire Department's Arson Section)

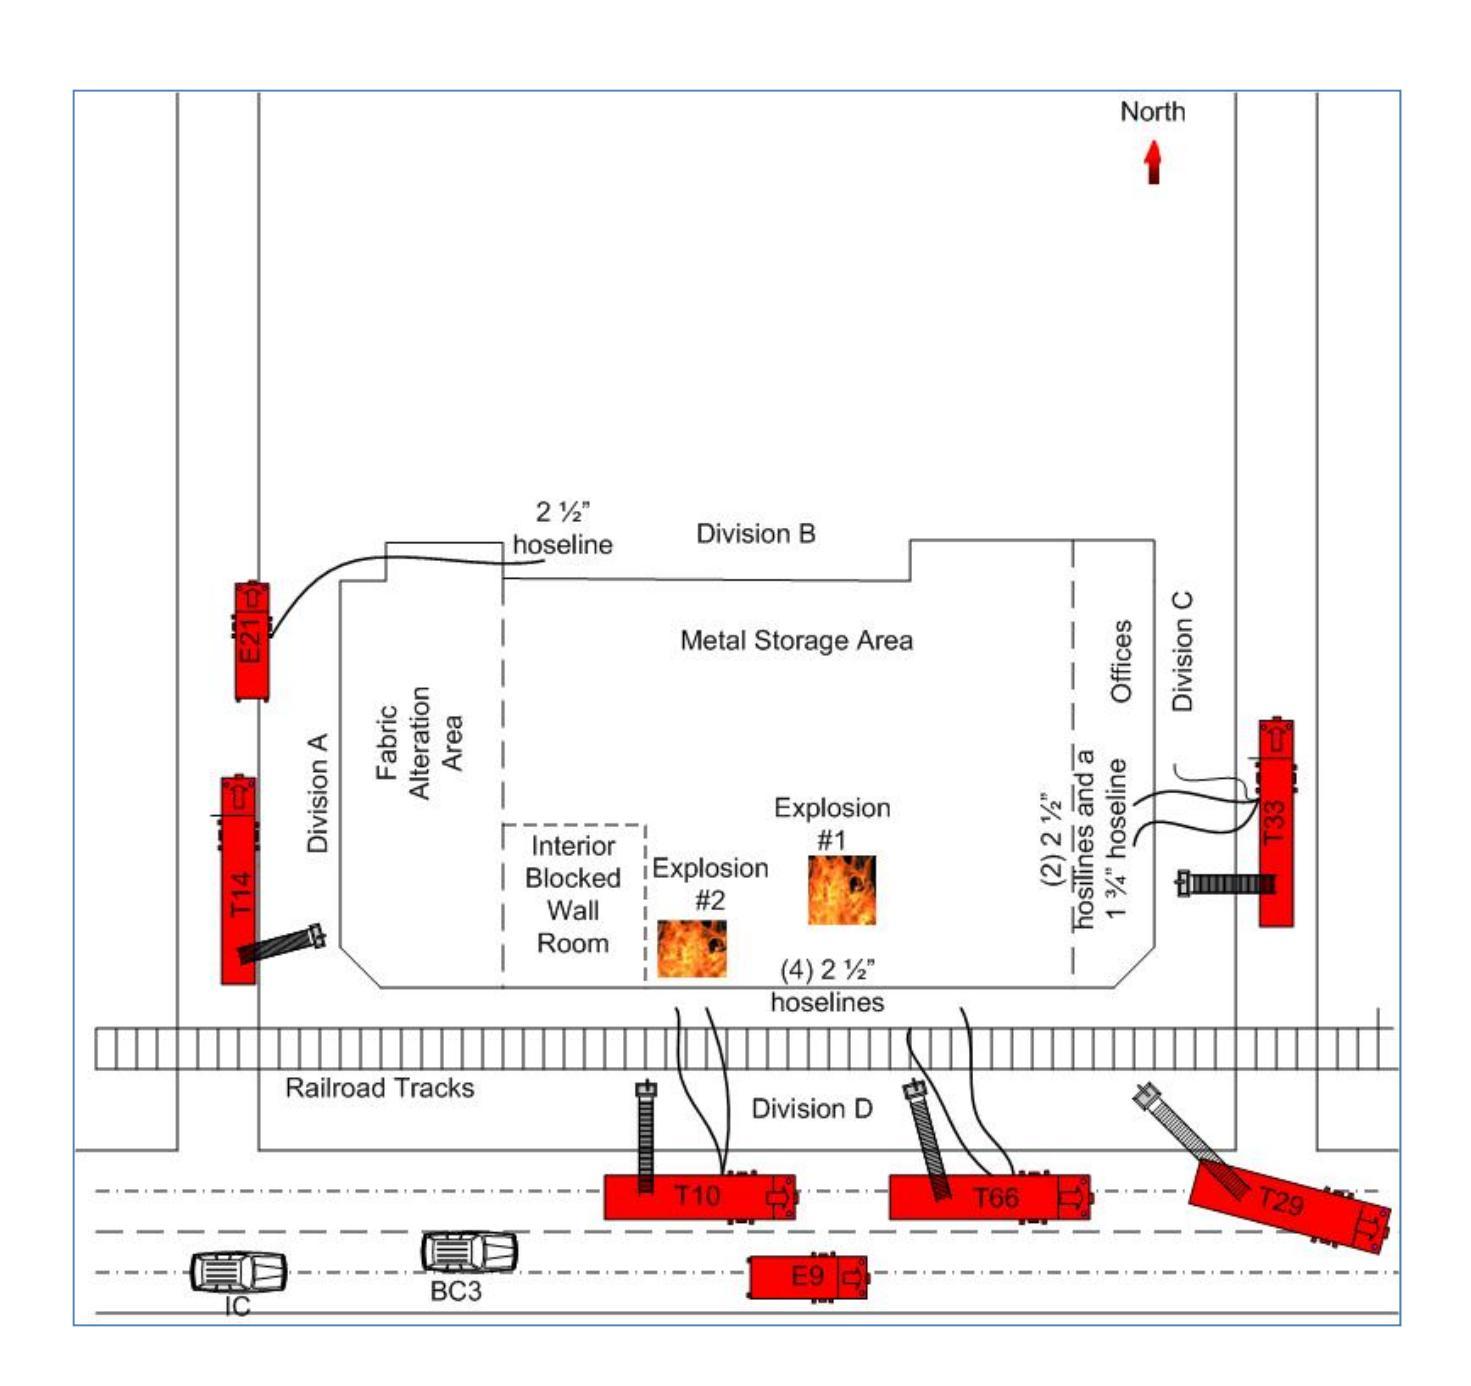
At 2356 hours, DC2 assumed IC. Ladder pipe operations were established on the 3 street accessible sides of the structure (see Diagram 1). T14, T33, T10, and T66's ladderpipes were flowing 750 gallons of water per minute. On Division A, BC1 was assigned as the division supervisor and was in the breezeway unloading area with SQ4 cutting 3 holes in the metal wall panels along the B-side to access fire inside the storage area. E21's crew had a 2 ¹/₂" hoseline and flowed water through the holes after they were cut. On Division C, two 2 ¹/₂" hoselines and a back-up 1 ³/₄" hoseline were flowing water inside the office area on the ground floor. BC13 was assigned to Division C as the division supervisor. On Division D, four 2 ¹/₂" hoselines (2 off T10 and 2 off T66) were flowing water to help protect the fire fighters on the trucks (see Diagram). *Note: Numerous fire fighters reported seeing bright white flames with hues of green and blue but this was not communicated to command.* At 0011 hours, BC11 arrived on scene and was assigned Division D as the division supervisor. Conditions had rapidly deteriorated forcing T33 and E66 crews to leave the roof. Seven minutes later, the IC ordered a defensive attack. At 0015 hours, USAR88 arrived on scene as the rapid intervention crew. At 0018 hours, BC7 arrived on scene and was assigned as the safety officer.

Diagram 1: Approximate Placement of Key Fireground Apparatus, Hoselines and Explosion Areas Relative to Commercial Fire Structure.

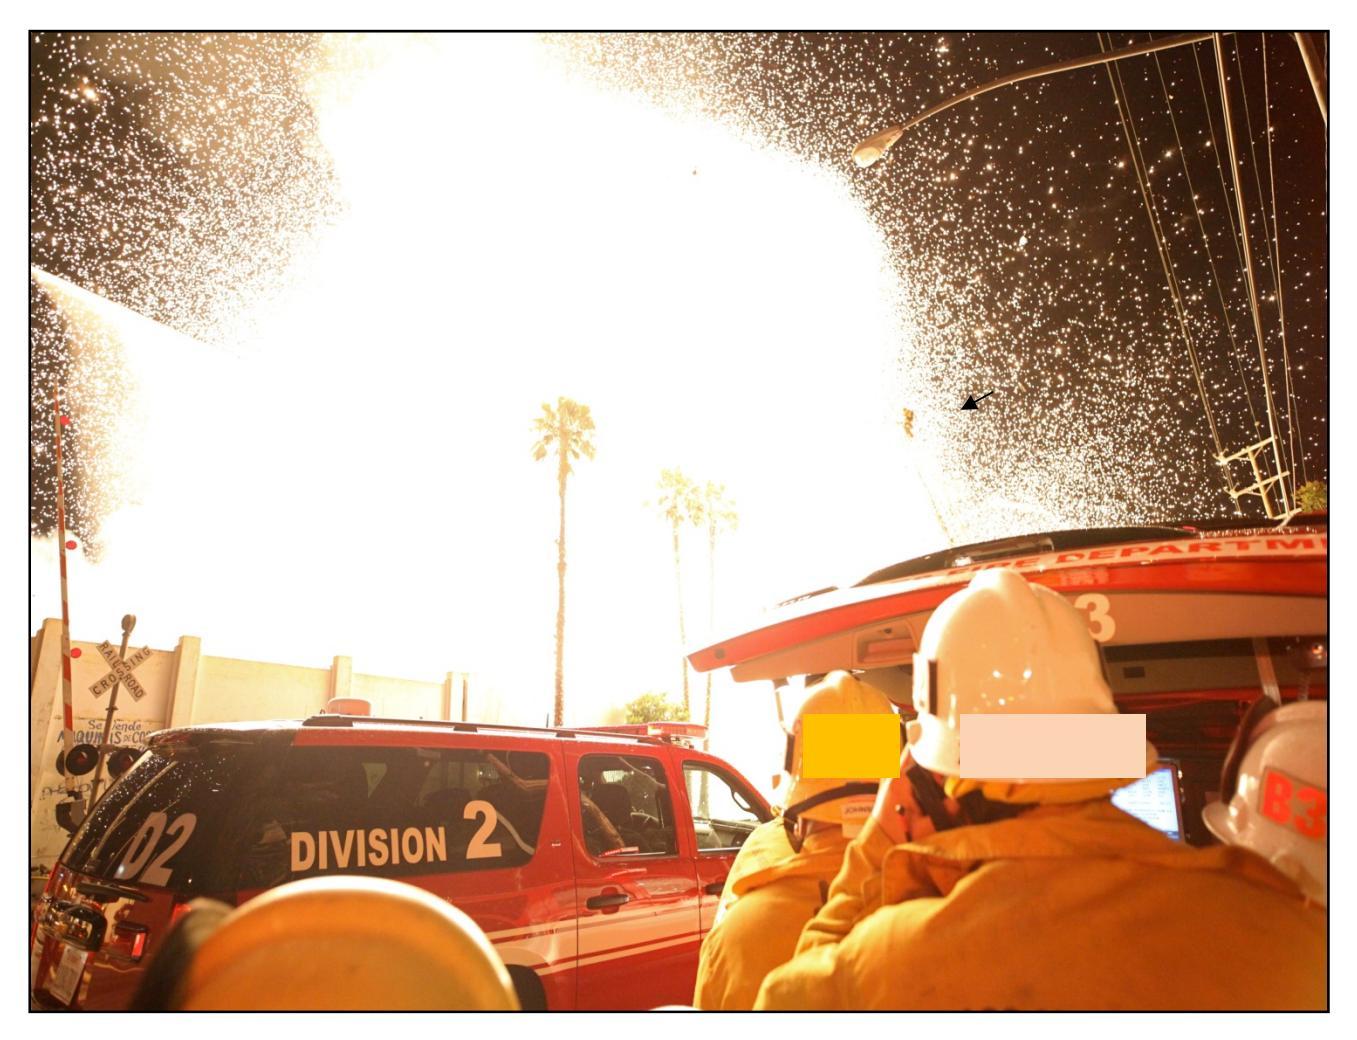
large explosion propelled burning shrapnel into the air and caused small fires north and south of the structure. T33 and E66's hoseline crews were blown backwards by the blast. T10 and mutual aid E9 were hit with flaming debris which broke through E9's driver-side door window and ignited the seat. T10 received several large dents and wooden ground ladders were ignited. Approximately 10 feet away, T10's hoseline crew was blown approximately 20' back and off the 2 ½" hoseline by the explosion. T10's captain was backing up the nozzleman and was hit with burning debris causing serious burns on his hand and ear. T66's captain jumped on the hoseline to stop it from whipping around. T10's fire fighter operating the ladderpipe had seen 2 white flashes and greenish plumes just prior to explosion. When the explosion occurred he turned his head to the left causing pain and ringing in his right ear as white hot debris went all around him. Multiple hose beds and hoses on the ground were burned through. The explosion was reported to have been broadcast up and out in all directions (see Photo 2).

Photo 2: The first explosion sent shrapnel up and out in all directions. A fire fighter can be seen on T10's ladderpipe to the right of the palm trees. (Courtesy of Fire Department's Arson Section)

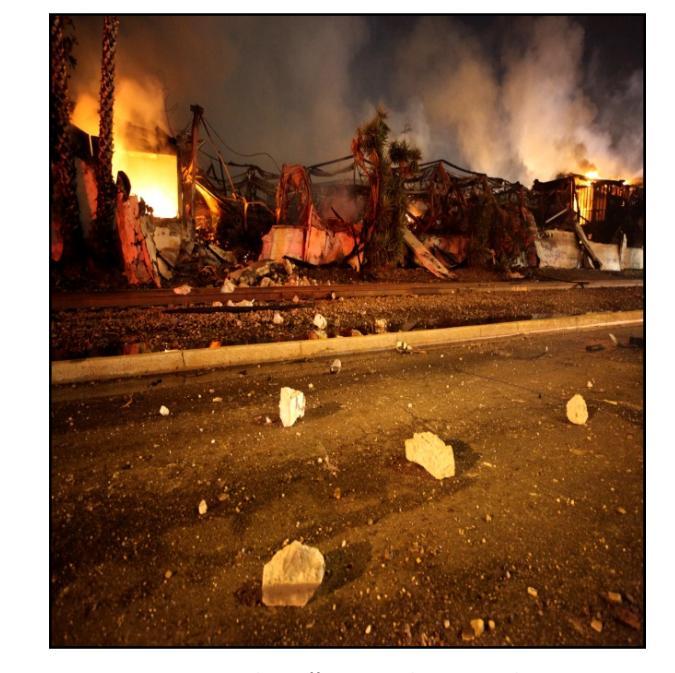
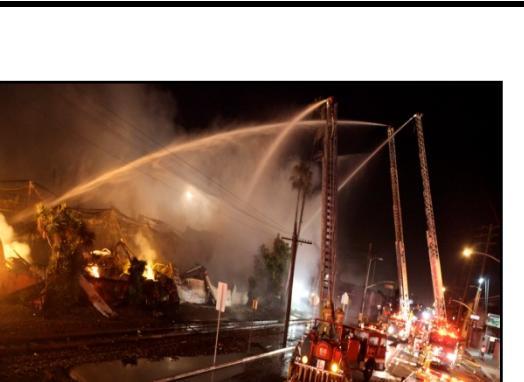
Photo 4: Second explosion (Courtesy of Fire Department's Arson Section)

charge containing large pieces of concrete and metal (see Photo 5). A PAR was immediately

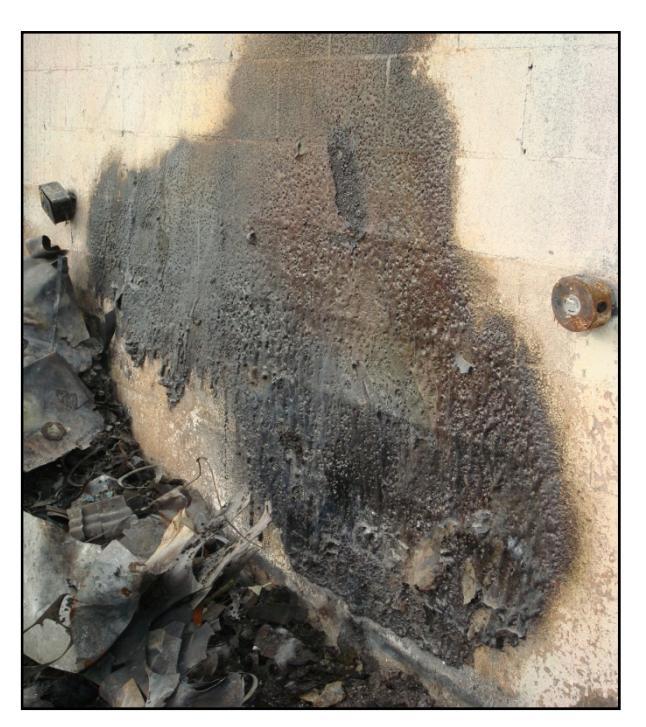
Discussion: Fire departments often respond to complex or unique hazards which require specialized/advanced knowledge and/or training in dealing with that hazard. Combustible metal fires present unique and dangerous hazards to fire fighters which are not commonly encountered in conventional structure fire fighting operations. The temperatures encountered in a combustible metal fire far exceed those of a structure fire.¹⁰ A block wall near the first explosion had an appearance of brown and black glass, suggesting that temperatures exceeded 3000 degrees F (see Photo 6).¹¹

Photo 6: In order to change the sand in the cement block to a smooth brown and black glass as depicted in this photo, the block wall would have had to sustain temperatures over 3000 degrees. Molten flow marks and indentations can be seen in the photo. (NIOSH Photo)

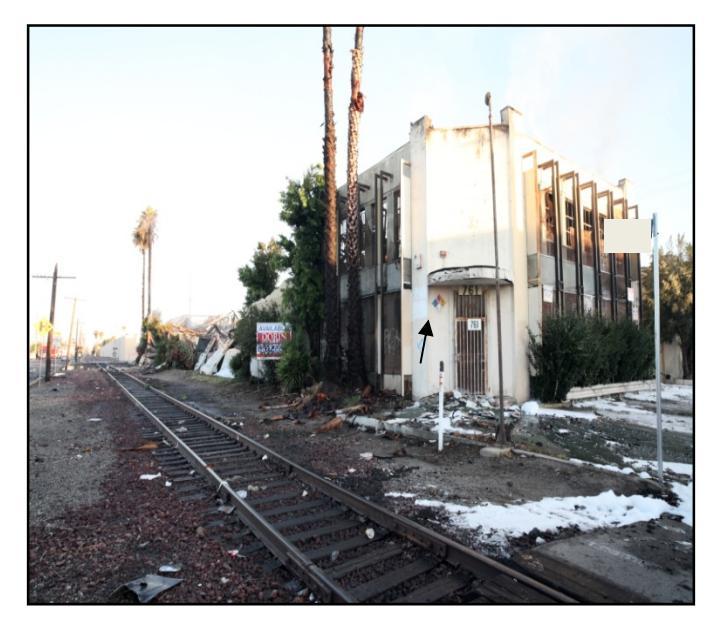
In this incident, placards existed at the A and C/D corner of the structure. However, they were not identified until after the explosion. The late night hour, poor lighting, angled corners of structure, and fire attack from doorways other than the front entrance may have contributed to first arriving personnel and

Photo 7: NFPA 704 Placard located on top left corner of barred entry door. (Courtesy of Fire Department's Arson Section)

fire officers not seeing and acting upon the information on the placard (see Photo 7).

Recommendation #4: Fire departments should ensure that first arriving personnel and fire officers look for occupancy hazard placards on commercial structures during size-up.
