A summary of a NIOSH fire fighter fatality investigation

January 18, 2012

# Career Fire Fighter Dies in Church Fire Following Roof Collapse-Indiana

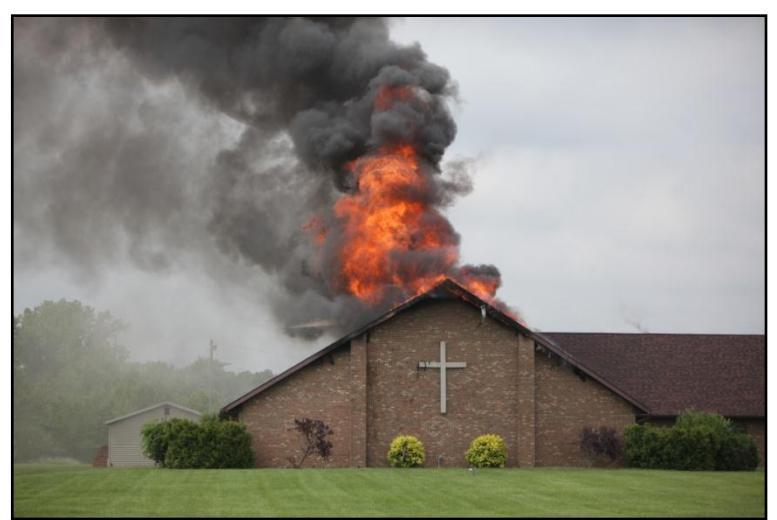
Incident scene. (Photo courtesy of Star Press.)

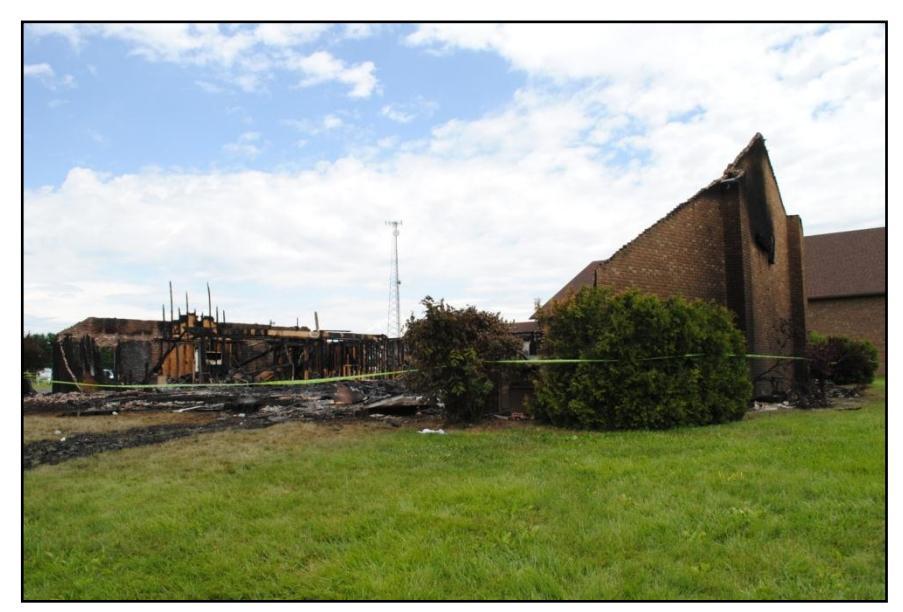
D-side of church following collapse and control of the fire. (Photo courtesy of fire department.)

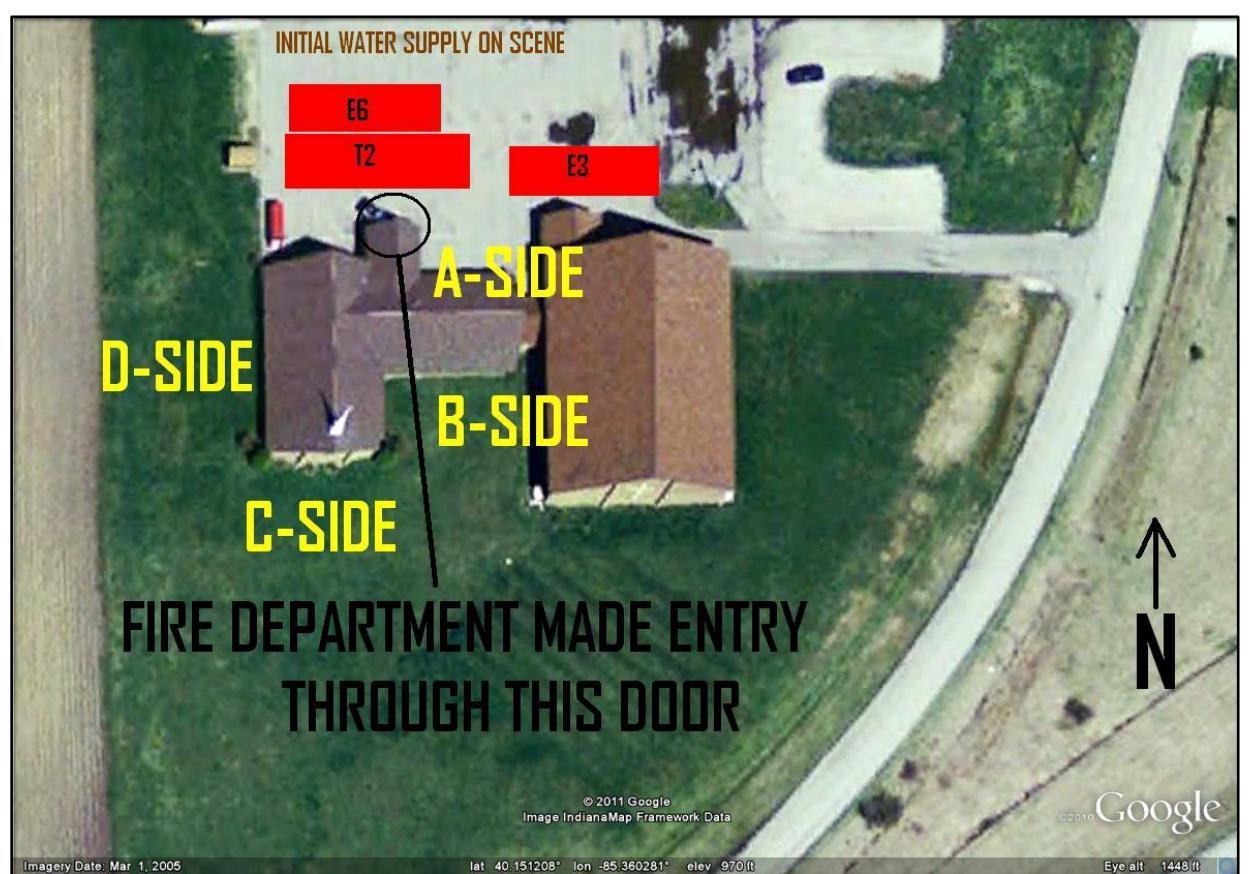
Photo 1. Initial incident scene with available water supply on scene. (Adapted from Google Maps® satellite image.)

The fire was located in a rural area, and no water hydrants were available in the immediate area surrounding the church. T2, with 400 gallons of water, was initially supplied by a 2½-inch supply line from E3, supplying them with an additional 1,000 gallons of water. E6 arrived on scene, pulled parallel to T2, and supplied T2 with another 1,000 gallons of water. A 2<sup>nd</sup> alarm and mutual aid tankers were requested by the IC upon his arrival, due to the lack of hydrants in the area. *Note: See Photo 1 for initial incident scene*.

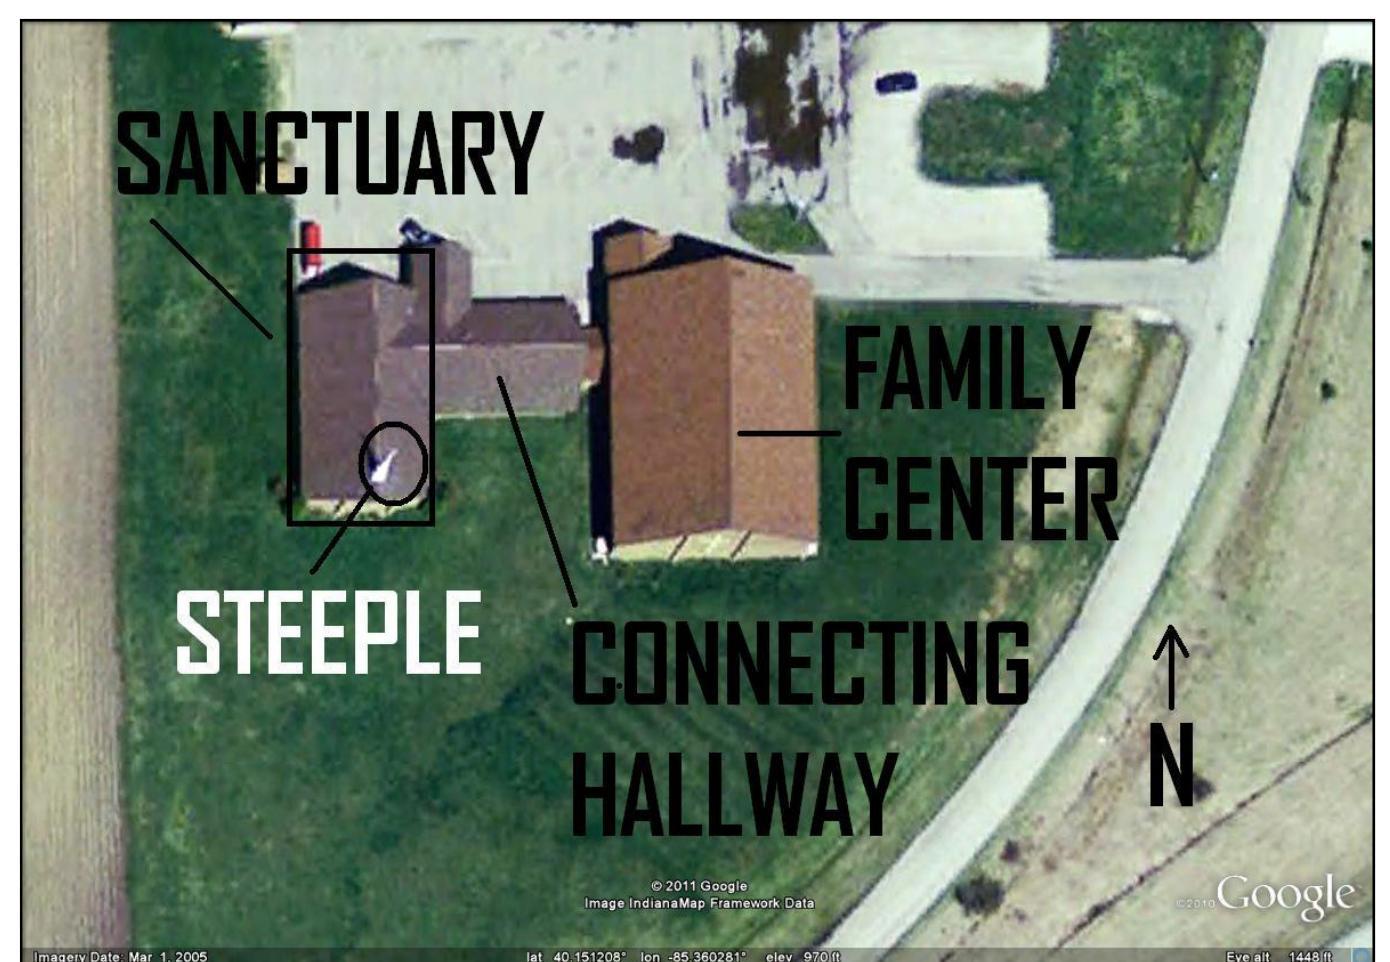
Photo 2. Aerial view of structure and property. The family center was not affected by the fire. The fire department was able to stop the fire's progression within the connecting hallway. Arriving from the south afforded incoming units with a 360 degree view of the complex. (Adapted from Google Maps® satellite image.)

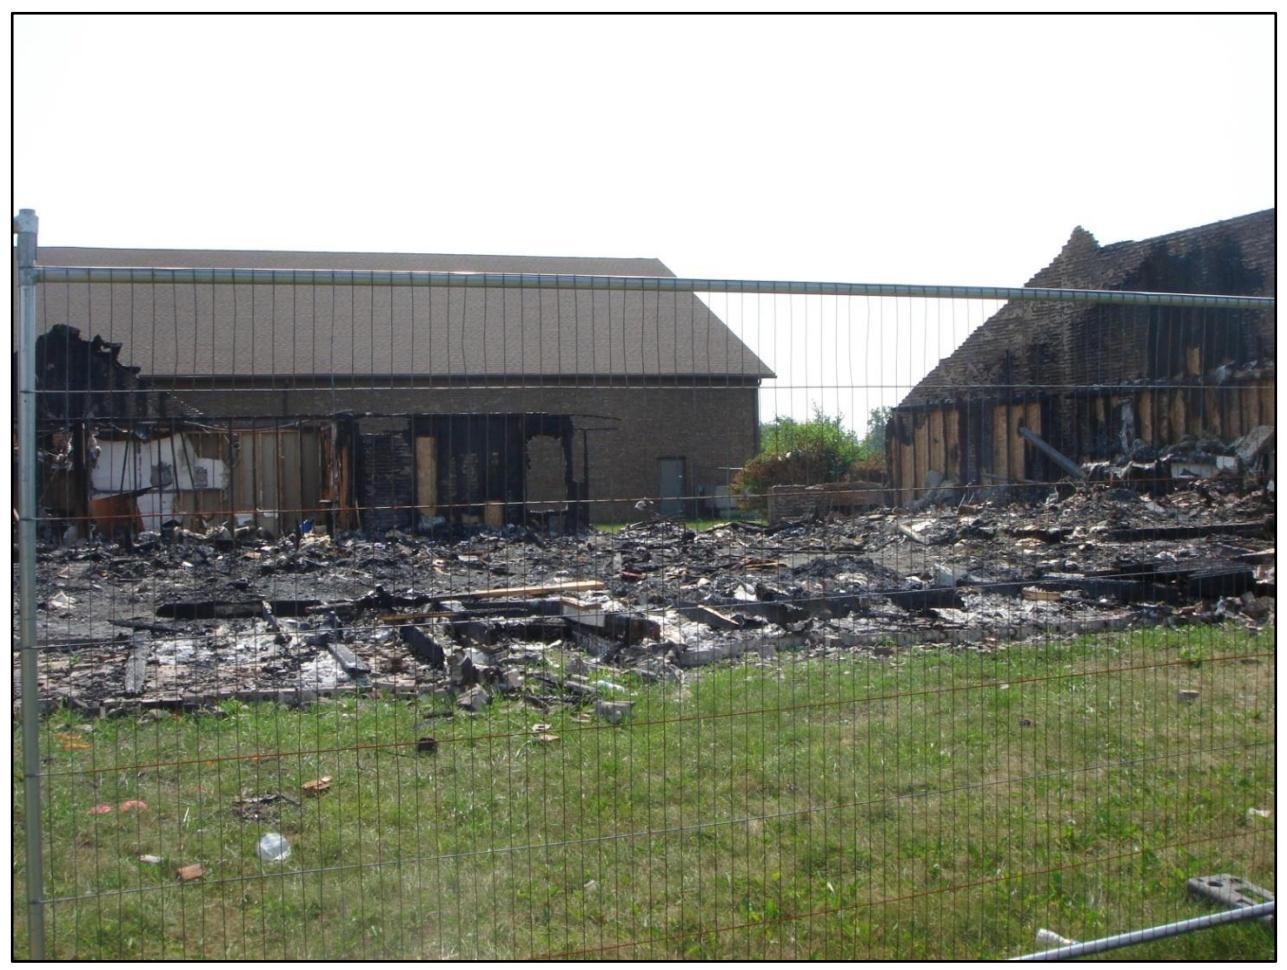
Photo 3. Picture taken from the D-side of the structure showing the remains of the sanctuary. (NIOSH photo.)

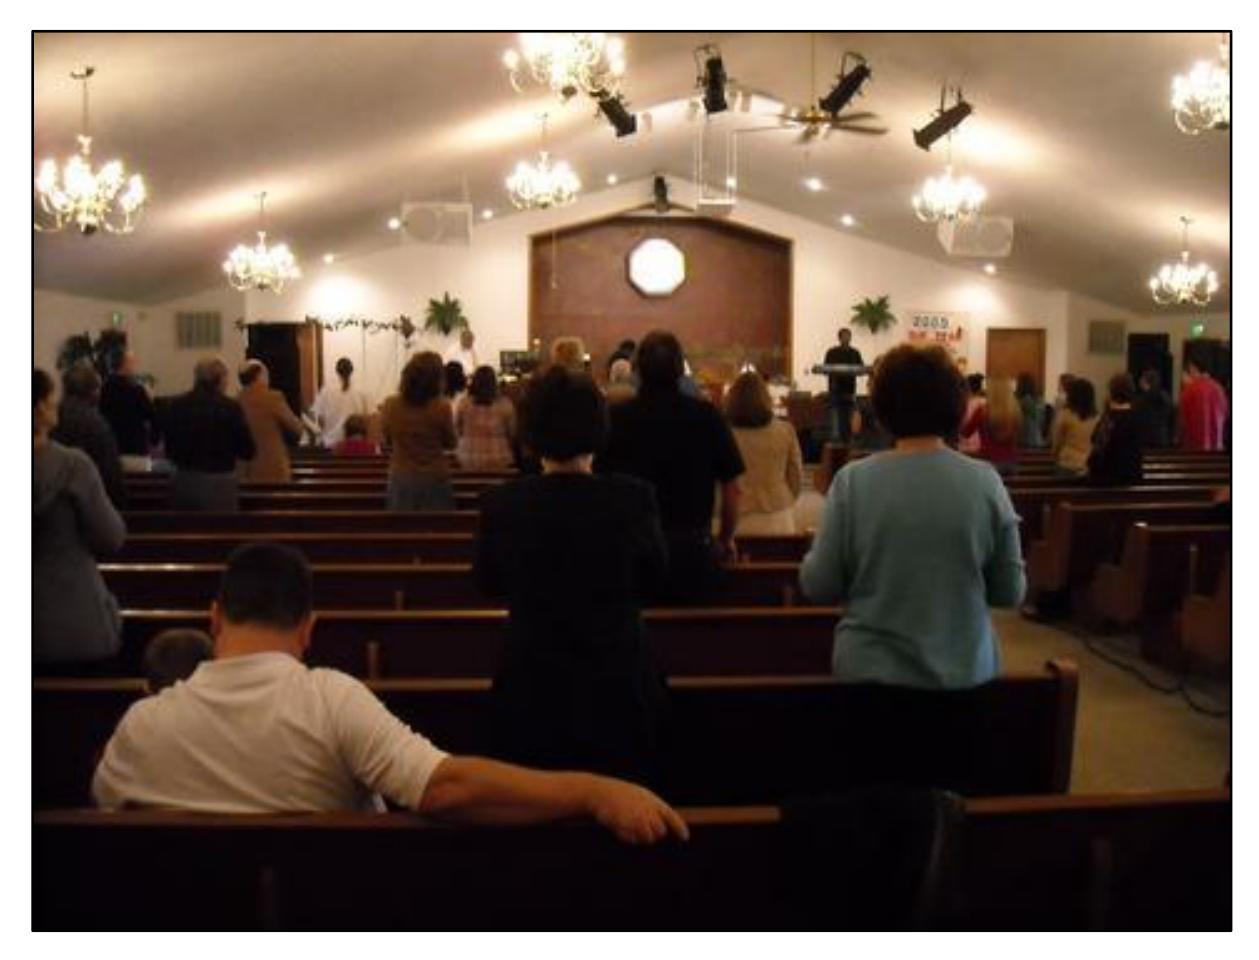
Photo 4. Interior view of sanctuary where fire fighters would have been working. (Photo courtesy of church's website.)

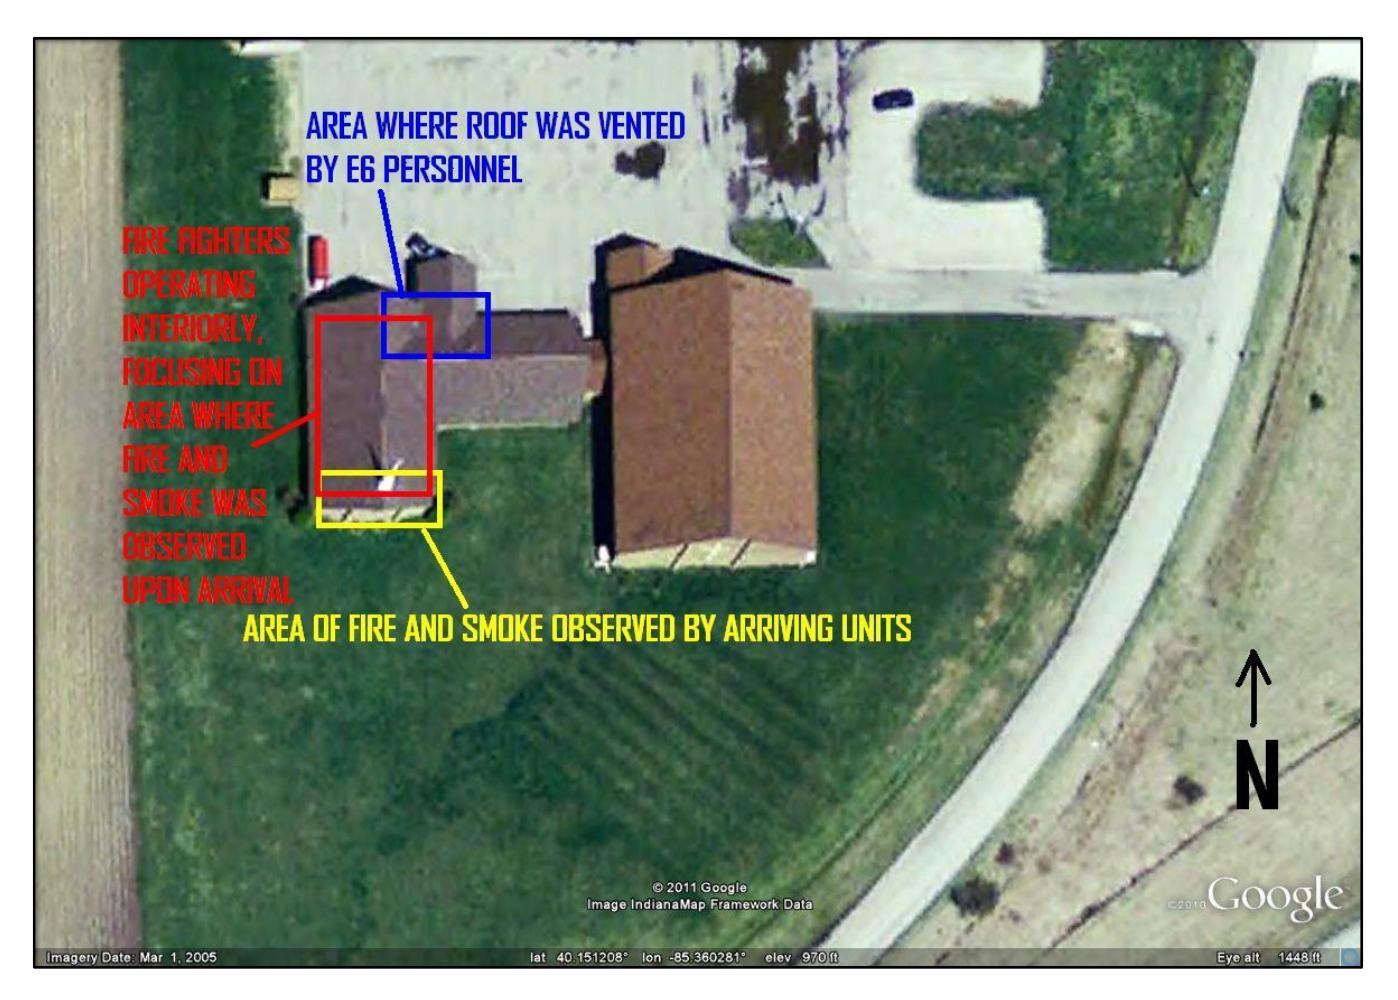
#### Photo 5. Aerial view of church complex focusing on where the ventilation hole was cut in relation to where fire and smoke were observed upon arrival and where interior fire fighters were working.

T2 was positioned in the parking lot in front of the entrance closest to the sanctuary. E6 pulled parallel to T2 facing the opposite direction, while R2 and the BC pulled into the parking lot away from suppression units. The driver of R2 placed an orange cone in front of this entry to signify the command post and the accountability tag drop point (all interior and roof personnel dropped their tags at the command post before entry). The church was secured, requiring a door on the A-side to be breached. After FF1 breached the entry door with a 6-foot pike pole, the R2 officer and four fire fighters (FF1 and FF2 from R2 and FF3 and FF4 from T2) made the initial entry into the sanctuary bringing with them a charged, single, 200-foot section of 1<sup>3</sup>/<sub>4</sub>-inch hoseline from T2 (see Photo 5). *Note: No additional equipment was initially brought in with them, such as a thermal imaging camera.* Two fire fighters from E6 were tasked by the BC with cutting a ventilation hole (trench cut) as close as possible to where the connecting hall roof met with the sanctuary roof, being sure to sound the roof as they got closer to the sanctuary (see Photo 5).

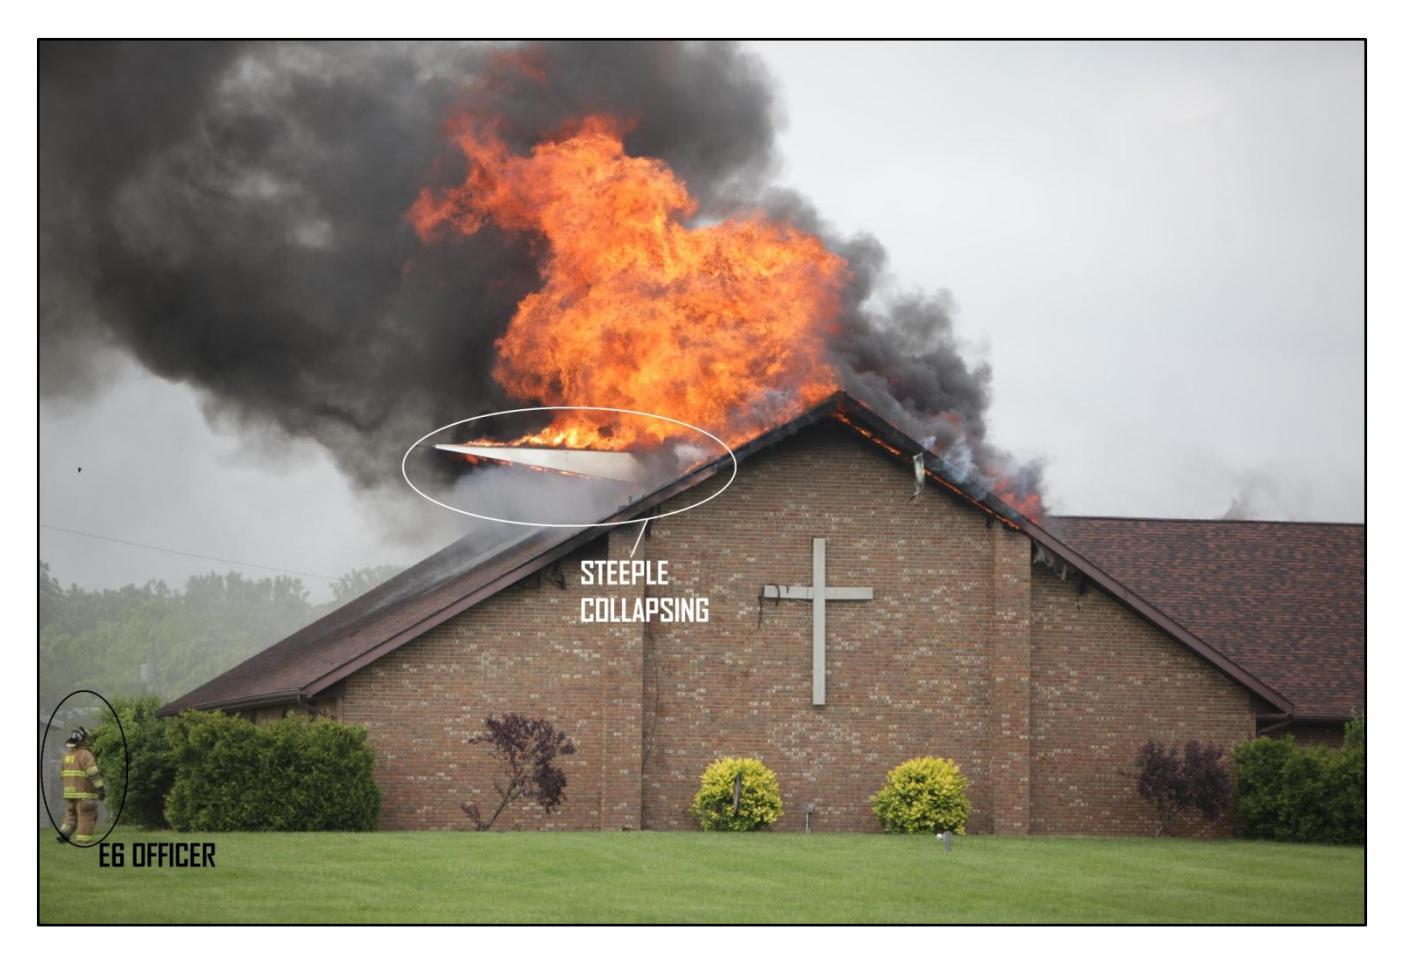
#### Photo 6. Steeple has toppled over onto the roof and it has begun to collapse into the roof system. The roof has not yet collapsed into the sanctuary. (Photo courtesy of Star Press.)

Before turning the corner to look at the C-side of the sanctuary, the BC was met by the E6 officer at the C/D corner where they observed the steeple tilting onto the sanctuary roof (see Photo 6). *Note: The BC stated he observed the steeple fall and immediately attempted to call the IC over the radio and advise him of this, but no radio traffic was heard or recorded on the 911 transcripts.* Following his attempts to contact the IC over the radio, the BC immediately walked back to the command post to speak with the IC regarding the integrity of the roof.

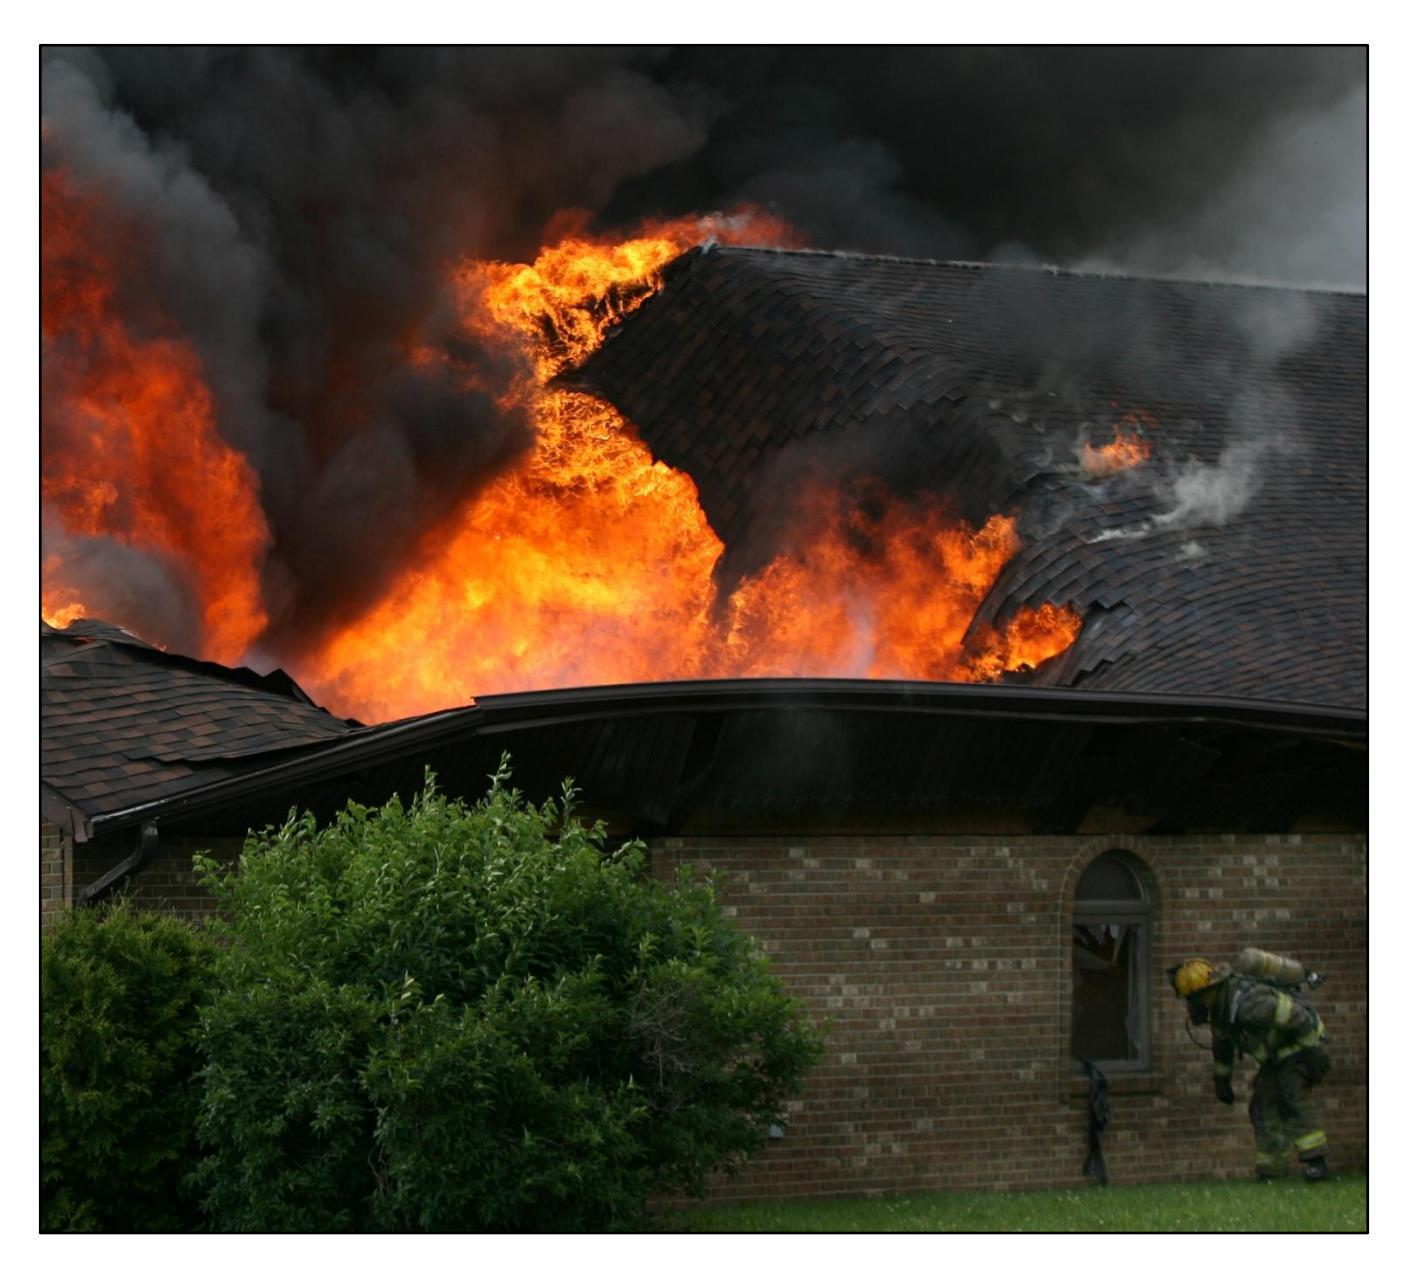
Photo 7. Photo shows FF5 looking back through the window on the B-side that he exited through following the initial roof collapse. Note the condition of the roof. (Photo courtesy of Star Press)

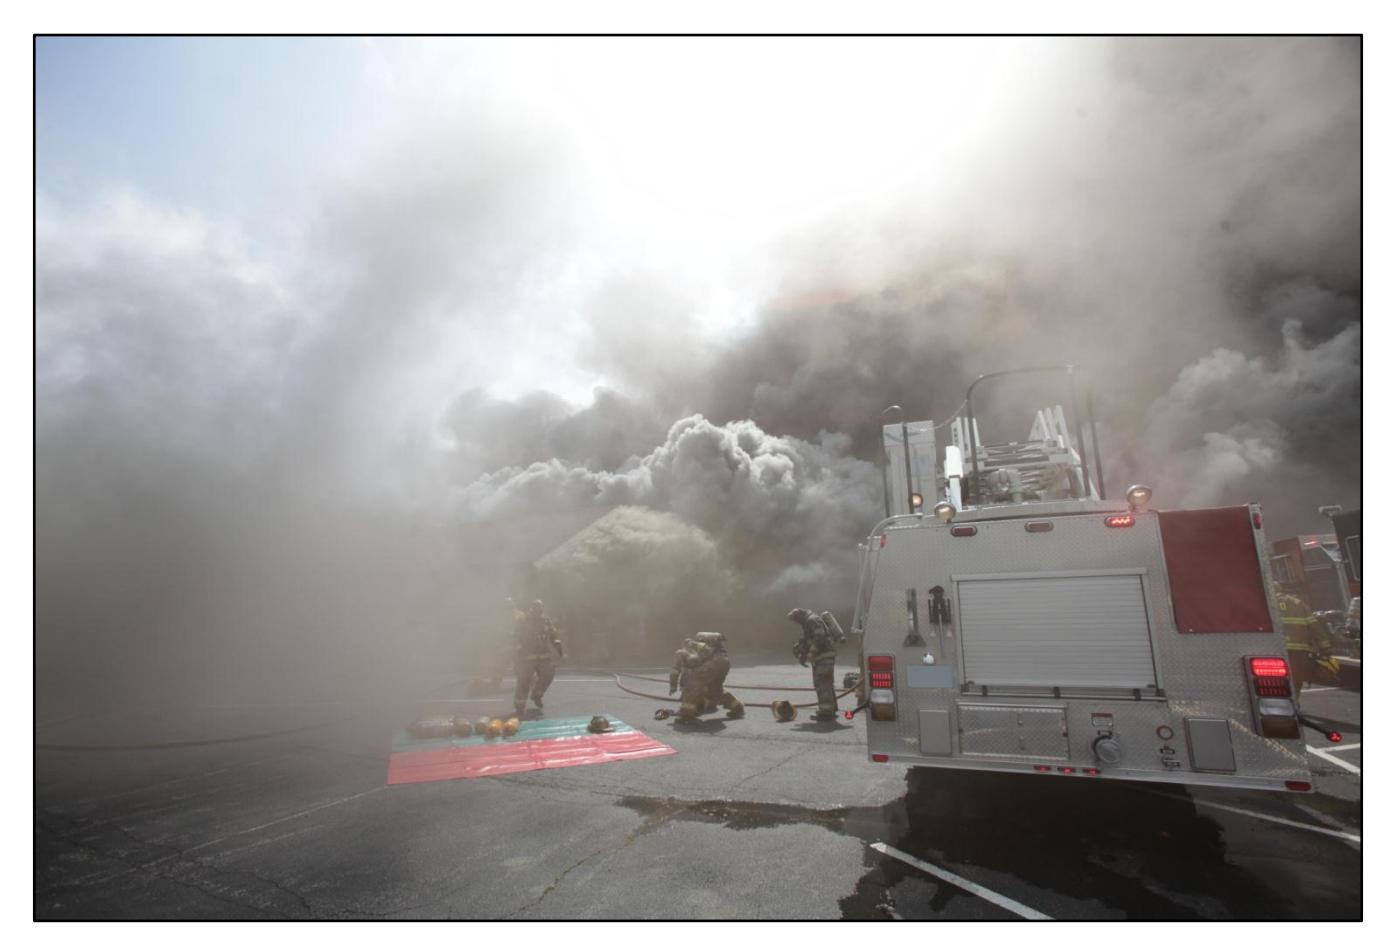
Photo 8. Fire fighters beginning their initial search and rescue into the building through the Aside forced entry door in an attempt to locate the victim. (Photo courtesy of Star Press.)

roof) through the initial entry door to the opening into the sanctuary where they were met with another collapse of the roof and fire debris throughout the sanctuary. Entry into this area was deemed unsafe and the IC ordered all fire fighters to evacuate the entire structure. The driver of T2 was ordered by the BC to sound his air horn to notify fire fighters to evacuate. Fire fighters searched around the building and checked the connecting hall and family center for the victim, but he remained missing within the sanctuary. *Note: See Photo 8 and Photo 9 for conditions during search operations for the victim.*

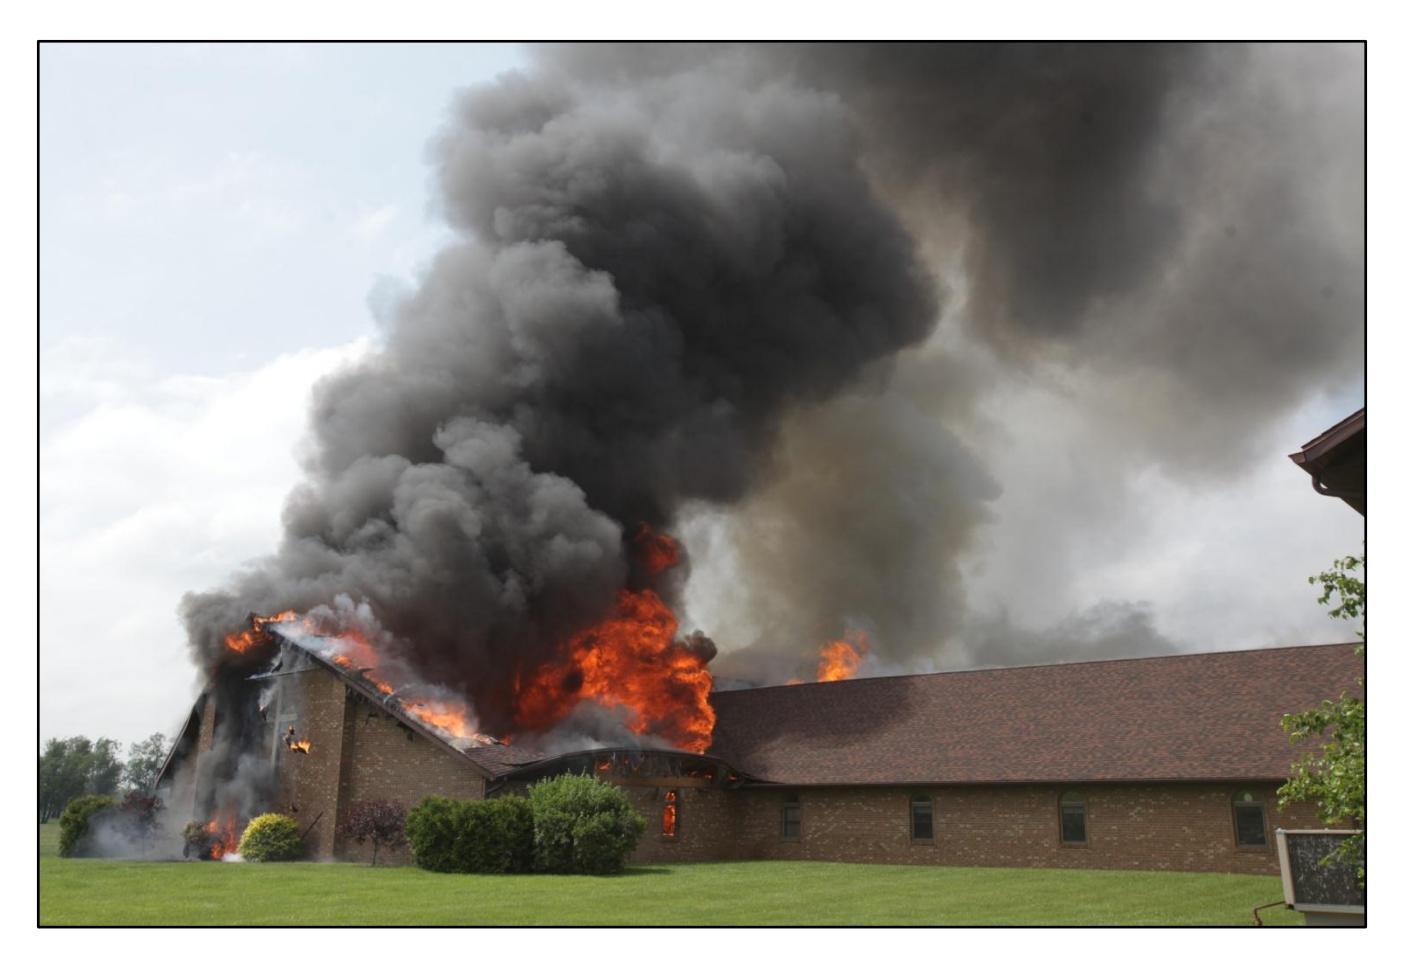
Photo 9. Photo shows the secondary collapse of roof into sanctuary area while search and rescue crews were inside the building. (Photo courtesy of Star Press.)

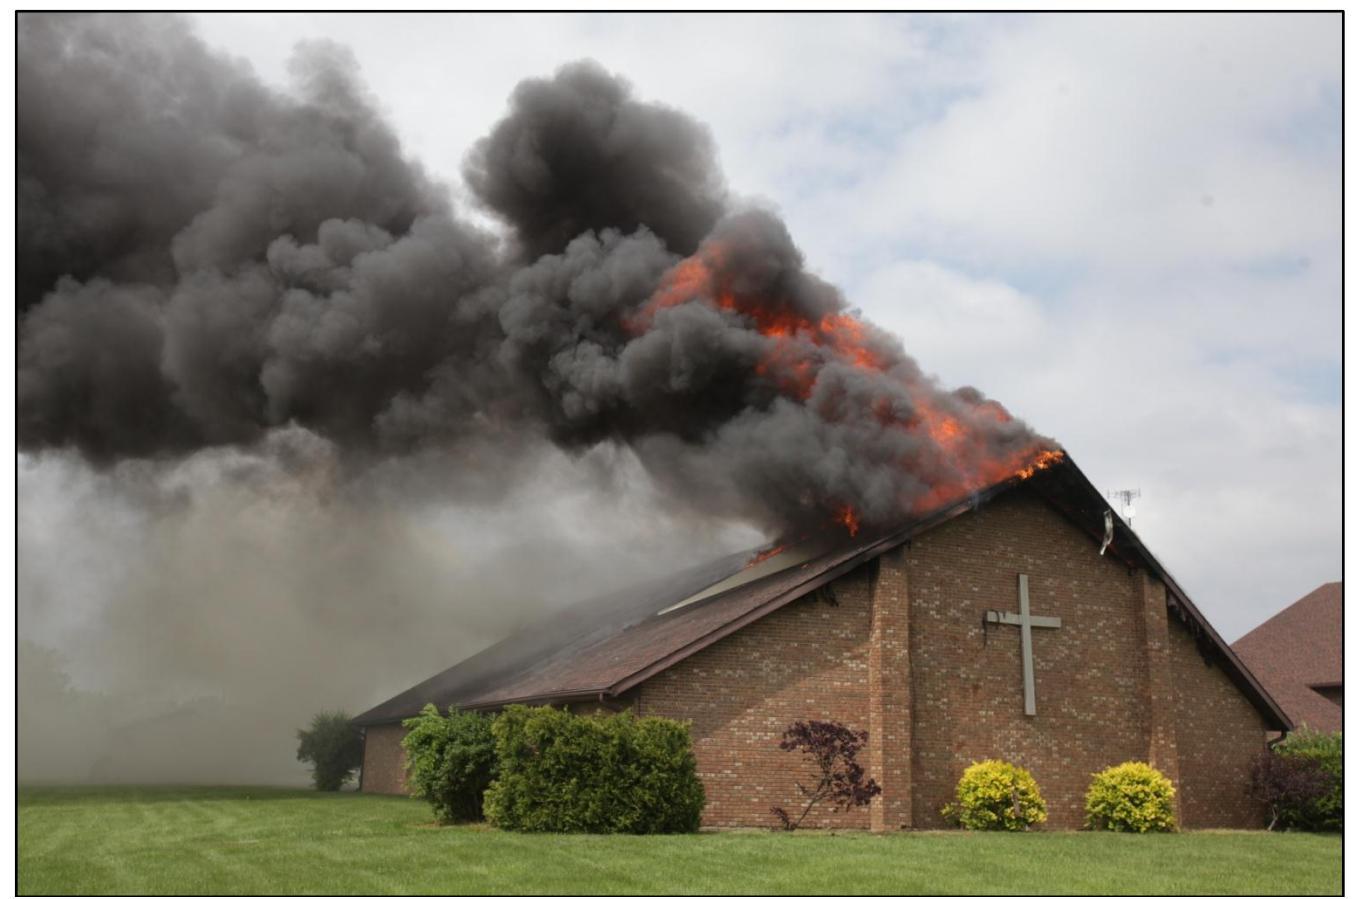
Photo 10. Steeple is lying on top of the sanctuary roof directly above where the fire fighters are working. Note column of smoke blowing toward the D-side of the structure and not flowing directly up. (Photo courtesy of Star Press.)

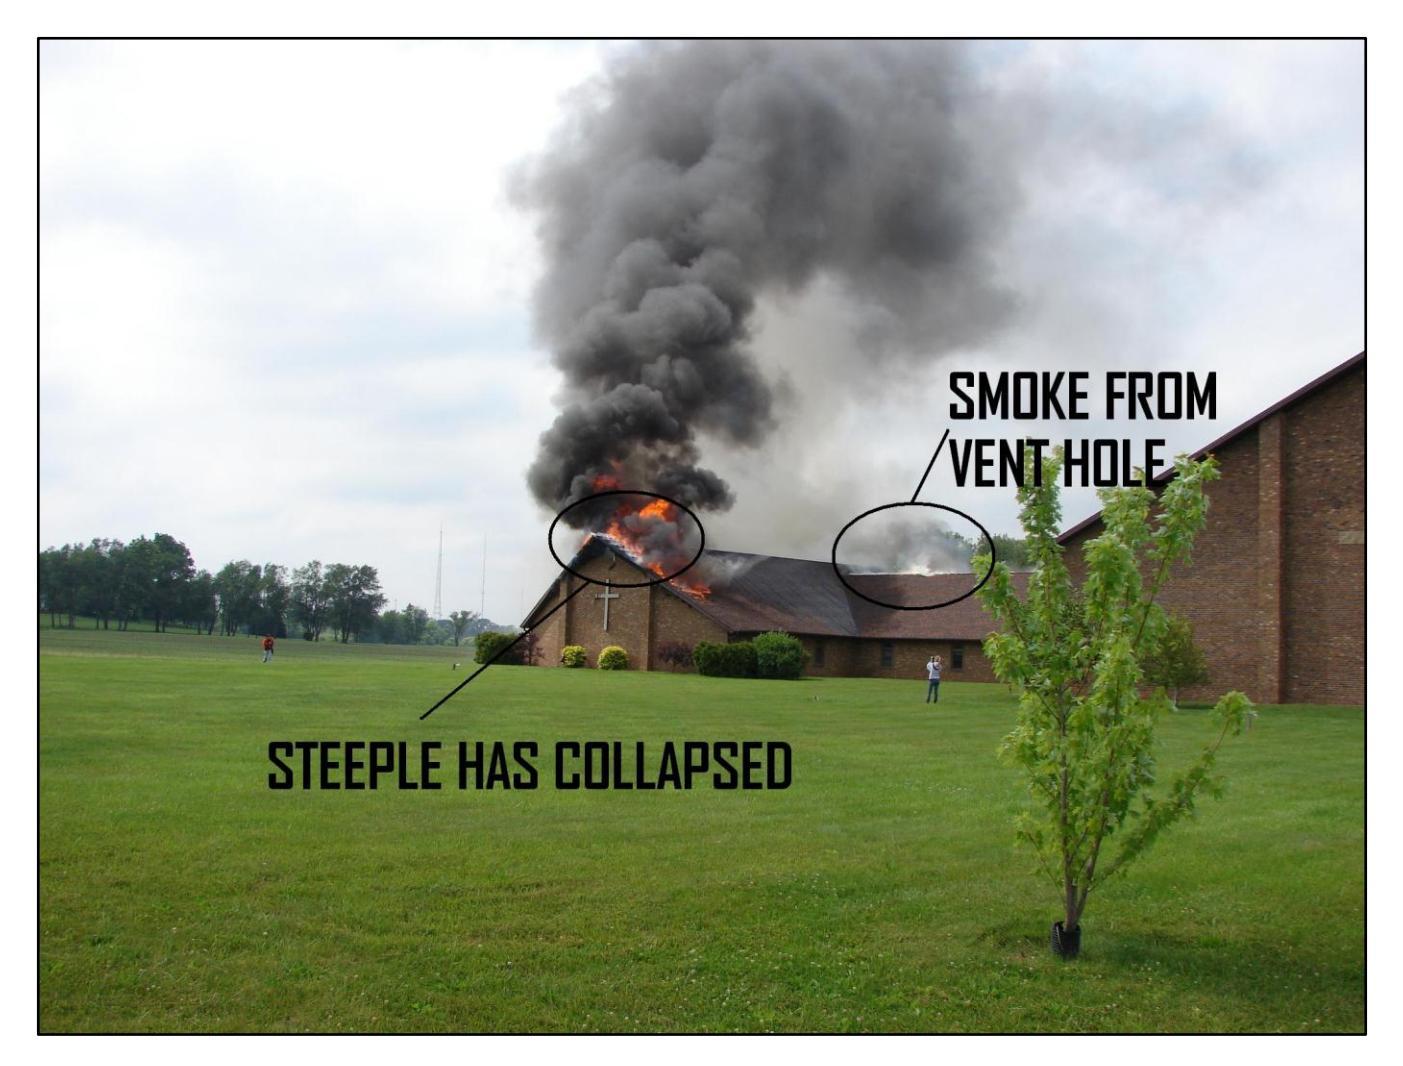
Photo 11. Photo shows the steeple has collapsed and the ventilation hole emitting smoke. (Photo courtesy of fire department.)

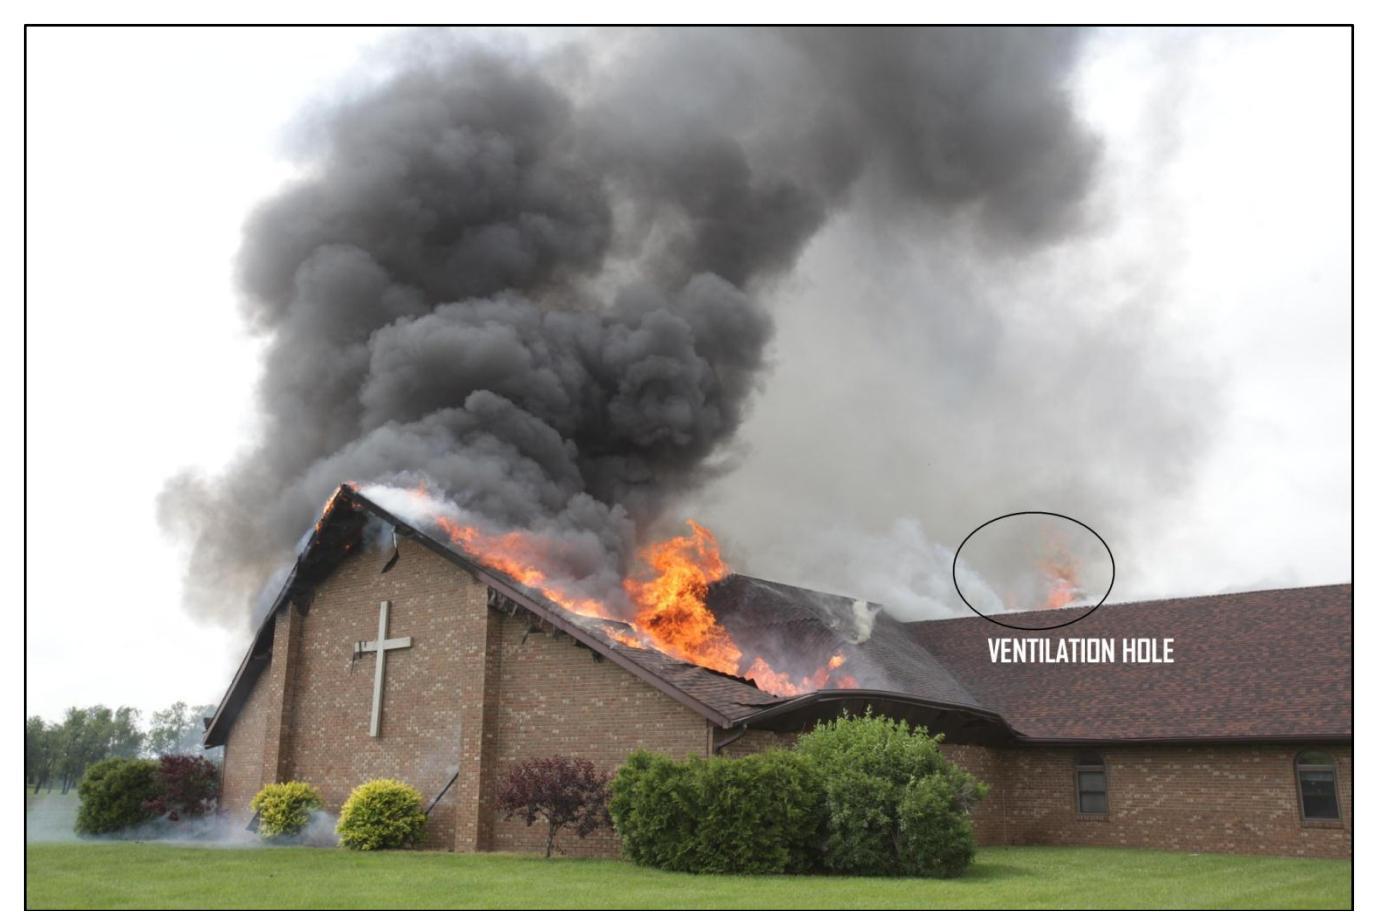
Photo 12. From the B/C corner, roof has collapsed into the sanctuary. Note fire blowing from the ventilation hole. (Photo courtesy of the Star Press.)

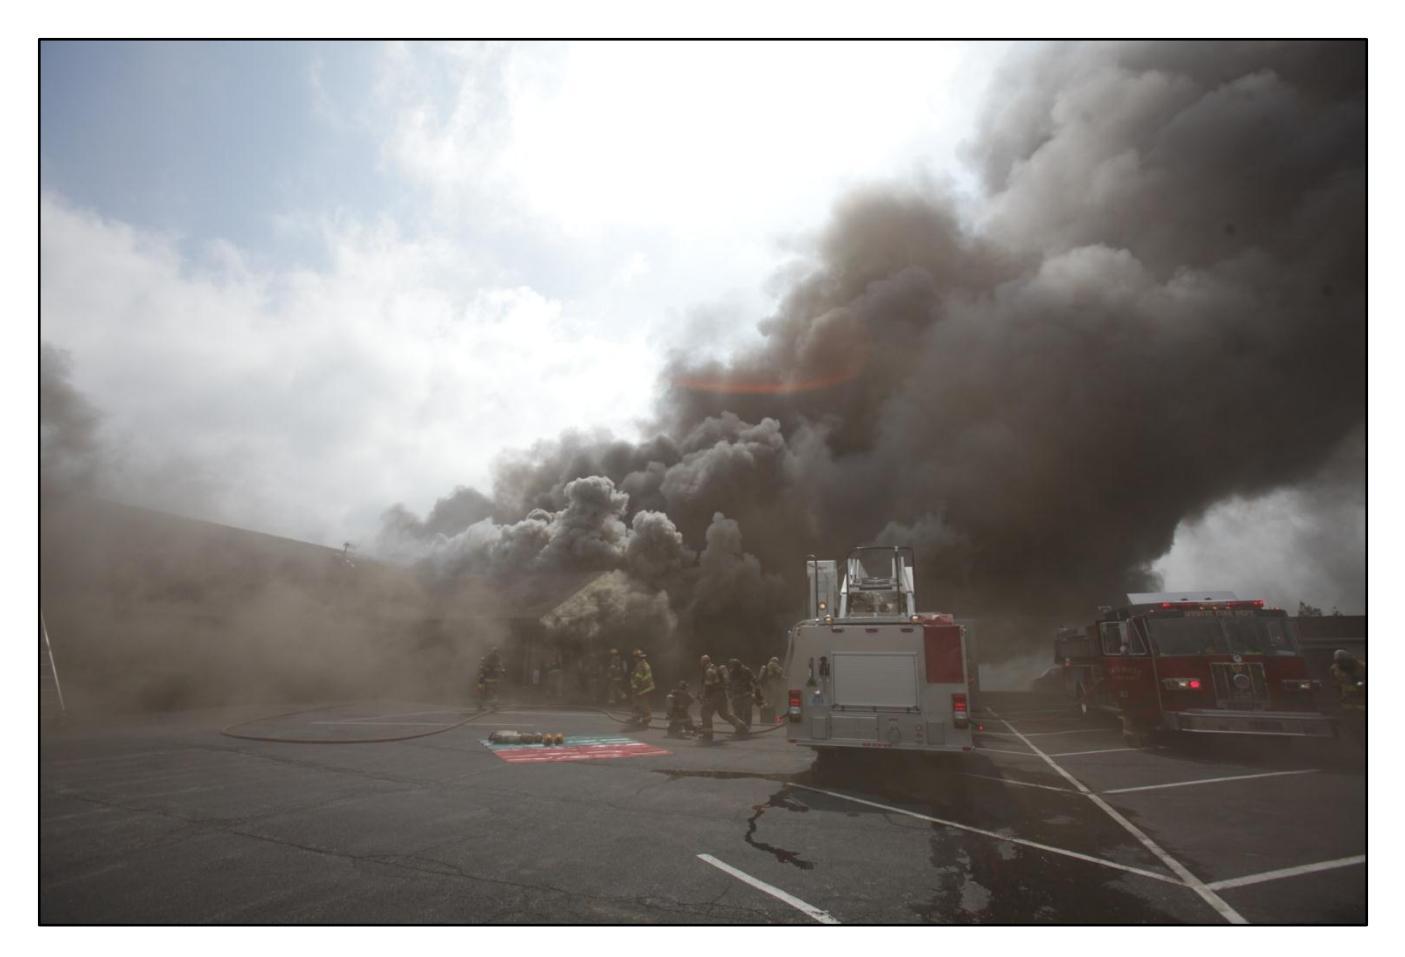
Photo 13. From the A-side of the complex, fire fighters gathered around initial entry point preparing for search and rescue of the victim. Note wind pushing smoke away from the building. (Photo courtesy of Star Press.)

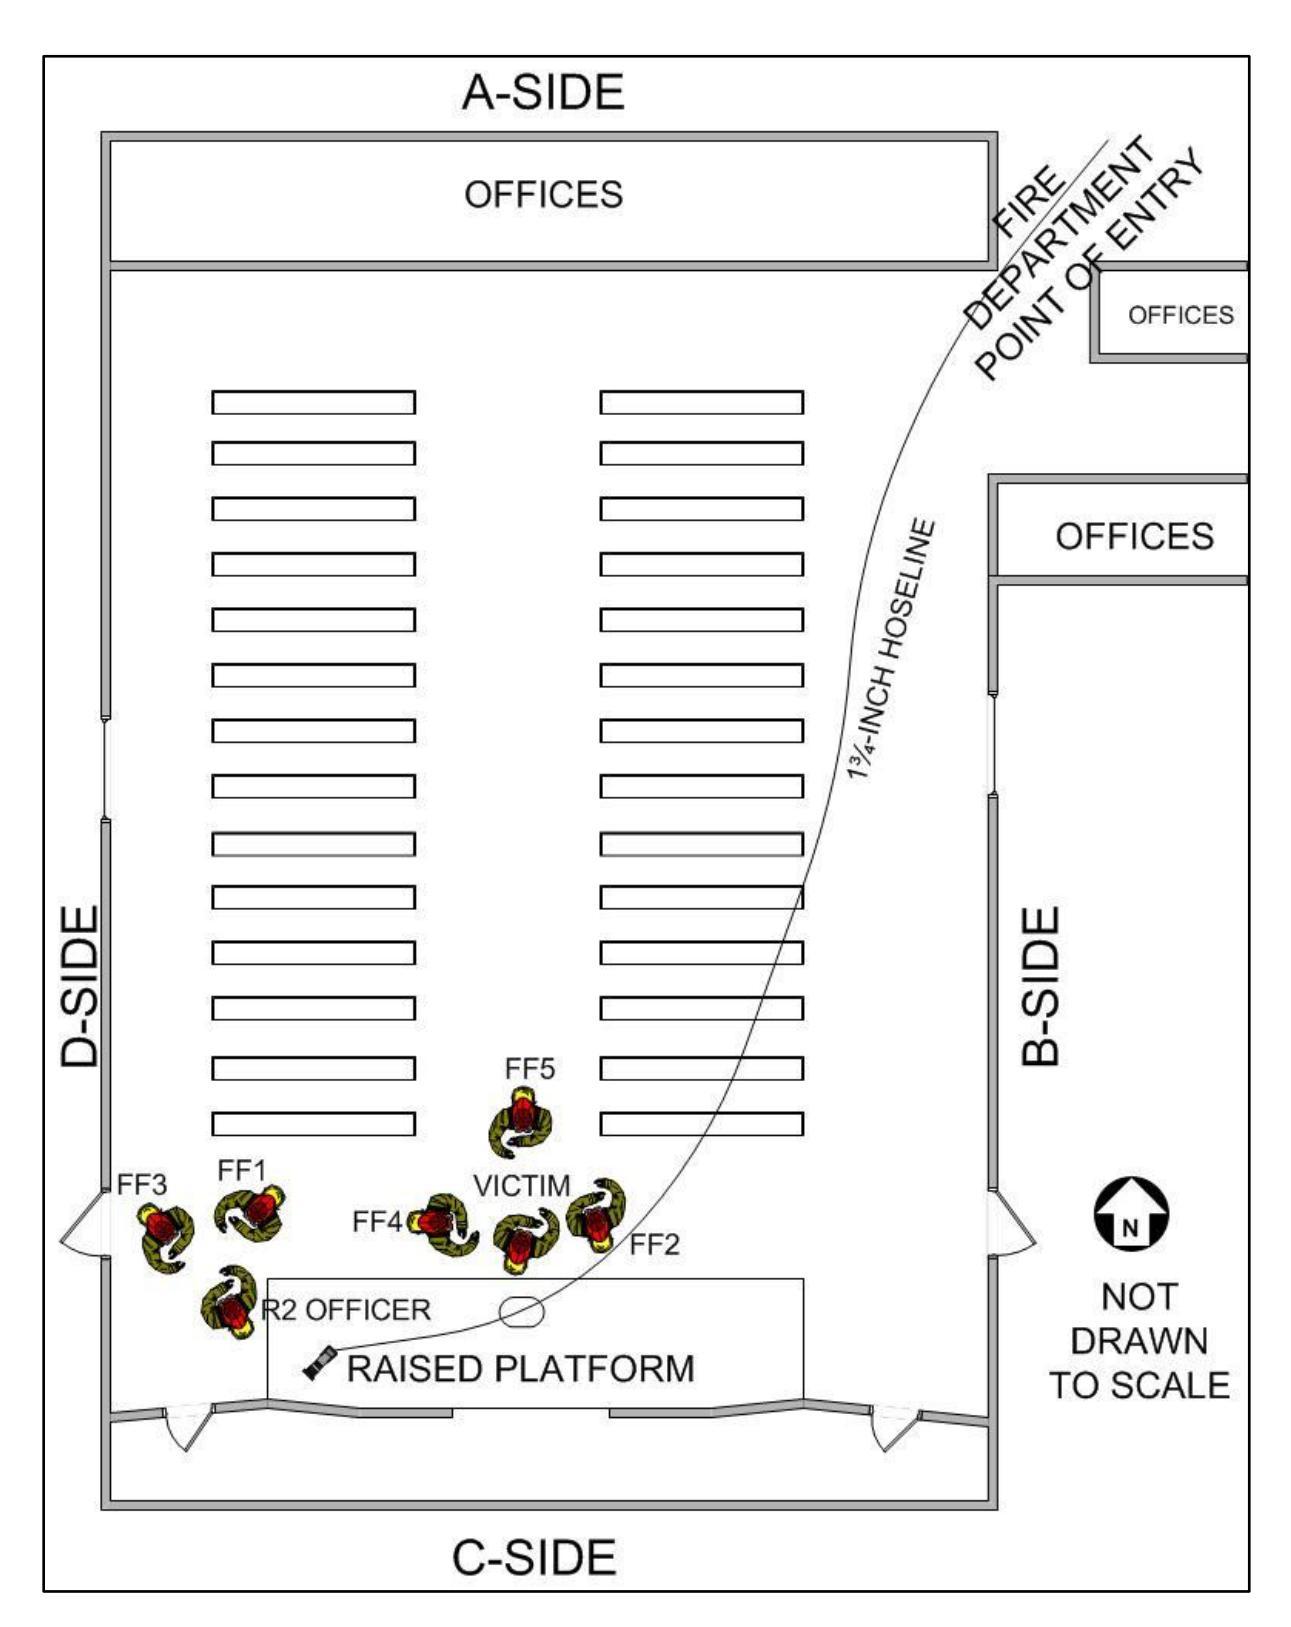
Diagram 3

At the time of the collapse, the R2 officer was standing with FF1 and FF3 (close to the C/D corner) (see Diagram 3). The sanctuary became engulfed with fire, burning debris, and extreme heat. The R2
