A summary of a NIOSH fire fighter fatality investigation

Career Fire Fighter Dies in Heavy Smoke on Second Floor of a Residential Structure—Texas

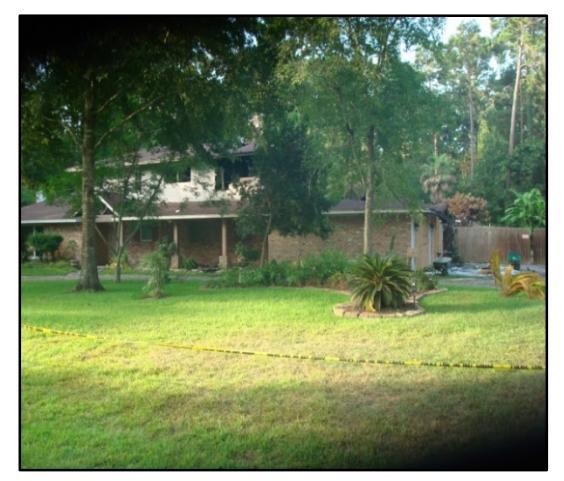
Two-story residential structure. (NIOSH photo.)

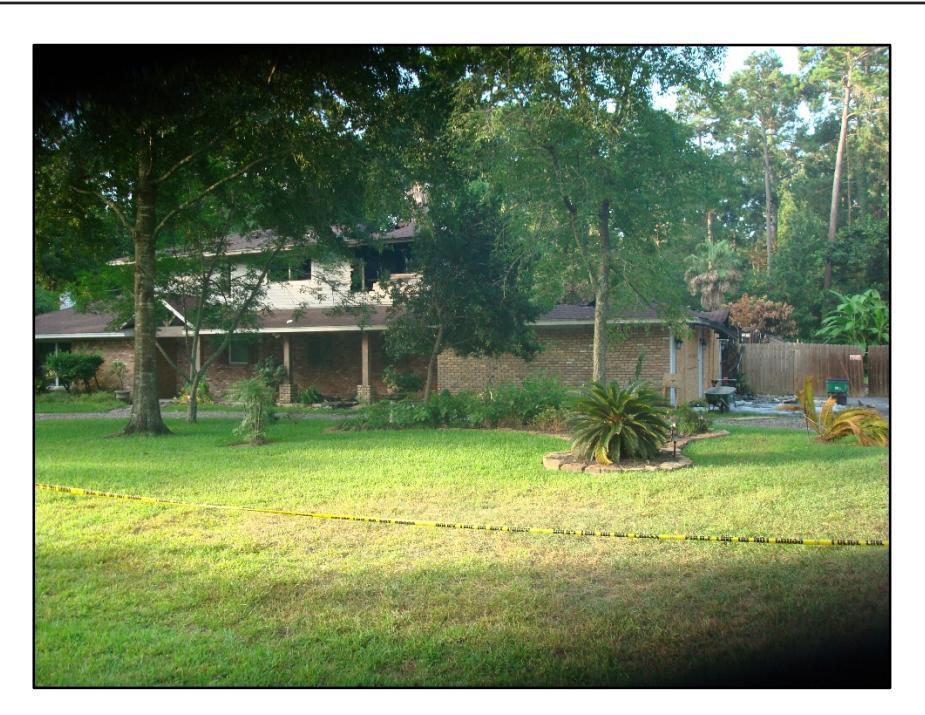
The residential structure was built in 1963 and was wood frame construction on a slab foundation (see Photo 1). The two-story ranch had been remodeled in 2012 and consisted of 4,608 square feet of living space. The first floor consisted of a large living area, large kitchen, full bathroom, master bedroom with full bath, attached two-car garage, and an attached storage shed, which contained ammunition reloading equipment, ammunition components, and ammunition. The second floor had two bedrooms, a full bath, and a sewing room with French doors that led out onto a deck (see Diagrams 1 and 2). The first-floor exterior was covered with brick, and the second floor was oriented strand board covered with vinyl siding. In the rear of the structure, the first floor had a covered patio and the second floor had a large deck.

Photo 1. Residential structure Side Alpha. (NIOSH photo.)

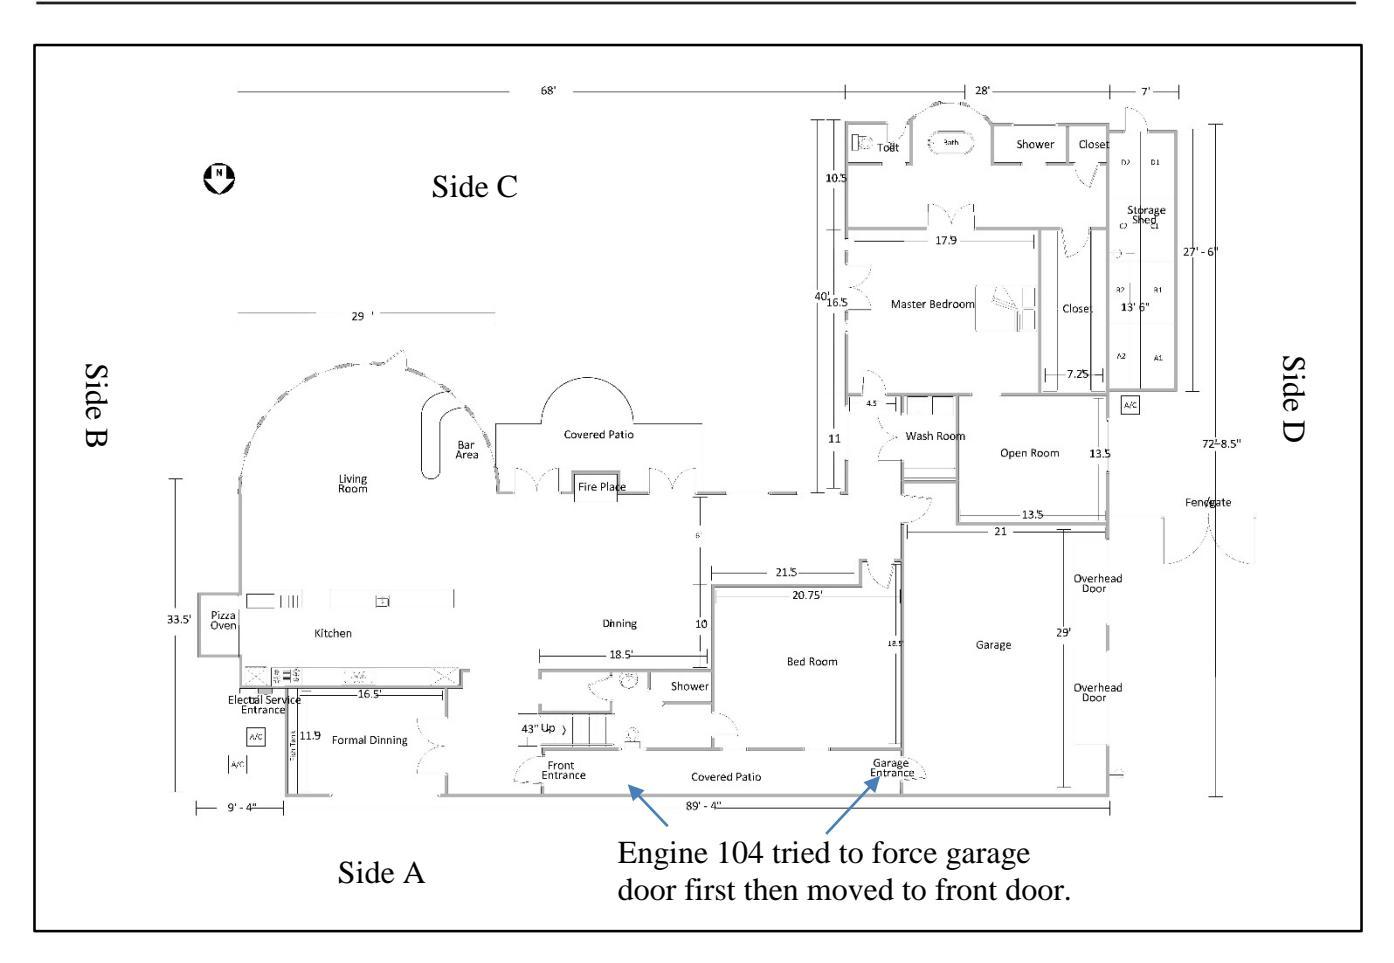
Diagram 1. First floor layout and general dimensions. (Courtesy of the Texas State Fire Marshal.)

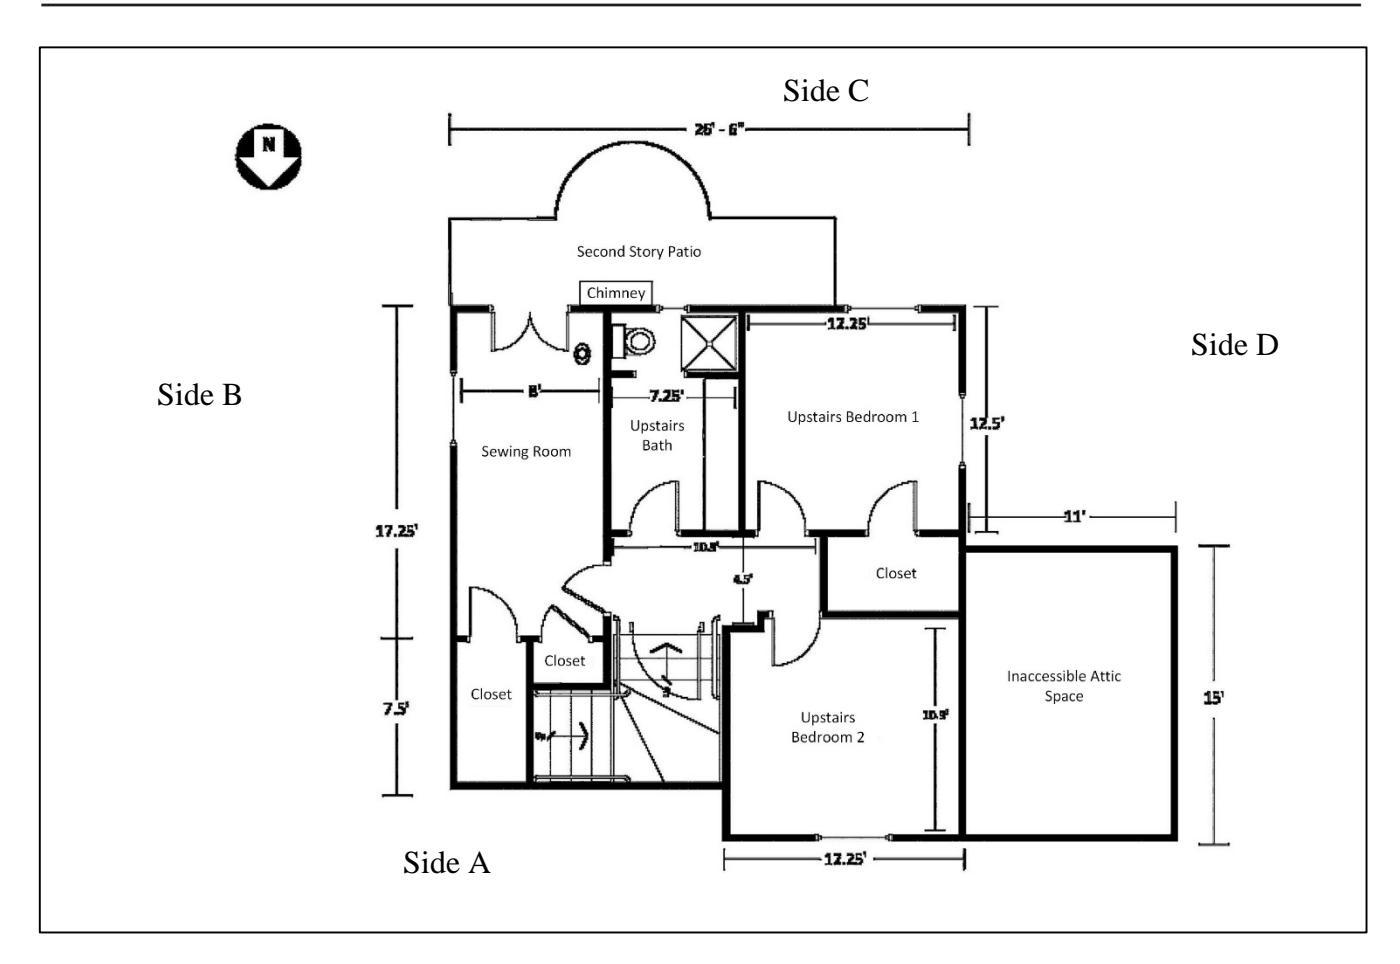
Diagram 2. Second floor layout and general dimensions. (Courtesy of the Texas State Fire Marshal.)

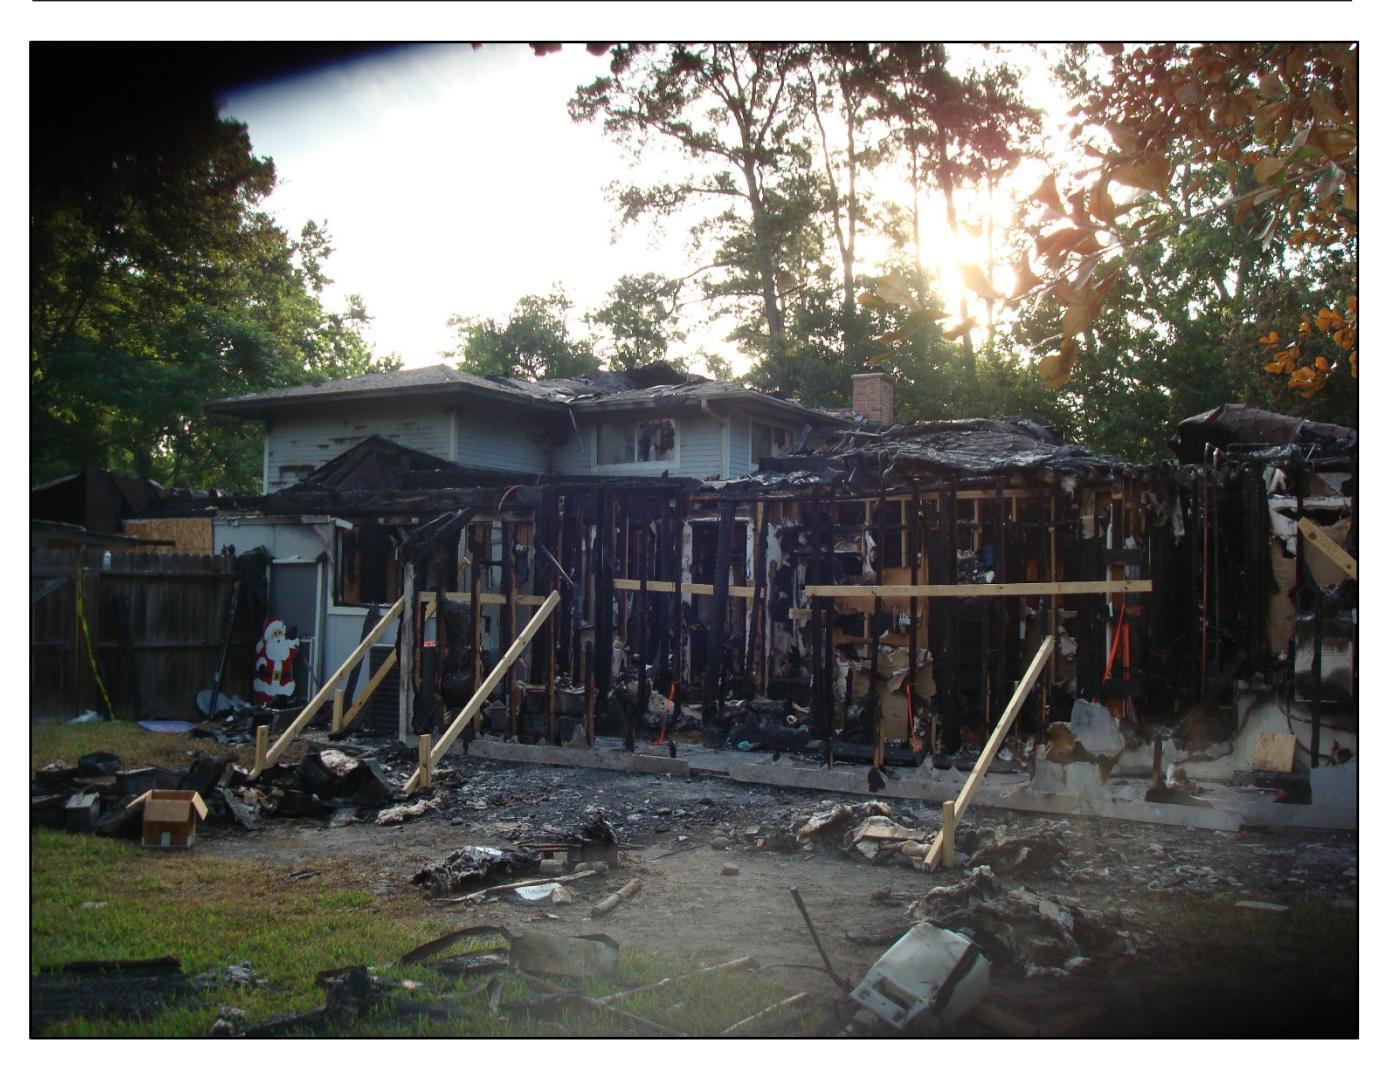
Photo 2. Side Delta of fire structure where the area of origin of the fire occurred. (*NIOSH photo.*)

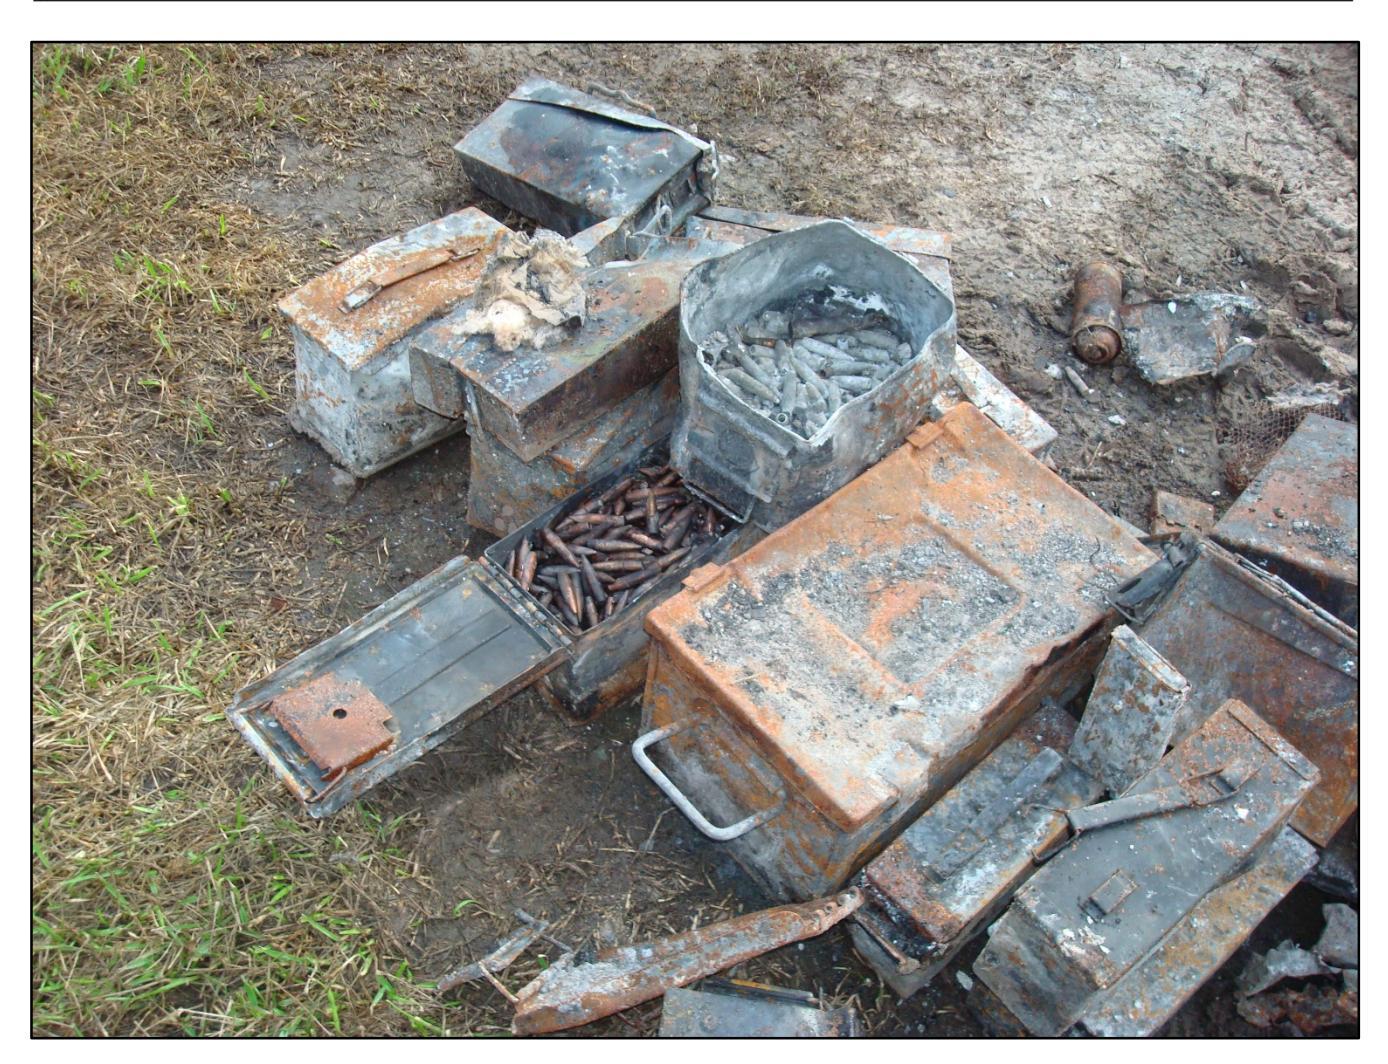
Photo 3. A sample of ammunition and reloading supplies found on Side Delta. (*NIOSH photo.*)

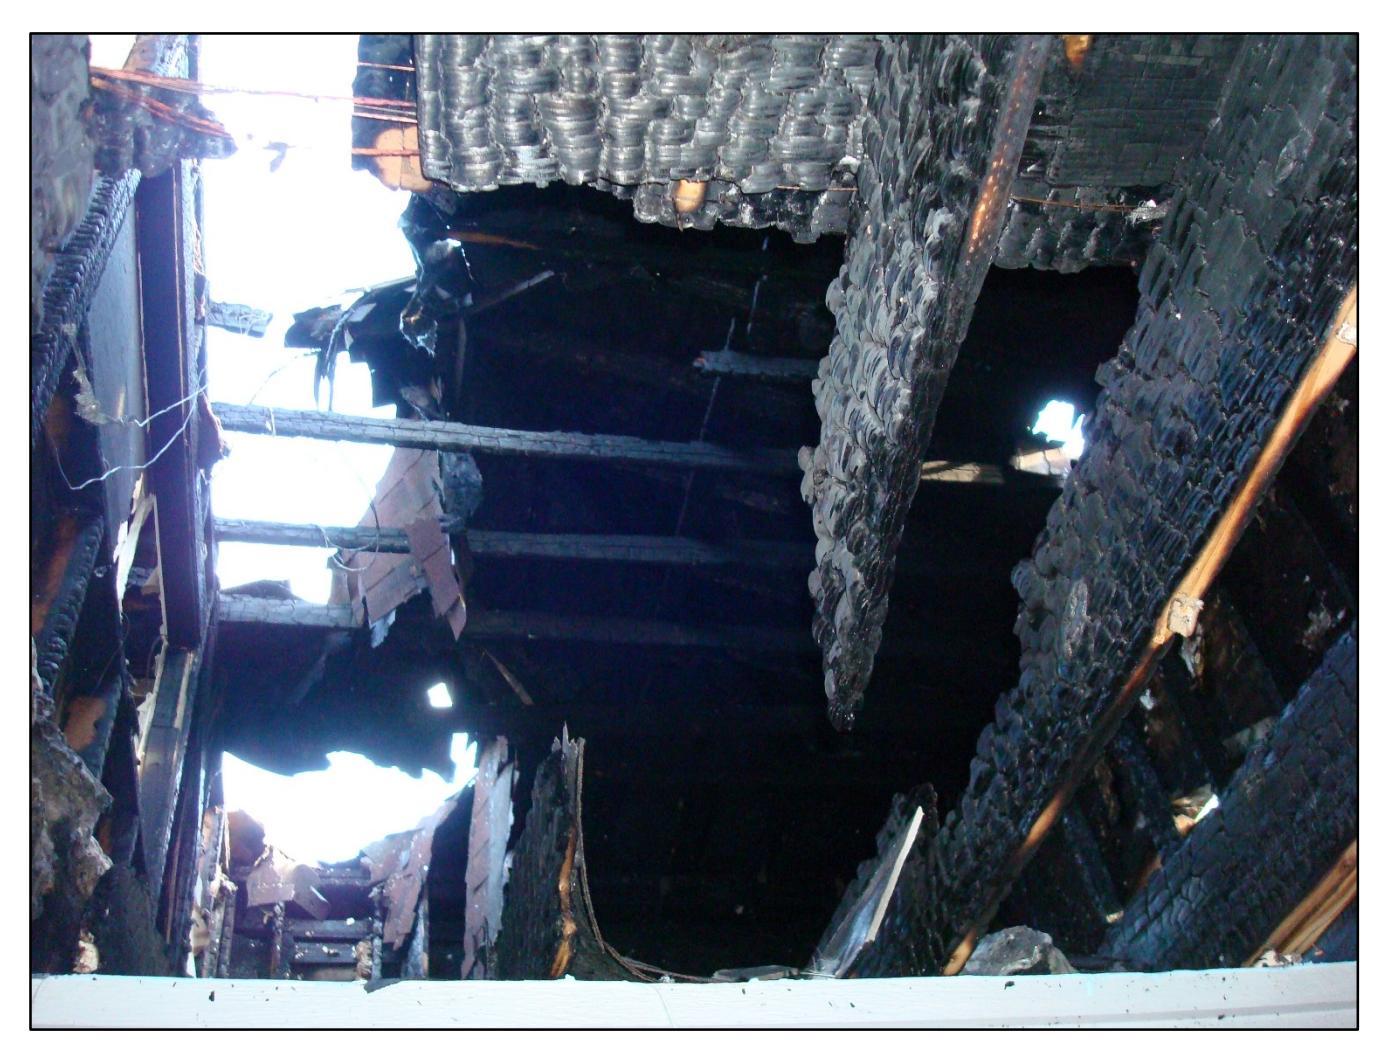
Photo 4. Large void space over the garage at the Alpha/Delta corner connecting the L-shaped attic structure. (NIOSH photo.)

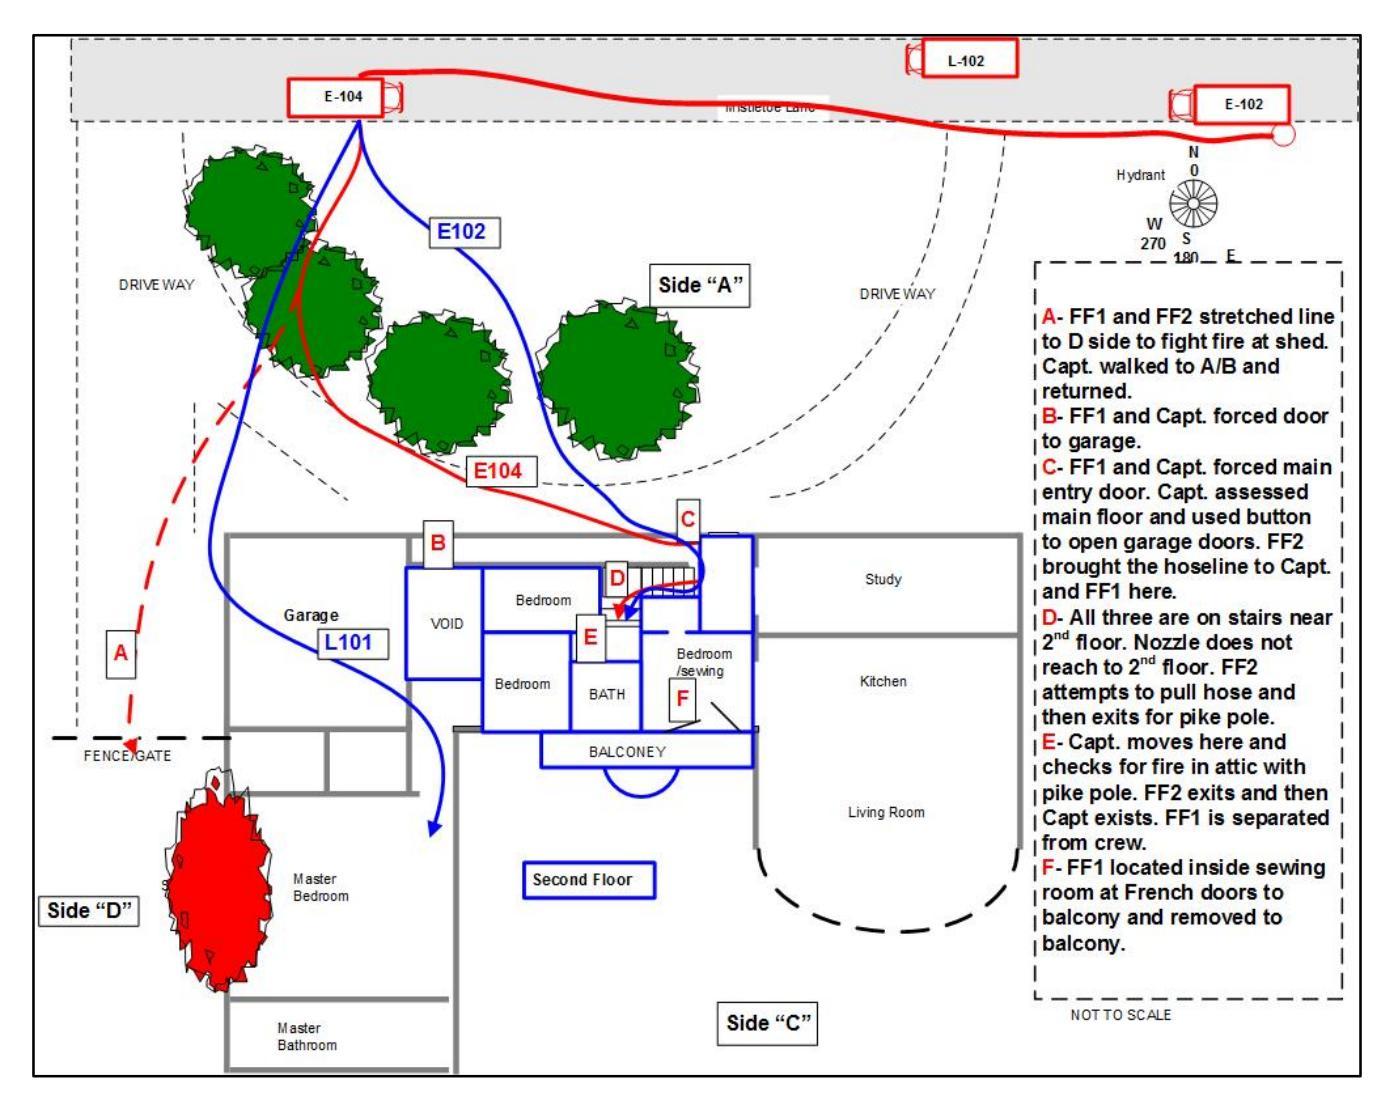
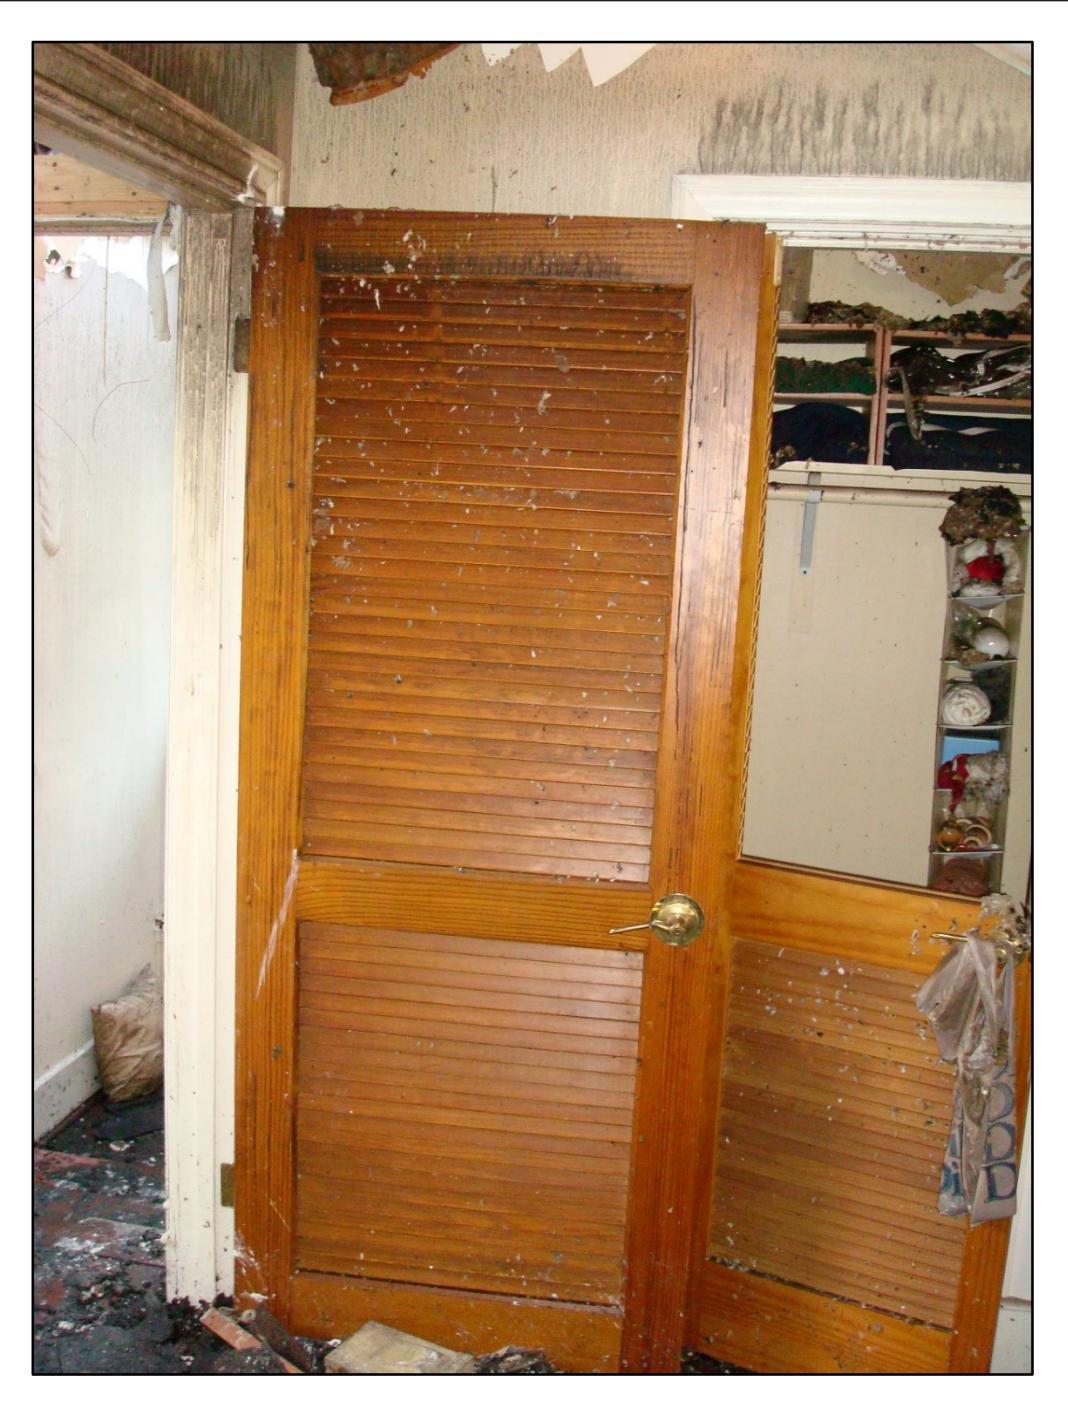
Photo 5. Louvered door to sewing room at top of stairs to the left. Picture taken from inside the room. The top half of the louvered closest door (right) is broken out (see <u>Possible scenarios</u>, #2). (NIOSH photo.)

may have become unconscious and collapsed on the floor. (2) In Photo 5, the top half of the louvered closest door is broken out. It is possible that FF1 thought this was the door on the left being the way out and tried to break through it, causing him to become trapped. (The entry door to the room was the same louvered style.) (3) In Photo 6, the right panel door has a nonoperating handle on it but it is bent down, possibly by FF1 trying to open the door just prior to him becoming unconscious.

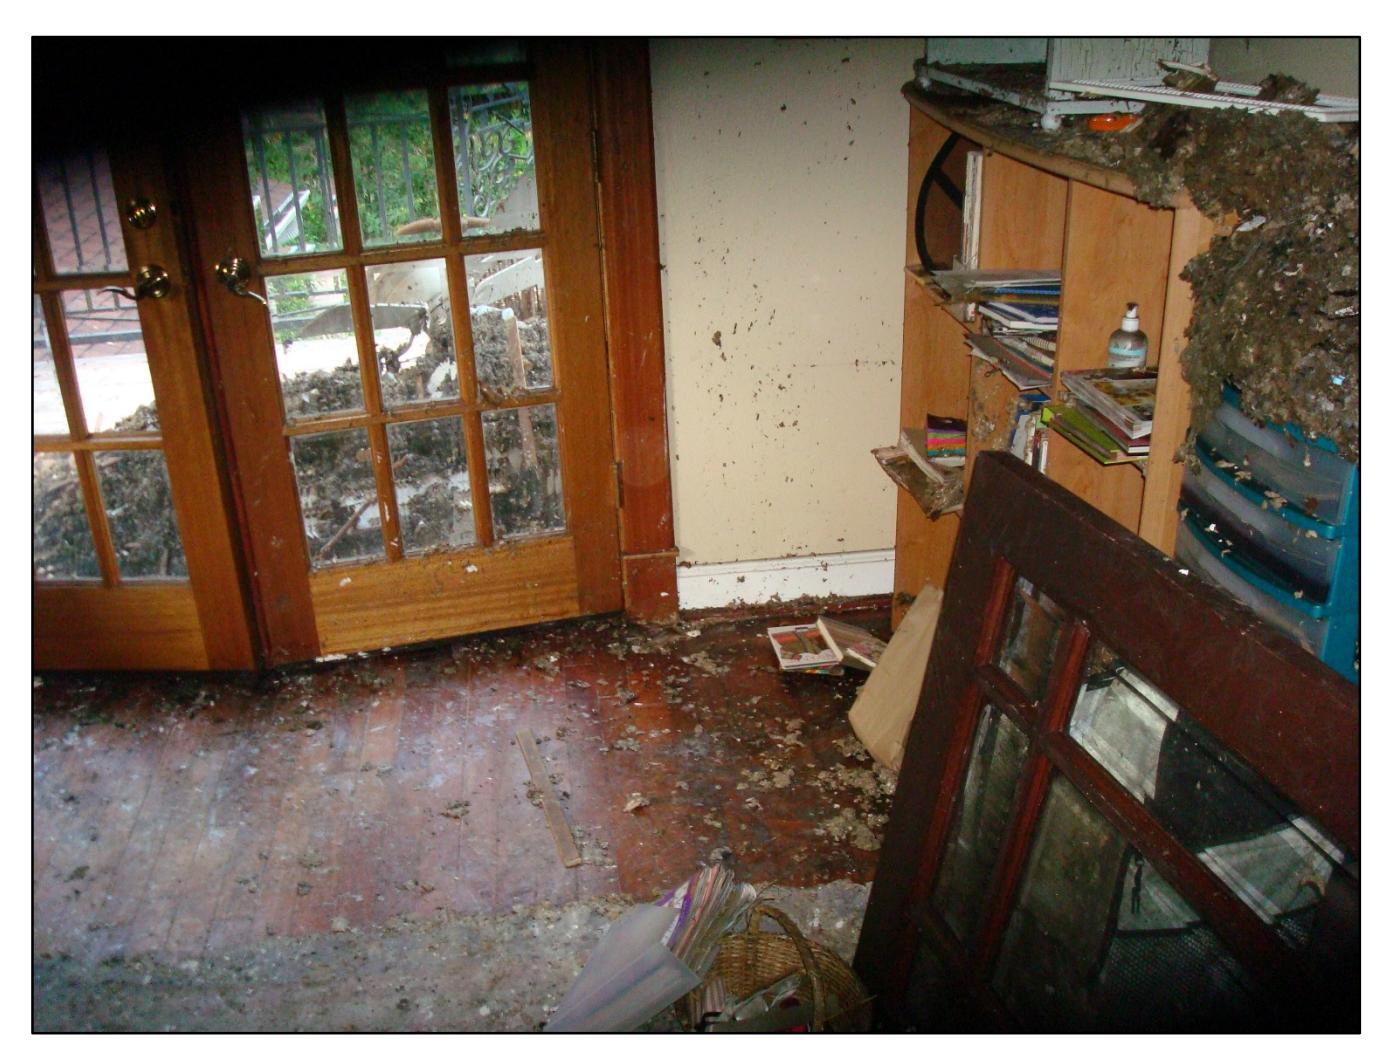
Photo 6. The double glass panel doors of the sewing room that lead out to the second floor balcony. Note that the door handle on the right is a nonfunctioning handle and is bent down (see <u>Possible scenarios</u>, #3). FF1 was found on the floor at the base of the right panel door. (NIOSH photo.)

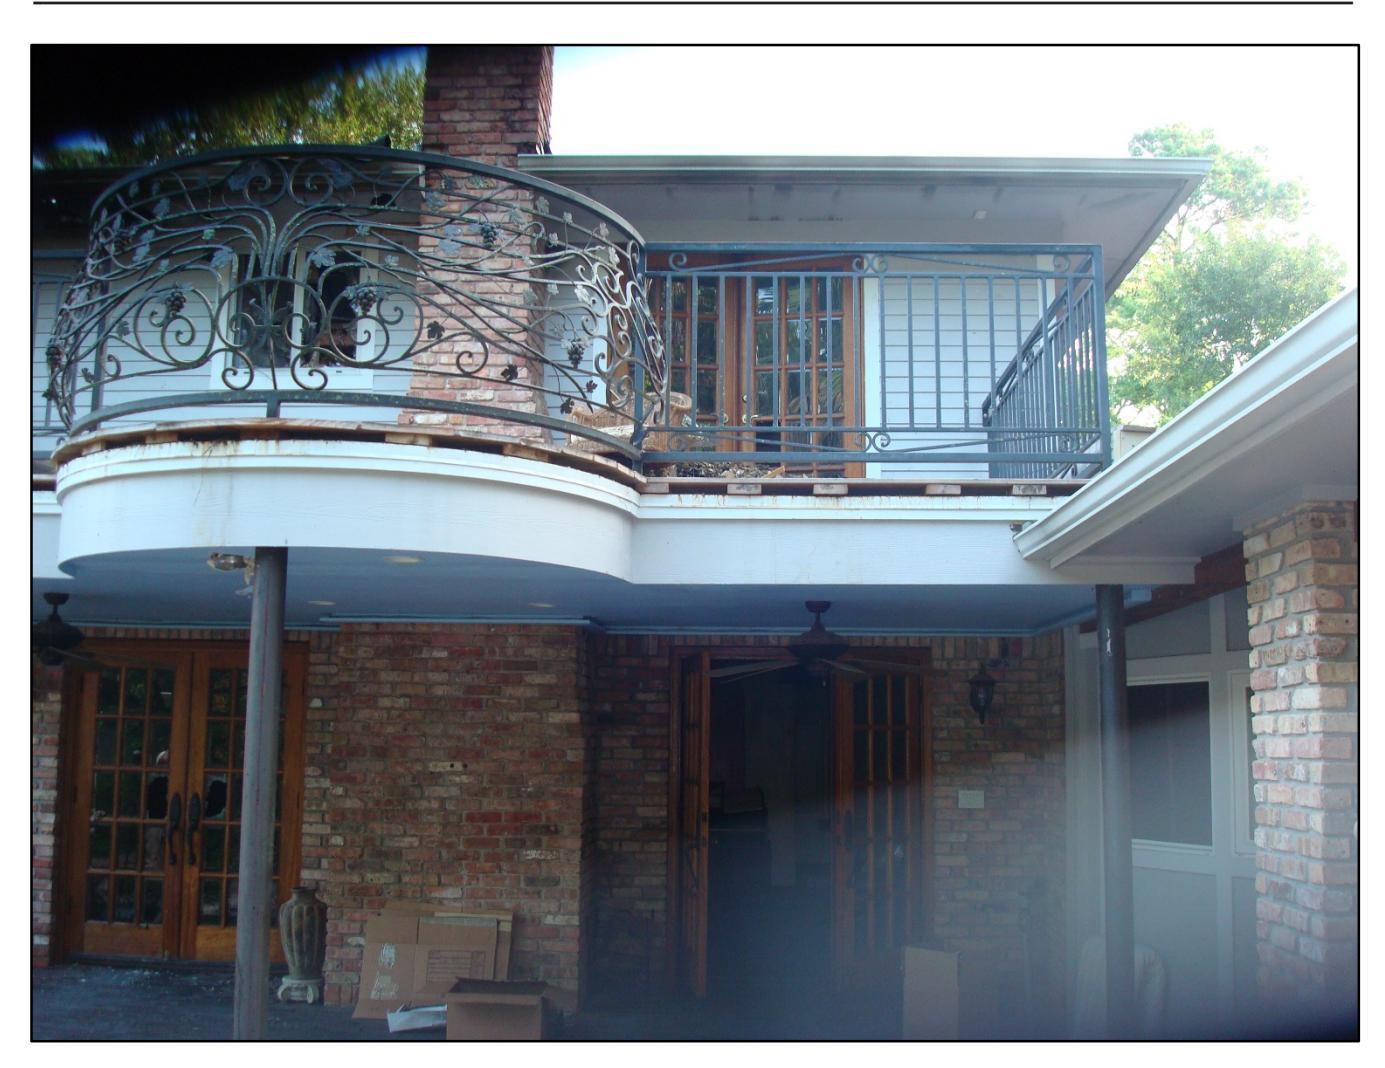
Photo 7. The second floor balcony where FF1 was brought out and lowered to the ground via a ground ladder. (NIOSH photo.)
