38-Year-Old Volunteer Recruit Firefighter Dies During SCBA Confidence Training at Fire Academy—California

Executive Summary

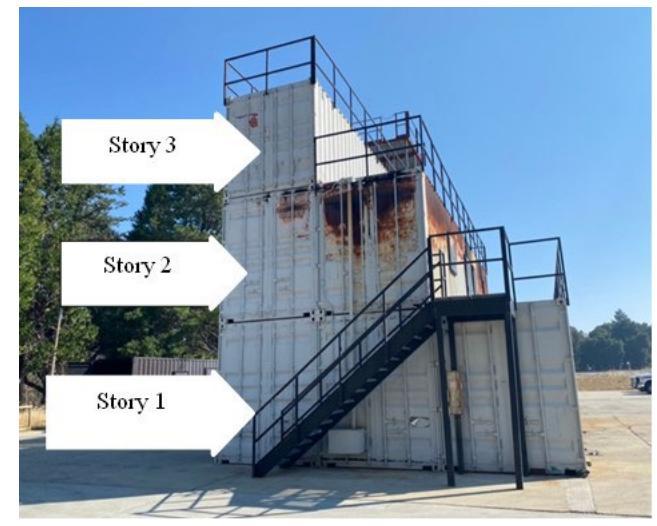
The training was being taught at a three-story training tower made of six shipping containers. The training tower had three containers on the first story, two containers on the second story, one container on the third story, and an observation deck on top (Figure 1).

Figure 1. The training tower involved in the incident. Photo by NIOSH.

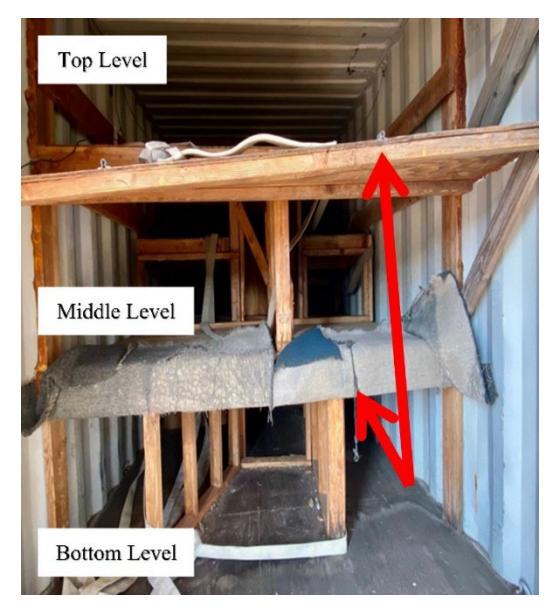
The maze was approximately 80 feet in total distance for students from entrance to exit. It measured 17 feet deep, 8 feet wide, and 9 feet high. It was divided into three levels (Figure 2).

Figure 2. SCBA maze with three levels. Arrows pointing to middle level open emergency door and raised drape to bottom level. Photo by NIOSH.

There were two emergency exits in the form of hinged wooden doors, located at the front of the prop at the top and middle levels with skirting at the bottom level to reduce incoming light into the maze (Figures 3 and 4). Emergency exit access was less than 20 feet from any area within the maze. This was within the recommended 50 feet maximum identified by NFPA 1402 *Standards on Training for Fire Facilities and Props, Section 11.3.1 Technical Rescue Training Props*.

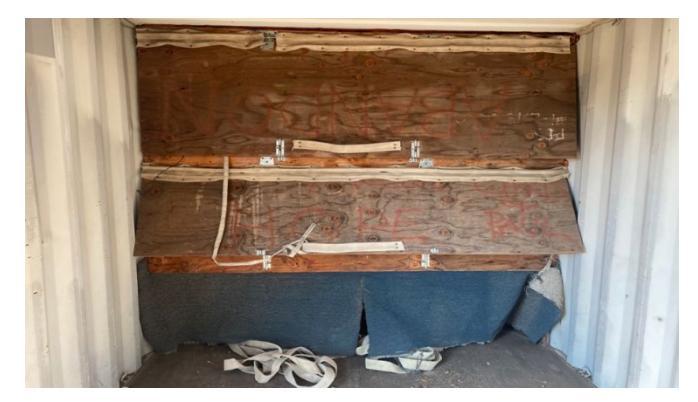
Figure 3. Maze with closed emergency access doors to middle and top levels and skirting lowered at bottom level. Photo by NIOSH.

The maze instructor immediately told the assistant working with him to open the maze emergency doors (Figure 3) and remove the Recruit from the opening. The maze instructor then alerted the lead instructor who was outside of the incident location. The maze instructor and lead instructor both arrived to find the assistant instructor performing cardiopulmonary resuscitation (CPR) after pulling the Recruit from the maze, CPR was initiated at approximately 1058 hours and the Emergency Communication Center (ECC) was advised of a firefighter down and a request was made for both ground and air advanced life support (ALS) transport due to the remote training location. Approximately 1149 hours, medics and nurses stopped resuscitation efforts and requested the coroner to the incident.

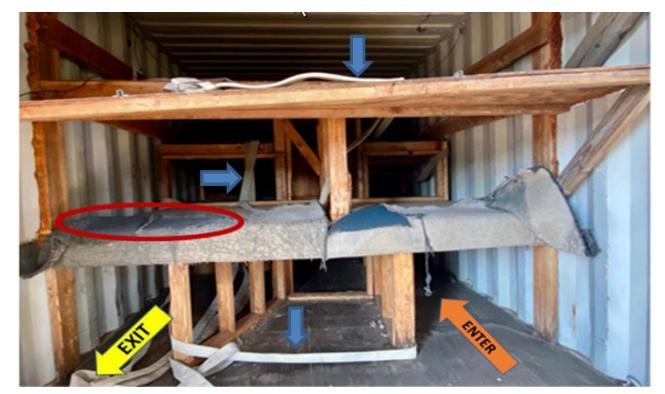
Figure 4. Cross section of the maze showing direction of movement and red oval indicates location where the Recruit collapsed. Blue arrows indicate hose line recruits used as a guide. Photo by NIOSH.

There were no significant obstructions in this first section as the recruits entered and a hoseline was used as a guide for the recruits to follow the correct path as they went through the maze. Recruits encountered different obstacles such as diminished clearance, mattress springs, debris, inclines, and declines (Figures 5–8).

The Recruit was still breathing ambient air as he sat on the floor of the middle level compartment with his legs hanging in the opening that led to the bottom level. He lowered his SCBA to the assistant instructor through the opening below who was assisting him to the exit. As he started to transition himself through the opening, he became quiet. The maze instructor asked him if he was ok, and there was no response. The Recruit became unresponsive as he was transitioning from the middle level to the bottom level as identified in Figures 4 and 8. The maze instructor noticed the Recruit was now slumped halfway through the opening. The instructor removed the Recruit's helmet and mask and heard agonal breathing, so he yelled to the assistant to remove him from the maze. When the assistant opened the maze emergency door at the middle level. He found the Recruit in a kneeling position on the bottom level with his arms in resting on the middle level and his head hanging between his arms. After moving the Recruits position in the opening, the assistant instructor was able to remove him from the bottom level.

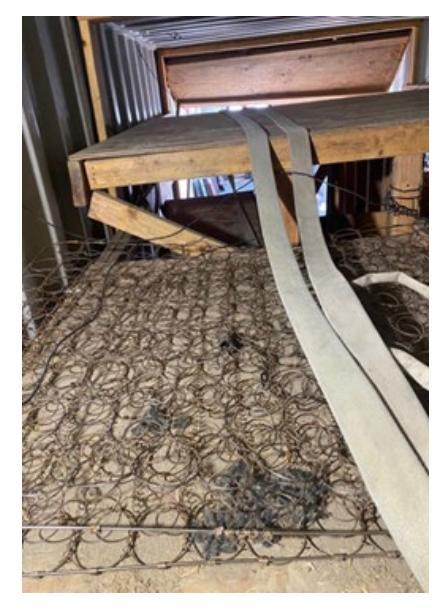
Figure 5. View from top to middle level. Photo by NIOSH.

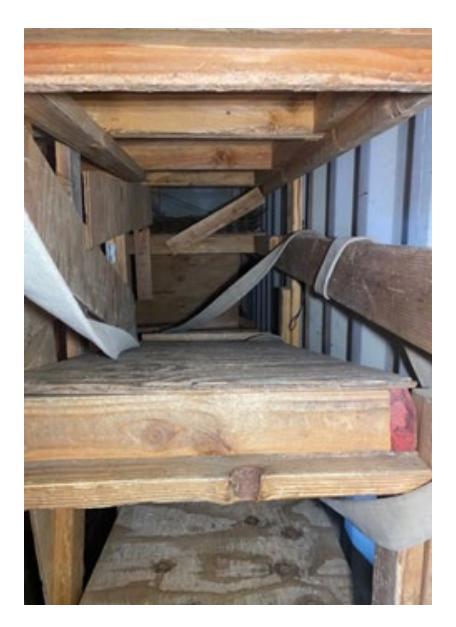
Figure 7. Decline to top of bottom level. Photo by NIOSH.

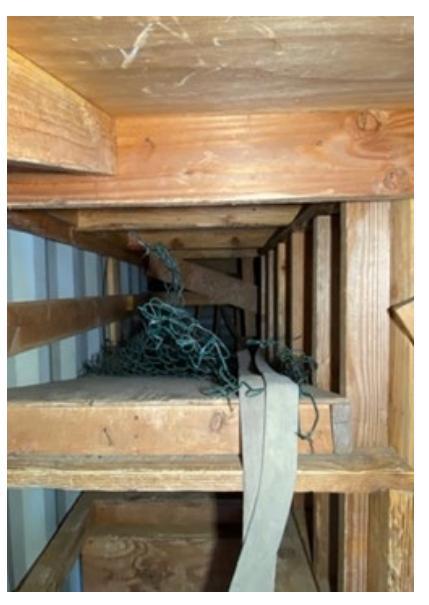
Figure 6. Diminished clearance. Photo by NIOSH.

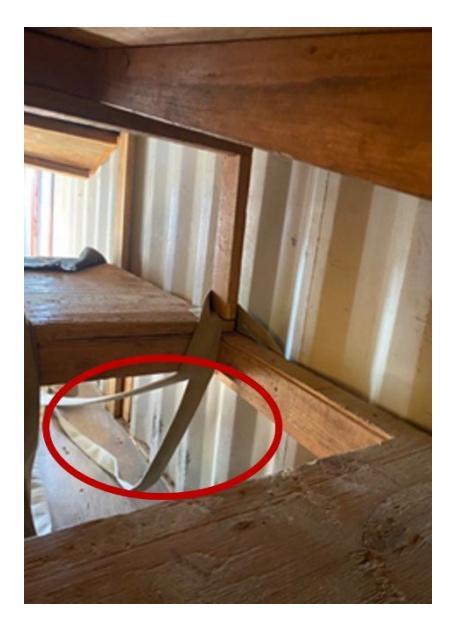
Figure 8. Middle level to bottom level that leads to exit with location of Recruit's collapse indicated by red oval. Photo by NIOSH.

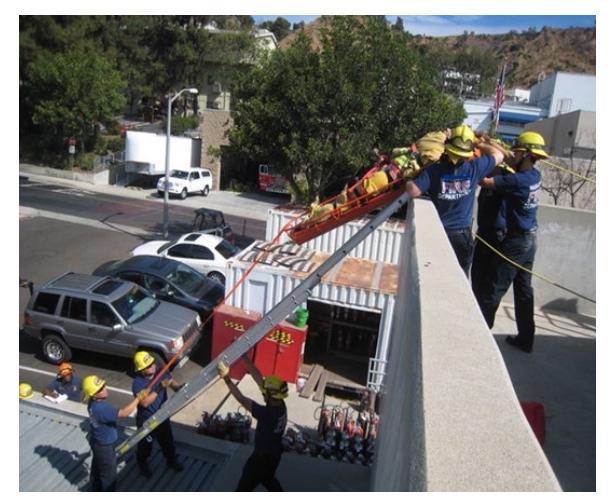
Due to access issues, a ladder system had to be set up before the Recruit could be lowered by a stokes basket to the second story (Figure 9). As other recruits set up the ladder slide system, instructors continued CPR and BLS, including a supraglottic airway as the Recruit was not breathing and did not have a detectable pulse.

Figure 9. Ladder slide demonstration showing how the Recruit was lowered to the second story of the tower. Not from actual tower. Photo courtesy of Lee & Associates.

In this incident, the maze was on the third story of the training facility with no access by stairs. A ladder was in place for the recruits to access the third story, but the single ladder was not sufficient to

extricate the Recruit. A system had to be built and CPR had to be stopped for approximately ten seconds to lower him to the ground.

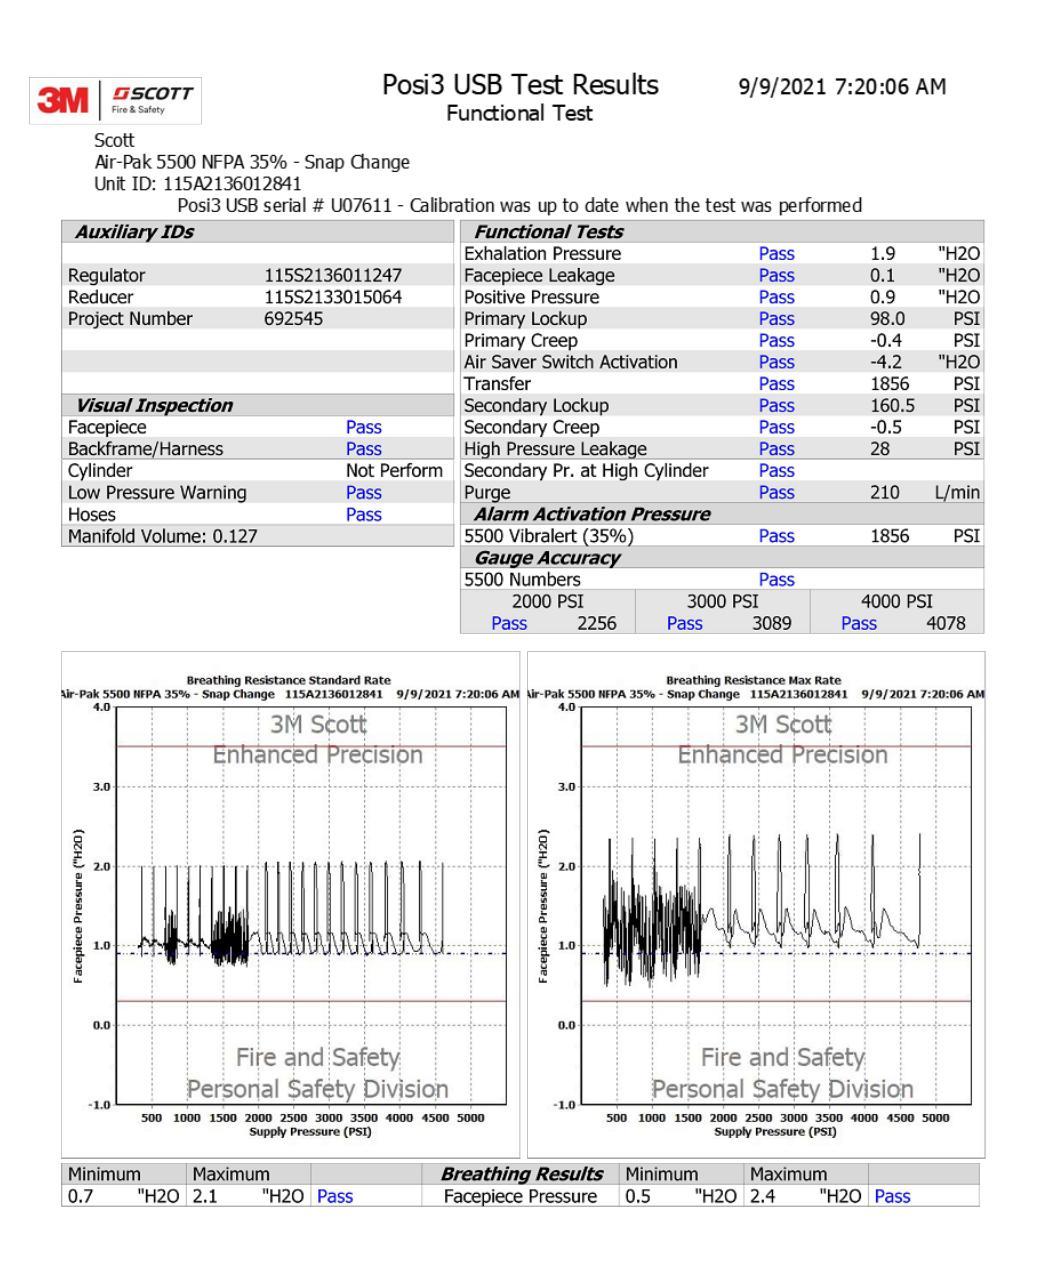
SCBA Test Results

After the incident, the SCBA unit, including air cylinder and mask, was taken by law enforcement to the coroner's office for testing. The coroner worked with the manufacturer, sales representatives and the fire agency for testing and it passed all tests (see Appendix A).
