Fatality Investigation Report

OR 2008-01-1

Mechanic killed by excavator bucket during maintenance

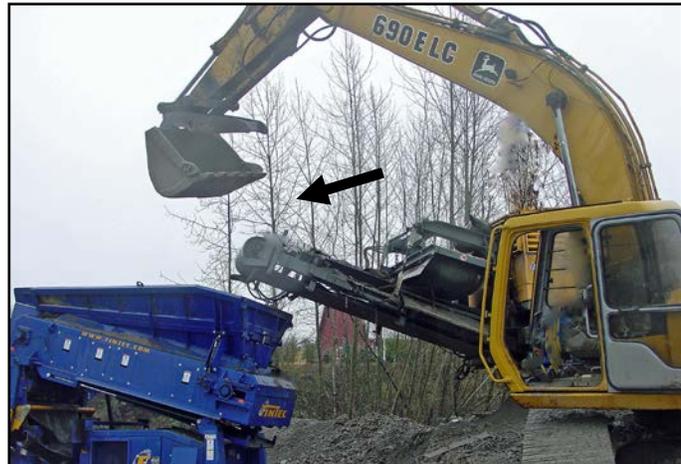
A mechanic was standing on the conveyor of a rock crusher (arrow), rigging the frame to an excavator bucket to lift the conveyor for maintenance. The excavator boom unexpectedly swung and dropped, and crushed him.

- **Loose clothing should be avoided when operating machinery and all tools/equipment should be stored outside the cab.**
- **Eliminate or reduce worker exposure to hazards by installing or purchasing equipment with protective features, such as “quick connects” or built-in anchor points.**

- **To aid in hazard identification and correction, employers should conduct and document workplace hazard assessments to include all job tasks, including maintenance, and ensure safe work procedures are followed.**
- **Use a dedicated signalperson in complex and limited sight lifts/picks.**
- **During lifting operations, individuals working near the point of operation should reposition themselves away from pinch points and the potential swing pivot area of machinery.**
- **Employers should ensure that workers are trained to perform best safety practices in each role during lifting operations with heavy machinery, including machine operators, signalpersons, and riggers.**

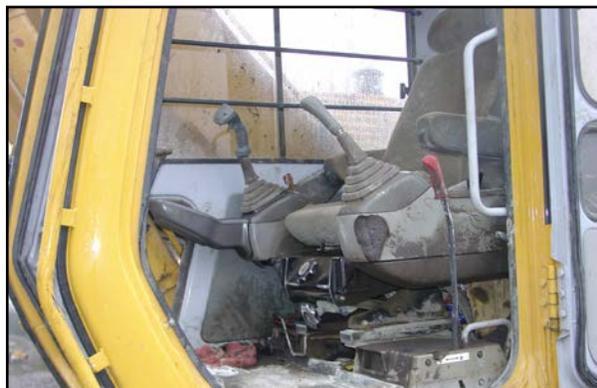
After leaning out of the right side cab window for a better view of the mechanic who was working near the bucket, the operator sat back down into his seat and his rain coat caught on the left-side control handle for the boom, causing the boom to swing and drop.

Recommendation #1: Loose clothing should be avoided when operating machinery and all tools/equipment should be stored outside the cab.

- Do not operate equipment with loose clothing, a tool belt, or other items that could interfere with the operator controls. In some machines the engine may not need to be running for an operating control to result in machine movement. Several Oregon occupational fatalities in the past decade were caused by unintentional activation of a control in the cab, including a caught jacket pocket similar to this incident, a tool belt, and a heavy object thrown onto an unguarded foot pedal (Readers are referred to Investigation Report #s OR 2003-15-1, OR 2004-07-1, and OR 2007-17-1).
