ALERT

**Preventing Falls of Workers through
Skylights and Roof and Floor Openings**

DHHS (NIOSH) Publication No. 2004-156
August 2004

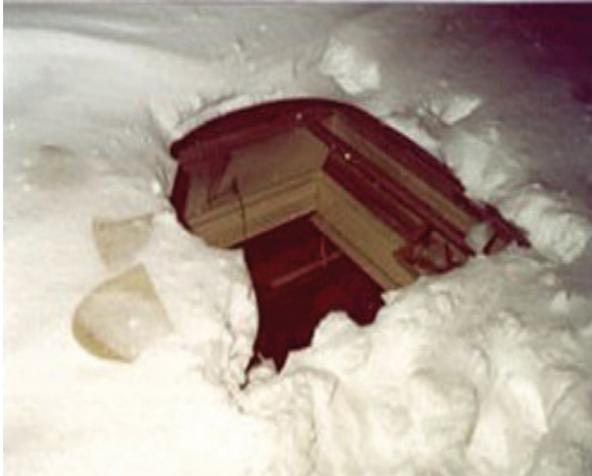
A 43-year-old male laborer at a coatings manufacturing company died after falling through an unguarded, 3-foot-square skylight lens to a concrete floor 14 feet below (Figure 1). The victim and a coworker were clearing snow from the flat roof of the building. The victim walked on the roof through deep snow that completely covered the skylights in that area of the roof. He apparently failed to see the snow-covered skylight and stepped onto its lens, which broke under his weight. The victim's coworker, who was walking toward the opposite side of the roof, looked back toward the location of the victim after hearing a noise coming from that area. He saw the broken skylight lens and called for help.

Figure 1. Snow-covered 3-foot-square skylight.

The skylight did not have a protective screen, cover, or guarding around it [Wisconsin Department of Health and Family Services 1999].

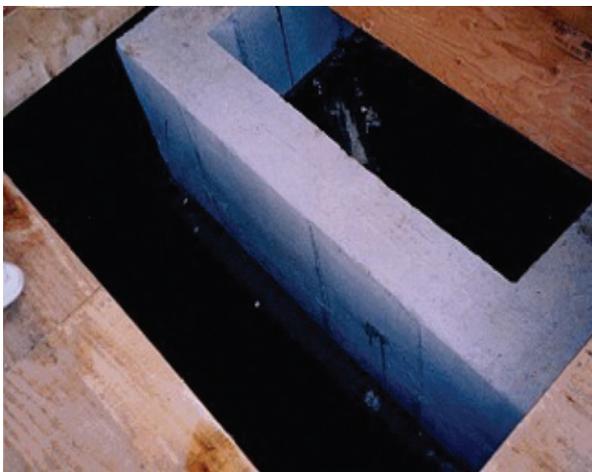
A 39-year-old, self-employed residential construction contractor died after falling through an unguarded floor opening and onto the concrete footing 10 feet below (Figure 2). He was framing the second floor with two other workers and was in the process of holding a level to the gable end of the second-floor master bedroom when

Figure 2. Unguarded floor opening.

he apparently stepped back into one of two floor openings built to accommodate a chimney. Both the first and second floors had been decked with plywood except for the chimney floor opening. Each floor opening measured approximately 4 feet x 5 feet [Massachusetts Department of Public Health 1999].

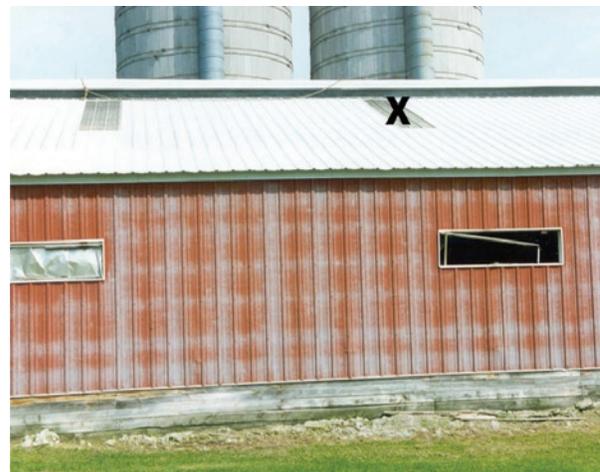
A 62-year-old farmer died from injuries sustained when he fell through a corrugated fiberglass panel used on the roof of a pole barn to let light into the building (Figure 3). On the day of the incident, the farmer drove a tractor equipped with a front-end loader next to the barn. He used the loader bucket to climb onto the roof. He walked up the slope of the roof until he reached a rope tied into the roof vent. Evidence suggests that he held the rope in one hand as he pushed snow off the roof. He stepped onto a snow-covered 3- x 10-foot corrugated fiberglass panel that broke, causing him to fall approximately 16 feet to the concrete floor below. The fiberglass panel had not been guarded or marked with a warning to indicate that it covered a hole [Minnesota Department of Health 1994].

Figure 3. Fiberglass panel on metal roof (marked with an X).

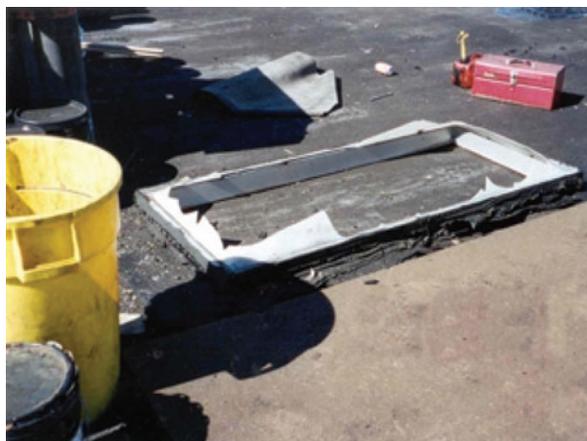
A 14-year-old male laborer died from injuries he sustained when he fell through the lens of a 56- x 24-inch, curb-mounted skylight to a concrete floor approximately 12 feet below (Figure 4). Along with several other day laborers, the victim and his 16-year-old brother had been hired by a roofing contractor on the day of the incident to pull up and remove built-up roofing materials from the flat roof of a one-story wholesale florist shop. The victim had been working for approximately 15 minutes pulling up roofing materials by hand when he fell back onto a skylight lens that broke under his weight. The skylight did not have a protective screen, cover, or

Figure 4. Rectangular skylight after it had been removed from the roof and placed on the ground.

guarding around it, and the lens was not marked with a warning against sitting or stepping on it. The employer had assigned the victim and his brother to roofing work in violation of HO16 [NIOSH 2002].
