Volunteer Fire Police Captain Dies After Being Struck by a Motor Vehicle at a Controlled Roadway - Pennsylvania

Executive Summary

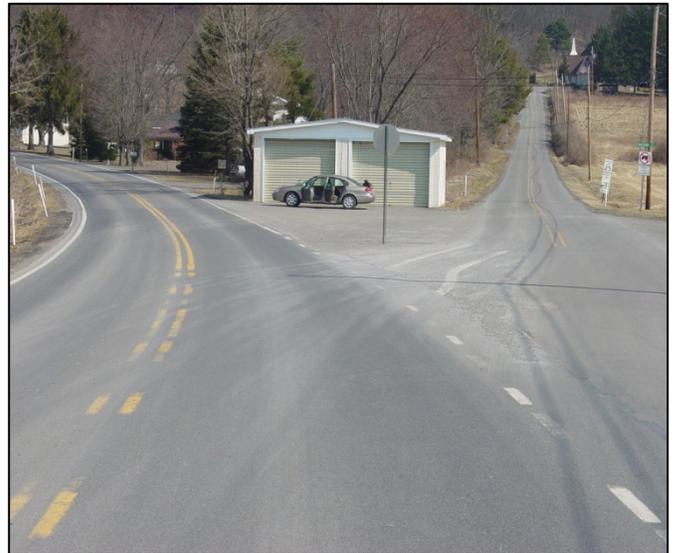
Incident scene. Approaching from the west.
(NIOSH Photo)

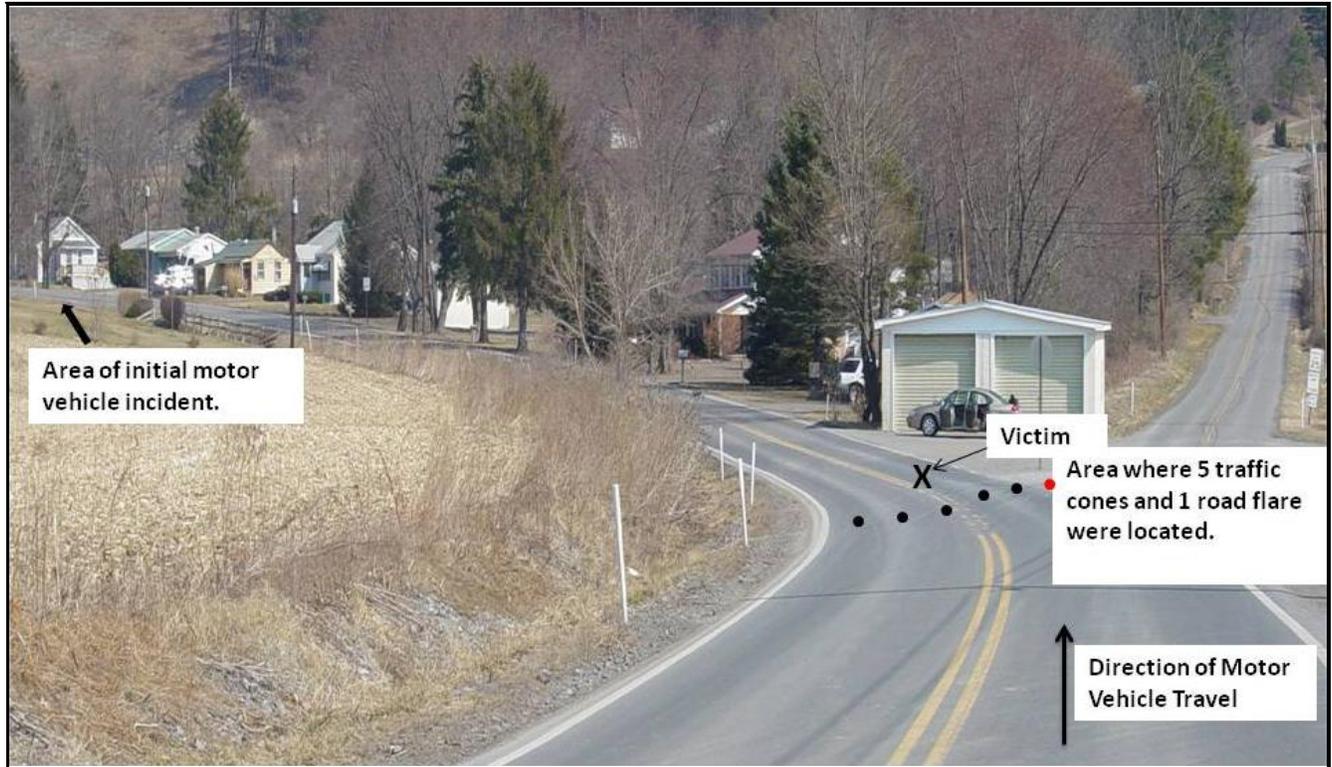
state highway. He also lighted a phosphorous road flare and placed it on the ground adjacent to the traffic cones (see Diagram and Photo 1).

The victim was standing on or near the double yellow lines in the roadway with his back to oncoming traffic from the west, while electric crews were replacing the utility pole. At about 1333 hours, a motor vehicle travelling in the east bound lane approached the coned area and drove through the coned area and struck the victim. Upon impact, the victim was thrown onto the hood of the car, carried on the front of the vehicle and then thrown to the ground in front of the vehicle when it came to a stop.

Photo 1. View of the intersection where victim was standing when struck by a motor vehicle travelling in the eastbound lane of the roadway.

The roadway on which the incident occurred had a 45 mph posted speed limit. The road curved to the left and was at the juncture of a Y intersection. The victim had placed a flare and 5 18-inch lime green traffic cones across the roadway at the juncture of the Y intersection approximately 400-foot west of the initial motor vehicle incident. Also, the victim’s personal vehicle was parked nearby with a red mini-light bar activated. No other traffic control devices such as signs (e.g. Be Prepared to Stop or Detour signs) were used in advance of the controlled roadway. At about 1333 hours, the victim was standing behind the lime green traffic cones on or near the double yellow lines on the roadway with his back to oncoming traffic. The victim was struck by a motor vehicle and died several hours later. The driver of the vehicle that struck the victim reported to law enforcement that he did not see the victim.

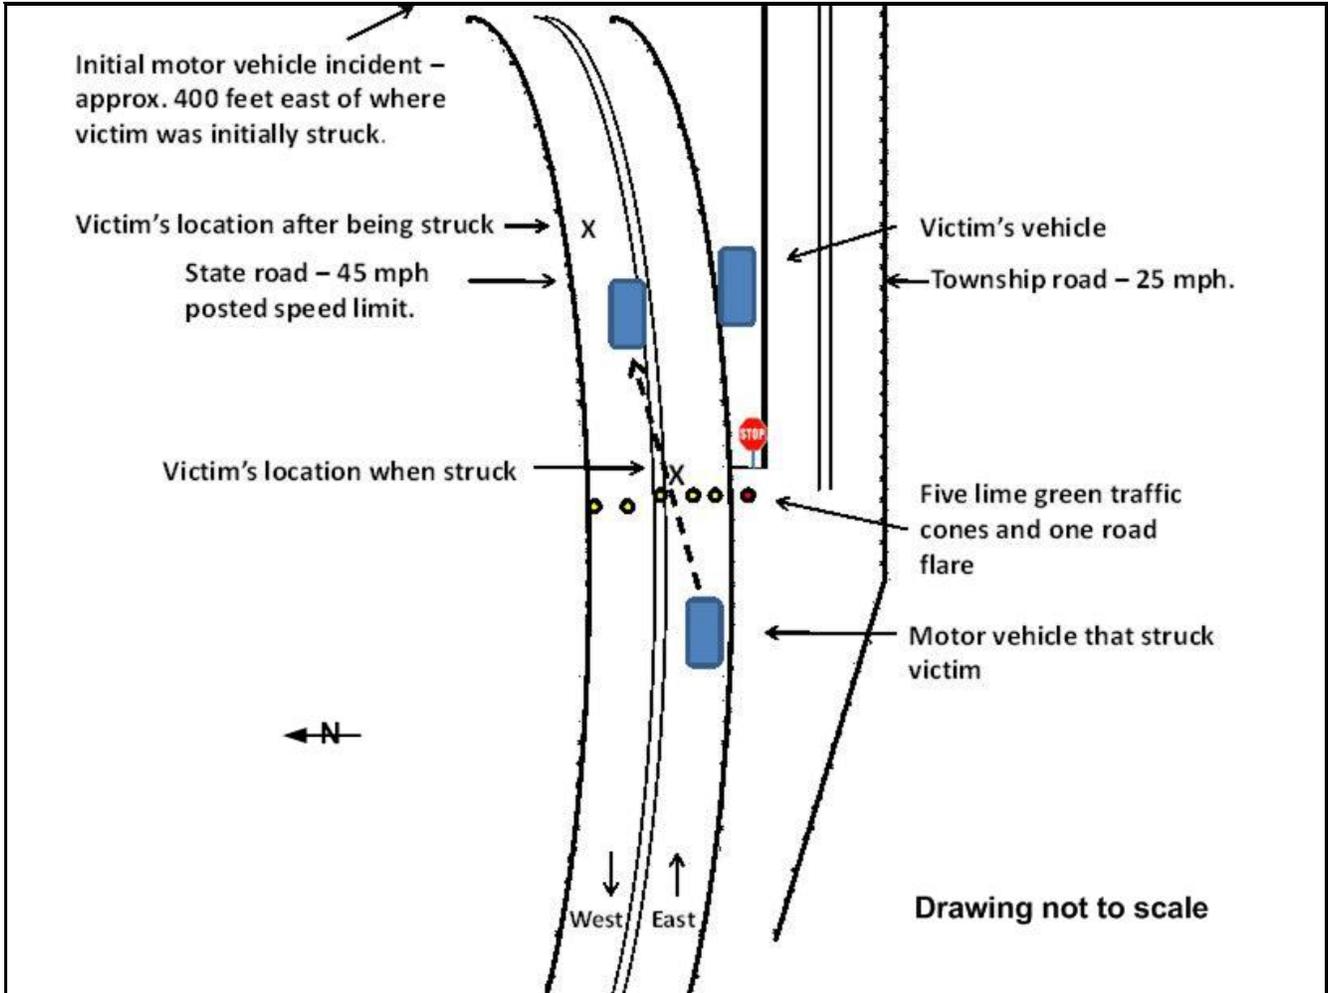
The volunteer fire police captain (the victim) arrived on scene at 1250 hours. While travelling to the scene, he received instructions from the 911 communications center to close off the road at the “Y” intersection west of the motor vehicle incident. The victim proceeded about 400 feet west of the motor vehicle incident to the “Y” intersection where he closed both lanes (east/west) of the state roadway. The road traffic was to be detoured at the “Y” intersection to an adjacent township roadway around the motor vehicle incident (see photo 1). The victim parked his vehicle on the side of the road at the juncture of the two roadways at the “Y” intersection, and activated the red mini-light bar atop his vehicle. The victim, dressed in coveralls with some reflective areas and carrying a flashlight/traffic wand, placed five 18-inch florescent lime green warning devices (traffic cones) across both lanes of the

Diagram 1. Overview of the incident scene.
