HETA 95-0333-2546  
OCTOBER 1995  
DEKALB COUNTY BOARD OF HEALTH  
DECATUR, GEORGIA

NIOSH INVESTIGATORS:  
Max Kiefer, CIH  
Stan Salisbury, CIH

## SUMMARY

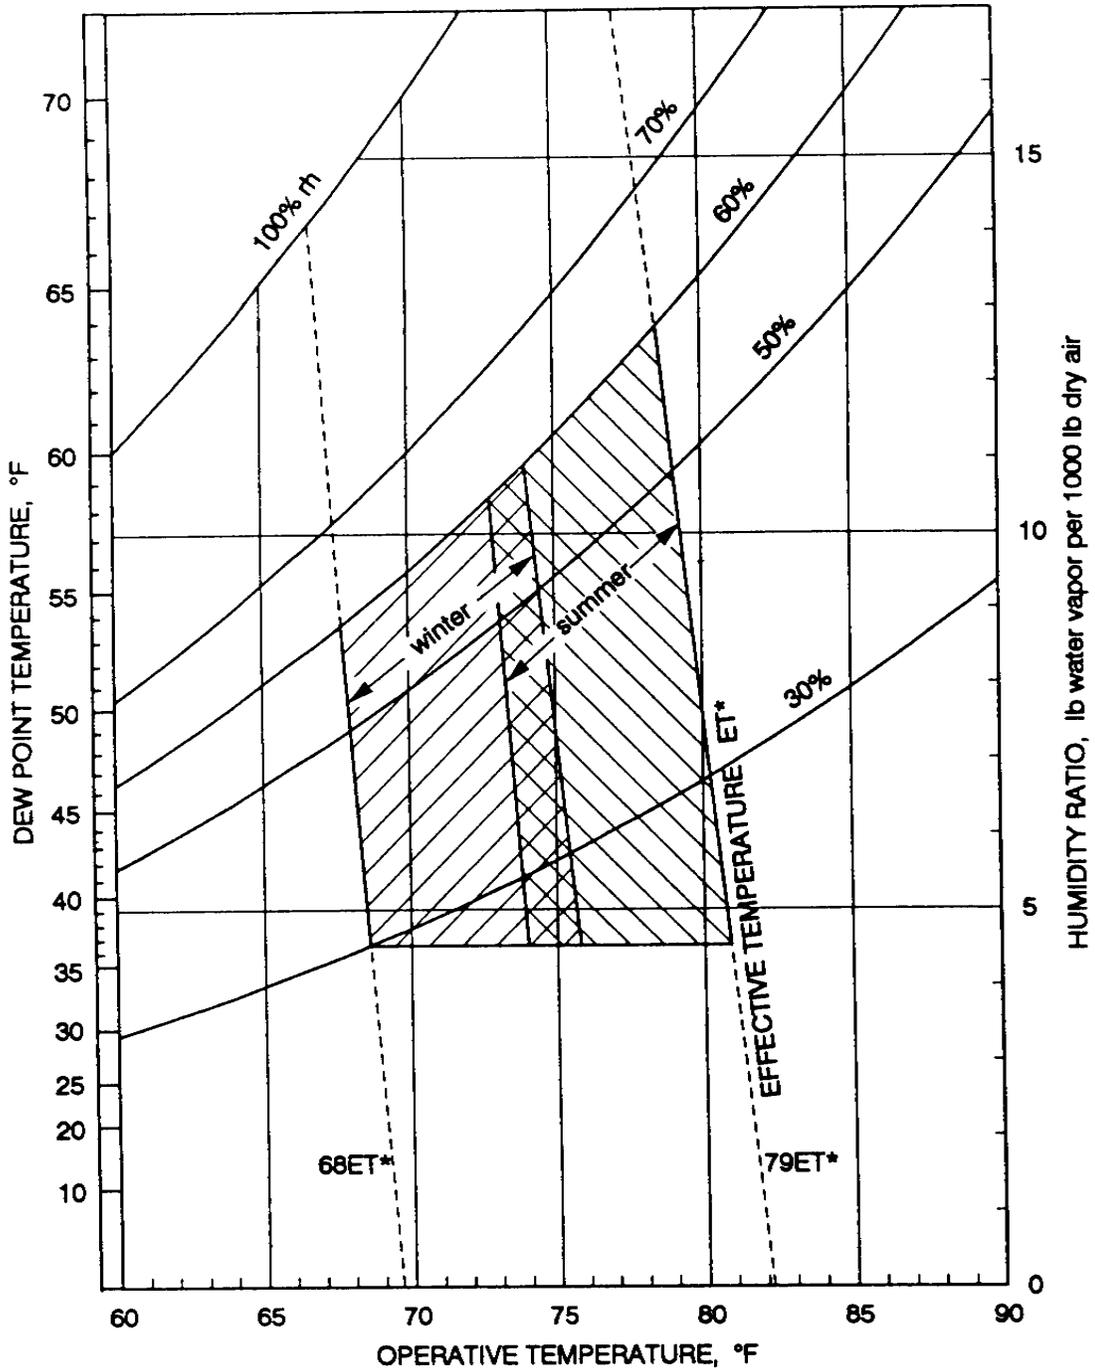
Figure 1  
ANSI/ASHRAE Standard 55-1992  
Thermal Environmental Conditions  
for Human Occupancy

Temperature and RH measurements are often collected as part of an indoor environmental quality investigation because these parameters affect the perception of comfort in an indoor environment. The perception of thermal comfort is related to one's metabolic heat production, the transfer of heat to the environment, physiological adjustments, and body temperature.<sup>27</sup> Heat transfer from the body to the environment is influenced by factors such as temperature, humidity, air movement, personal activities, and clothing. The American National Standards Institute (ANSI)/ASHRAE Standard 55-1992 specifies conditions in which 80% or more of the occupants would be expected to find the environment thermally acceptable.<sup>25</sup> Assuming slow air movement and 50% RH, the operative temperatures recommended by ASHRAE range from 68-74° F in the winter, and from 73-79° F in the summer (Figure 1). The difference between the two is largely due to seasonal clothing selection. ASHRAE also recommends that RH be maintained between 30 and 60% RH.<sup>(24,25)</sup> Excessive humidities can support the growth of microorganisms, some of which may be pathogenic or allergenic.
