Evaluation of deep-seated crib block fires and direct application fire suppression agents

M.A. Trevits and A.C. Smith

J.E. Urosek and M.P. Valoski

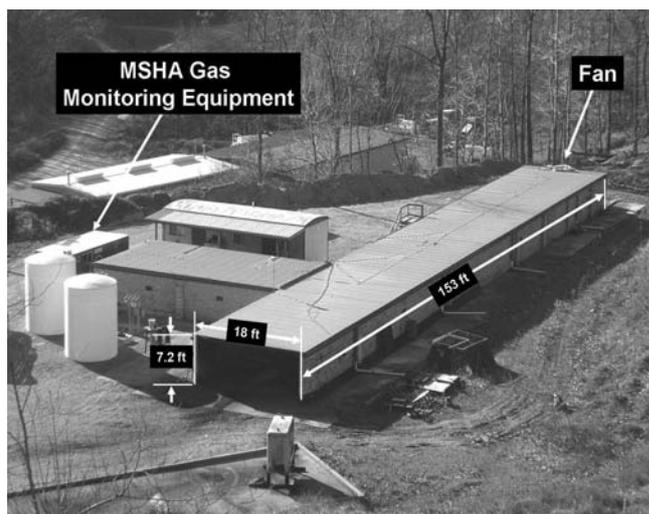
Figure 1 — Fire suppression facility.

The FSF was configured to simulate a 46-m- (150-ft-) long mine entry. The interior height of the simulated mine is 2.2 m (7.2 ft) and the width is 2.4 m (8 ft). The roof of the simulated mine is made of corrugated steel bridge planks, the ribs are made of 203-mm- (8-in.-) thick mortared solid concrete blocks, and the floor is made of reinforced concrete. The interior roof is covered with a 50.8-mm- (2-in.-) thick layer of Fendolite M-II® (a specialized fire resistant mixture of vermiculite and Portland cement) and a 25.4-mm- (1-in.-) thick layer of Fendolite M-II® has been placed on the ribs.² For ventilation, a 1.8-m- (6-ft-) diameter variable-speed axivane fan (equipped with a pneumatic controller to adjust fan blade pitch) has been installed at one end of the simulated mine. The fan can provide blowing sustained airflow up to about 5.84 m/s (1,150 fpm) over the cross-section of the entry. Two doors, which permit access to the inside of the FSF, are located about 14 m (47 ft) from the fan. Figure 1 shows the exterior of the FSF.

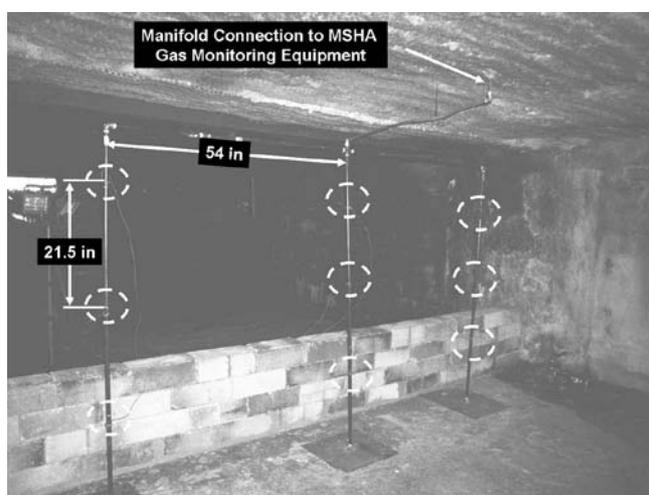
Figure 2 — Layout of a gas-monitoring array. (Circled areas show gas monitoring points and thermocouples.)

The components of the fire gases were measured using three gas-monitoring arrays. The first was a nine-point array located 6.46 m (21.2 ft) from the trailing edge of the crib block sets. The array consisted of an interconnected network of 12.7-mm- (1/2-in.-) diameter black iron pipe set across the width of the mine entry. A total of nine 3.175-mm- (1/8-in.-) diameter holes were drilled into vertical sections of the pipe to sample the fire gases. The holes in the pipe were spaced equally apart from the roof-to-floor and across the width of the entry (Fig. 2). A thermocouple was also positioned at each gas sampling point to measure the temperature of the fire gases. The gases collected at each sample point were mixed together in a manifold that penetrated the FSF roof. The manifold was connected to a Tygon® tubing line that led to the MSHA gas monitoring truck. The second gas-sampling array was configured in the same manner as the first and was located 29.1 m (95.5 ft) from the trailing edge of the crib block sets. The third gas-sampling array was positioned near the second gas-sampling array and consisted of four 3.175 mm (1/8 in.) holes drilled into 25.4-

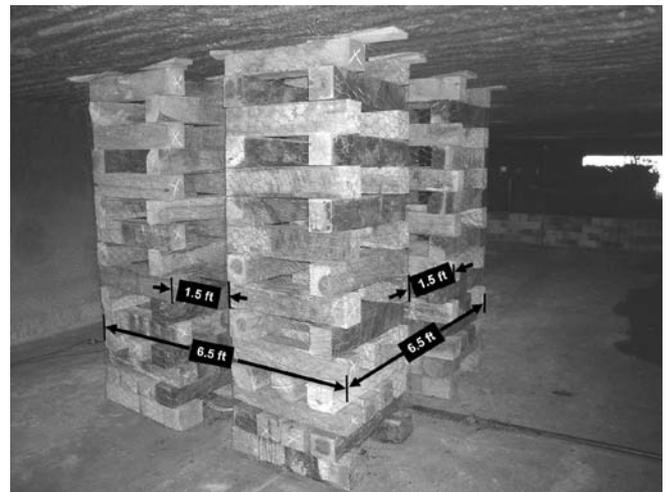
Figure 3 — Typical crib block set-up prior to a test.

Table 2 provides information about the crib blocks used in this study. Each crib block set was constructed on a foundation consisting of eight solid concrete blocks, with each concrete block measuring 152 mm high, 203 mm wide and 406 mm long (6 in. high, 8 in. wide and 16 in. long). A total of 34 crib blocks were stacked vertically to build each crib set (17 of the older crib blocks and 17 of the newer crib blocks). Each row of blocks was oriented perpendicular to the adjacent row. The bottom row contained four crib blocks (two newer blocks on the outside and two older blocks on the inside) oriented with the 152 mm (6 in.) side facing down, the next row contained four crib blocks (two newer blocks on the inside and two older blocks on the outside) oriented with the 152 mm (6 in.) side facing down. The next row contained three crib blocks (two older blocks on the outside and one newer block on the inside) oriented with the 152 mm (6 in.) side facing down. The next row contained three crib blocks (two newer blocks on the outside and one older block on the inside) oriented with the 152 mm (6-in.) facing down. The remaining rows contained two crib blocks each, alternating between the new and older blocks in each row with the 127 mm (5 in.) side facing down. The final row of blocks was adjusted with the 127 or 152 mm (5 or 6 in.) side facing down, depending on the relative closeness of the mine roof.

The crib blocks were secured to the roof with wedges as needed. To insure the maximum stability of each crib set, for the longest period of time, each crib set was wrapped with poultry fencing that was affixed to the wood with staples. Figure 3 shows the typical crib block set-up prior to a test.

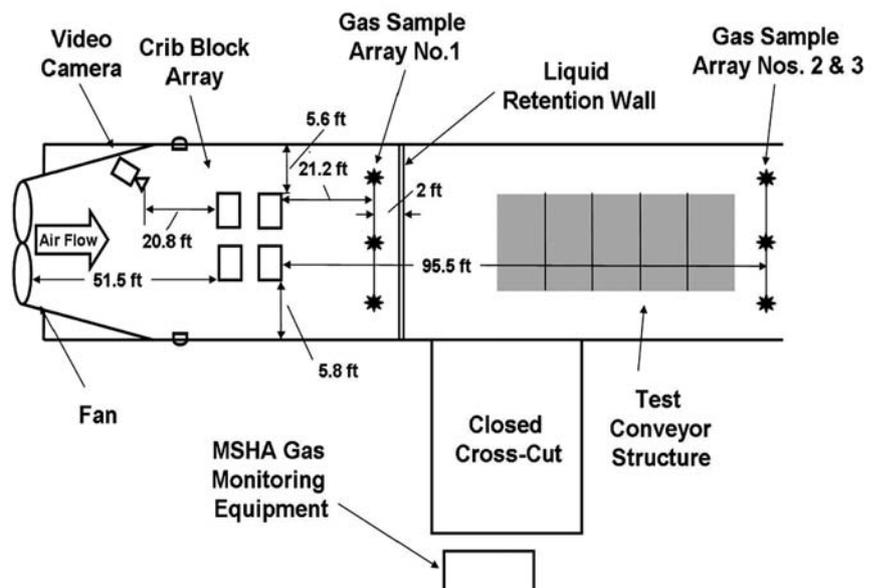
Figure 4 — FSF typical set-up for a crib fire test.

The layout of the FSF for the crib block tests is shown in Fig. 4. The crib blocks were located 15.8 m (52 ft) from the fan and 10.4 m (34 ft) from a simulated conveyor structure in the FSF. The crib block sets were placed 0.45 m (1.5 ft) apart and were positioned near the center of the entry. As mentioned

above, the crib block sets were constructed on solid concrete blocks and located in the middle of the blocks was an impinged natural gas burner that was equipped with 60 stainless steel jets (with a rated heat output of 44 to 114 kW). The burners were set on the simulated mine floor with the jets positioned about 50 mm (2 in.) below first row of crib blocks. Natural gas was used instead of an accelerant (e.g., diesel fuel) to assist in starting the fires, because it was more readily consumed by the fire and left no residue that could have altered the wood fire combustion products. A series of preliminary experiments showed that the natural gas burners would need to operate for about 50 minutes to ensure that the crib fires would burn without the need to relight the burners.

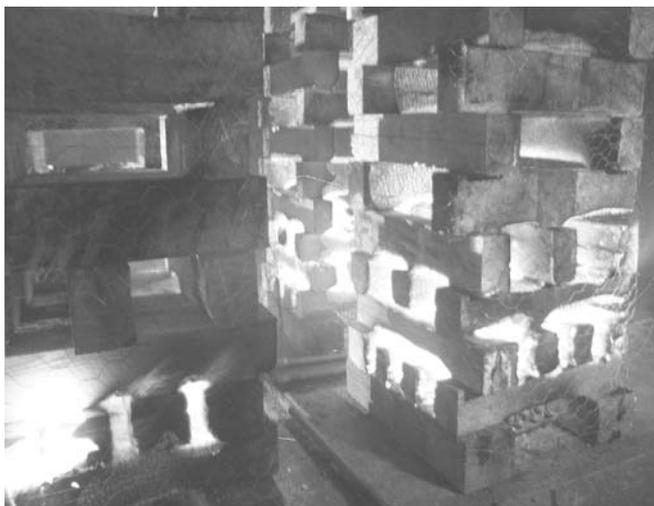
**Figure 5** — Control test – Burning crib block sets.

Crib block Tests 1 and 2 (control tests). In Test 1, after the gas supply was turned off it was observed that the back set of blocks were burning more intensely than the front set of blocks, most likely because they were sheltered from the ventilation air flow by the front set of crib blocks. Although the fire grew vertically through each crib block set, the ventilation air currents caused the fire to burn more intensely towards the backside (downwind side) of each crib block set (Fig. 5). It was determined that this burning condition would most likely cause the crib sets to topple over rather than collapse vertically. The fire burned unremarkably until 94 minutes into the test, when the rear left crib block set fell down. About 18 minutes later (112 minutes into the test) the rear right crib block set fell down. About 30 minutes later (142 minutes into the test) the front left crib block set fell down into the debris of the left rear crib block set and about 20 minutes later (162 minutes into the test) the front right crib block set fell down into the debris of the rear right crib block set. Each time a crib block set fell, the intensity of the fire increased for a short period of time.

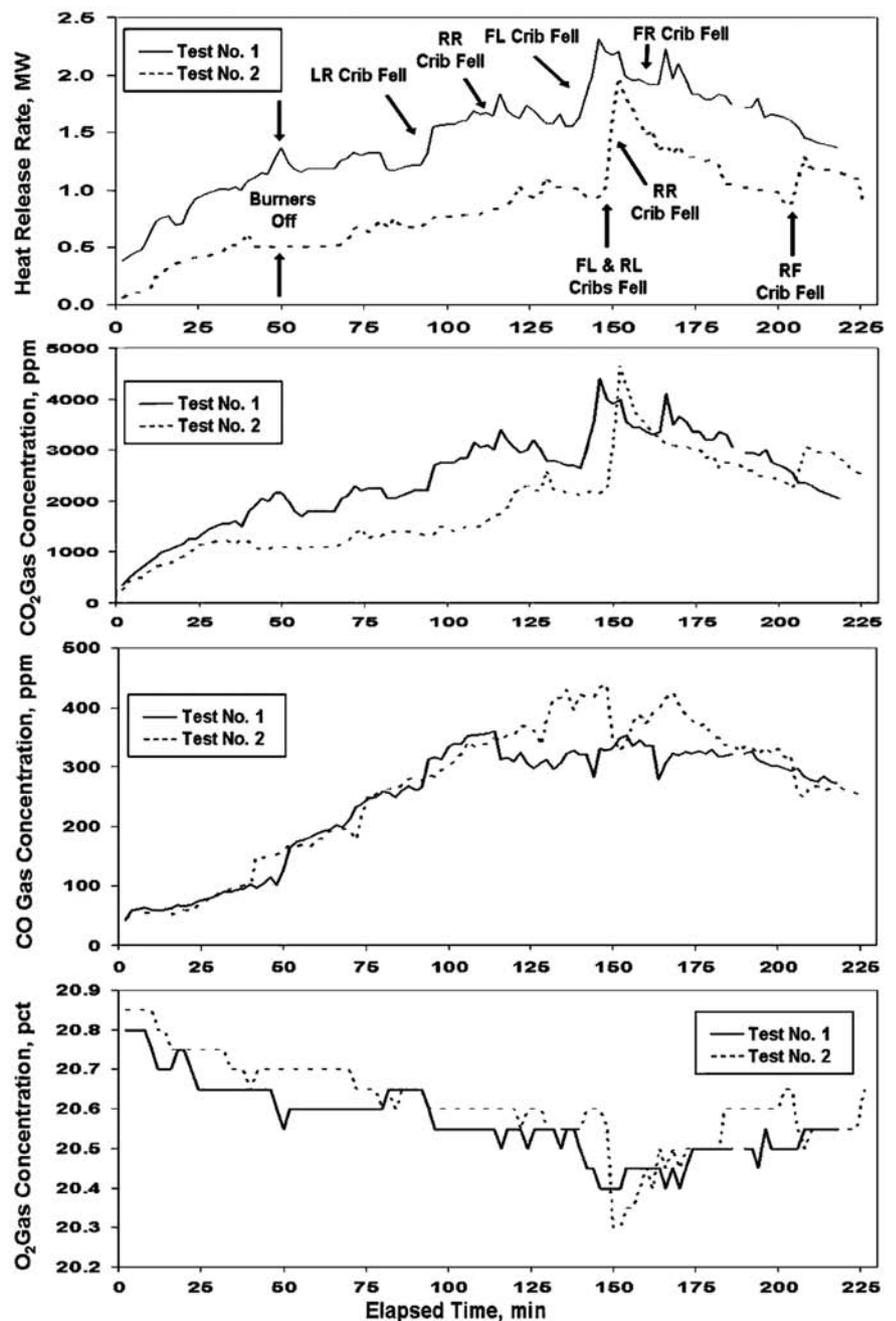
Figure 6a — Plot of estimated heat release rate and products of combustion for crib block Tests 1 and 2.

A plot of the estimated heat release rate and the products of combustion for both tests are shown in Figs. 6a, 6b and 6c. From the figures, it appears that Test 1 emitted a larger amount of heat and produced a larger amount of CO₂ and less CO, suggesting more complete combustion of the crib blocks than in Test 2. Also, the gas chromatograph data (Fig. 6c) shows that H₂, C₂H₂, C₂H₄ and C₂H₆ gases were observed in the combustion product air stream during both tests, and these gases are most likely the products of incomplete combustion and pyrolysis of the wood. During Test 1, the concentration of hydrogen and the hydrocarbon gases appeared to follow the general trend of the CO gas concentration. This same relationship was observed in the H₂, C₂H₂, C₂H₄ and C₂H₆ gas concentrations measured during Test 2.

Each time a crib block set fell, the geometry of the wood changed, and the fire burned more intensely for a period of time. The change in the intensity of the fire is reflected as an increase in the estimated heat-release rate immediately following one of these events along with the associated increase in the products of combustion. The increase in fire intensity is most likely due to the close proximity of the fallen burning crib blocks and the associated heat build-up.

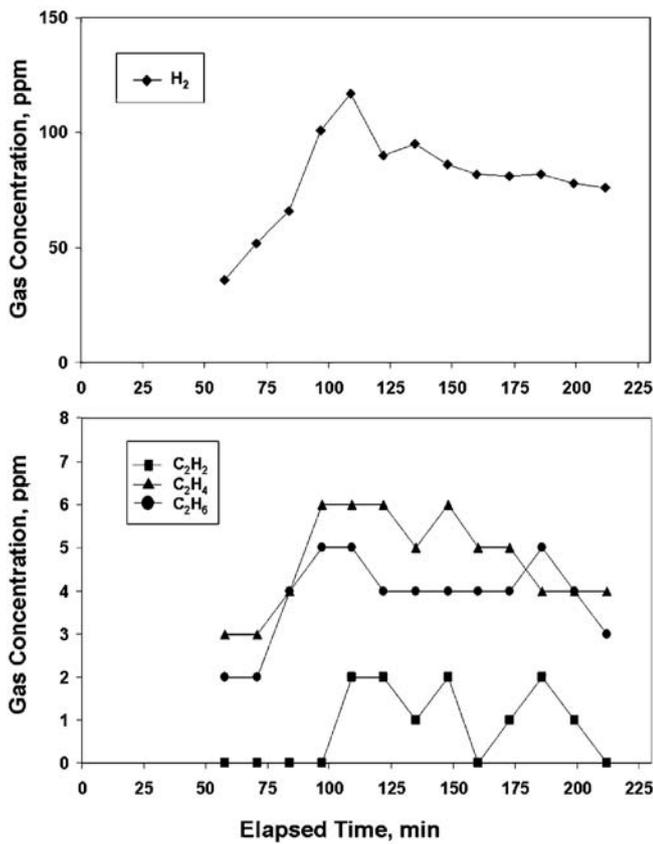
Figure 6b — Gas chromatograph data for Test 1.

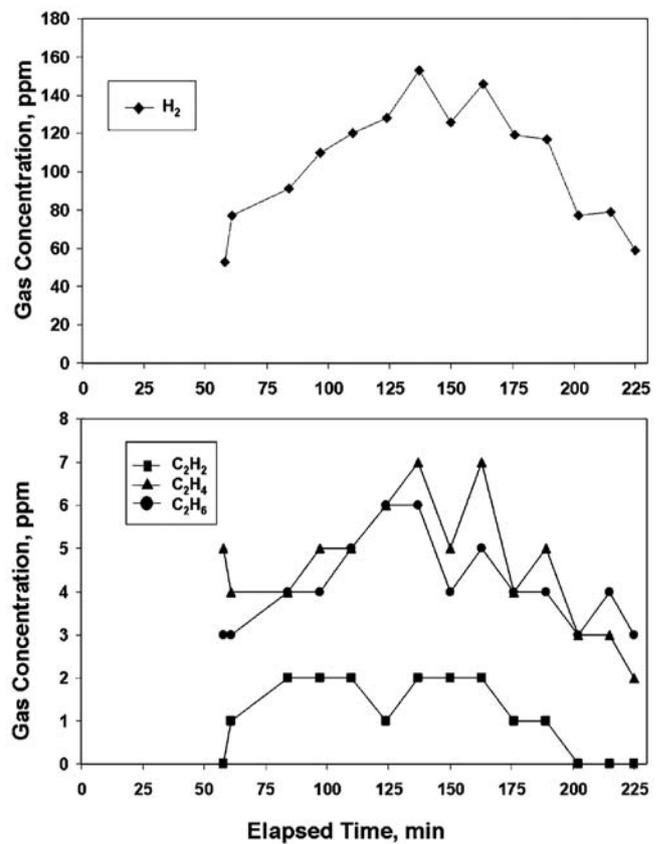
Figure 6c — Gas chromatograph data for Test 2.

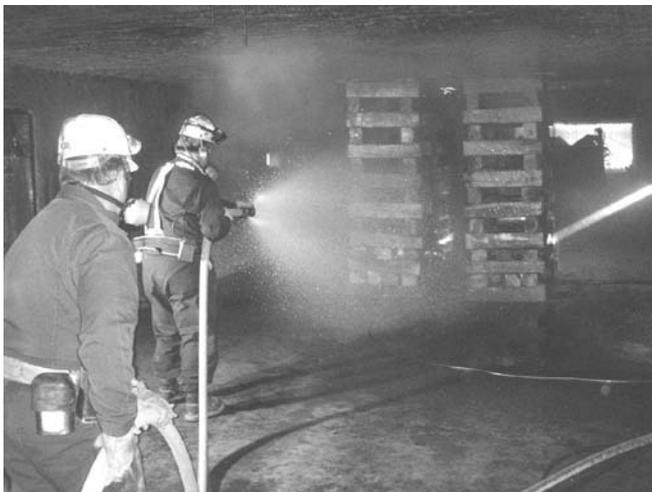
Figure 7 — Use of fire hose during crib block fire Test 3.

Crib block test (water suppression agent applied). This test was designed to observe the effects of water application on a deep-seated crib set fire because water is the most commonly available fire suppression technology. Water is an effective suppression and extinguishing agent because it cools the wood surfaces and therefore reduces rate of pyrolysis. For this test, water was supplied from a fire truck to a fire hose that was equipped with an industrial plastic fog nozzle (the type that is typically available in a coal mine) that was adjusted to form stream flow. A total of 9.07 m³ (2,400 gal) of water was available from the truck for the test. Water was supplied through the fire hose to the nozzle at a rate of 4.7 L/s (75 gpm) at 690 kPa (100 psi).

The individuals selected to apply the water to the fire were NIOSH technicians who had previously served as coal miners and had training and experience in the use of a fire hose. The technicians were instructed to apply the water until they observed that the fire had been extinguished. For personal safety reasons, the technicians were also instructed not to progress past a line that had been drawn on the entry floor (perpendicular to the trend of the entry) about 457 mm (18 in.) upwind from the leading edge of the crib block sets. This location was selected because it would keep the technicians out of the smoke and away from the heat of the fire. Water was applied to the fire for about four minutes when the technicians decided the fire had been extinguished, and a total of 1,135 L (300 gal) of water was used (Fig. 7). Observations of the wood showed that the horizontal surfaces appeared to be wet and water was observed to be actively dripping from the vertical surfaces. About four minutes after the water application was completed,

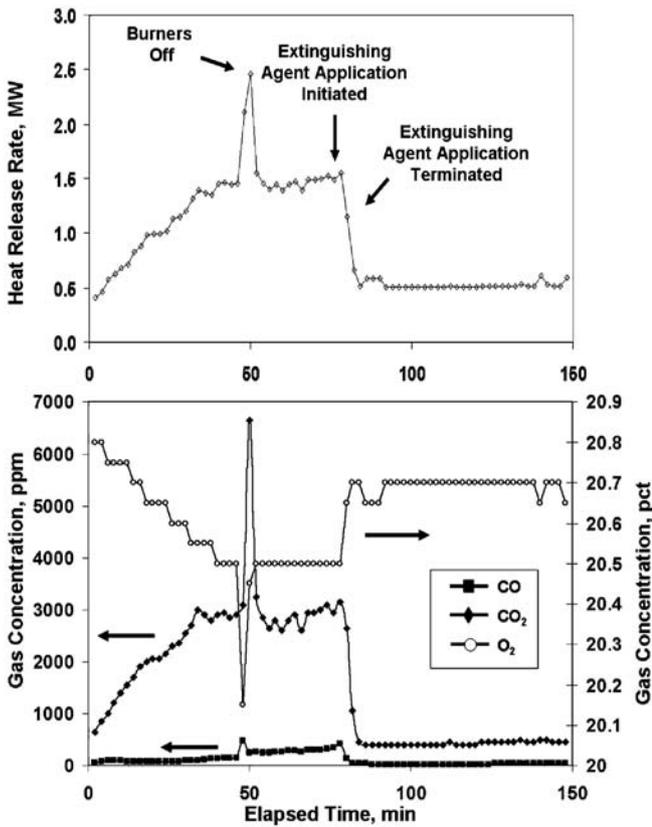
Figure 8a—Plot of estimated heat release rate and products of combustion for crib block Test 3.

Figures 8a and 8b are plots of the estimated heat release rate and the products of combustion for this test. As observed in the control tests, the fire showed an increase in heat output and CO₂ production during the intense burning event or when the crib block sets shifted or fell. CO production increased at a steady rate with only slight changes when the fire intensified or when the crib block set shifted or fell. As expected, the heat output of the fire and the production of combustion gases declined dramatically as the water was applied (refer to Figs. 8a and 8b). As observed in the controls tests, the fire also pro-

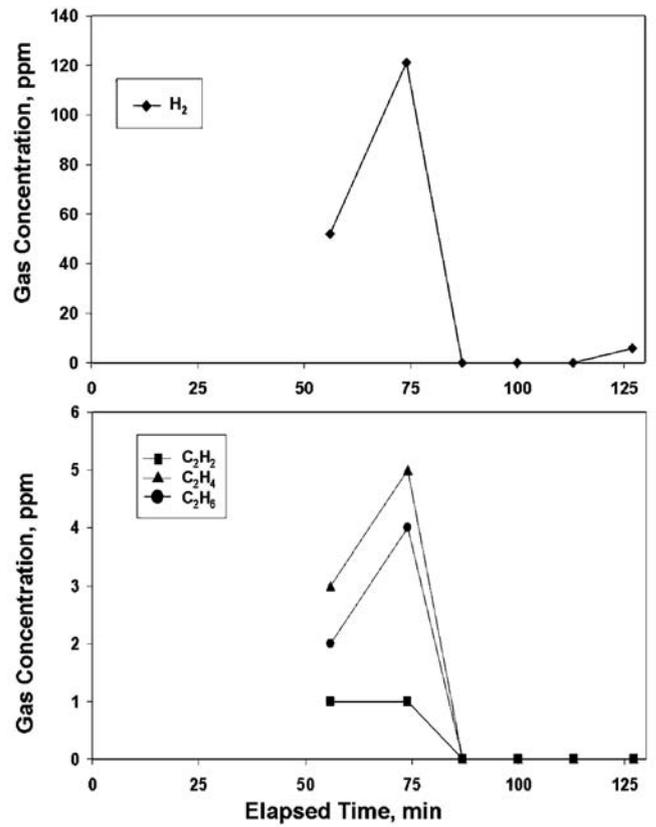
Figure 8b — Gas chromatograph data for Test 3.

duced H_2 , C_2H_2 , C_2H_4 and C_2H_6 gases, which are considered to be the products of incomplete combustion and pyrolysis of the wood. Unfortunately, because this test was of a short duration and only a very limited set of gas chromatograph data was collected during this test, it is therefore difficult to make comparisons with the other gas species.

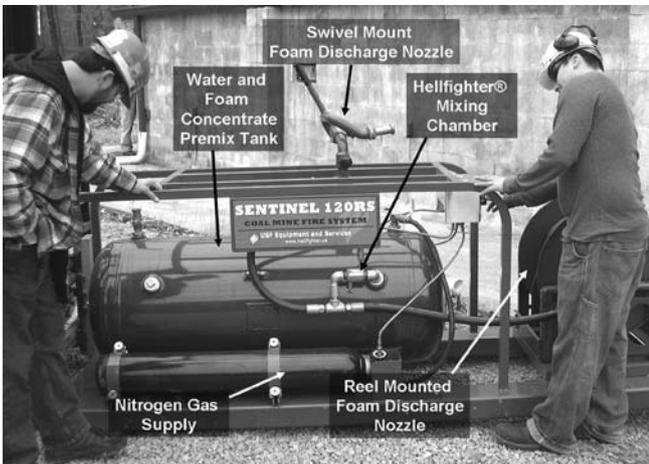
Figure 9 — USF Sentinel® unit used during crib block fire Test 4.

The system used was a Sentinel 120RS unit supplied by USF Equipment and Services (a research partner in this test). The Sentinel 120RS is a self-contained fire-fighting system that uses the patented Hellfighter[®] mixing chamber to create foam (USF Equipment and Services, 2006). The system used was capable of producing 9.07 m^3 (2,400 gal) of gas enhanced foam using a mixture of water, a small amount of Mine Fire Fighting Foam[®] (MFFF) concentrate and nitrogen gas (Fig. 9). The system can discharge up to 18.9 L/s (300 gpm) of gas-enhanced foam. Prior to the entry into the FSF, the NIOSH technicians were instructed on the proper use of the Sentinel unit and application of the foam product on the fire. As in the previous test, the technicians were instructed to apply the gas-enhanced foam until they observed that the fire had been extinguished.

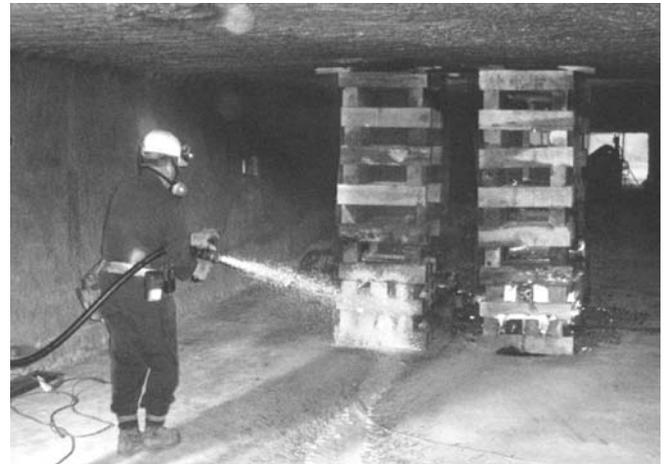
Figure 10 — Use of gas-enhanced foam during crib block Test 4.

Gas-enhanced foam application began 103 minutes into the test, and about 1 minute later, the right rear crib block set fell down (Fig. 10). Foam application continued for about 8 minutes when the technicians decided that the fire had been extinguished. A total of 9.07 m³ (2,400 gals) of gas-enhanced foam (the entire capacity of the system) was used. At about 40 minutes

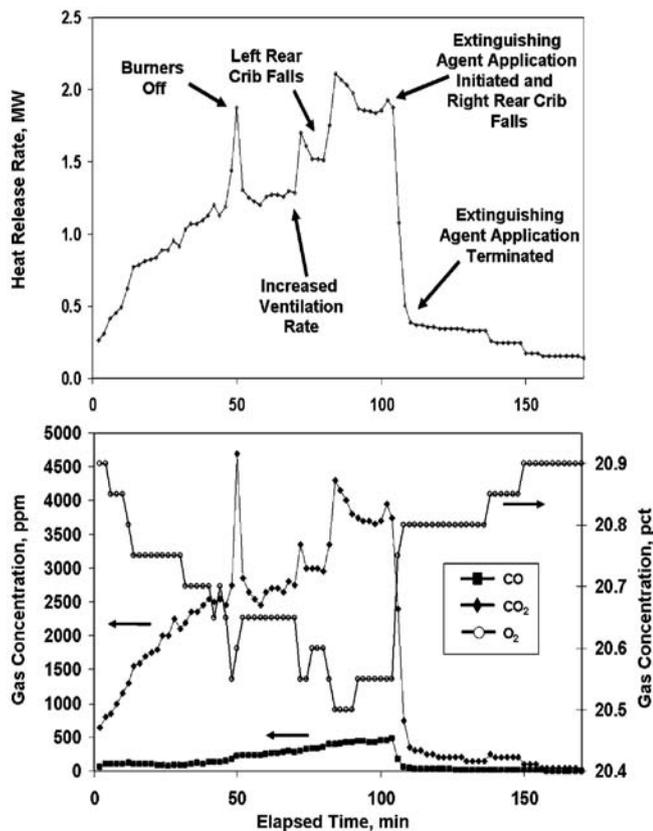
Figure 11a — Plot of estimated heat release rate and products of combustion for crib block Test 4.

Figures 11a and 11b are plots of the estimated heat release rate and the products of combustion for this test. As observed in the previous tests, the fire showed an increase in heat output and CO_2 production during the intense burning event or when a crib block set fell. CO production increased at a steady rate with only slight changes when the fire intensified or when the crib block set fell. The heat output of the fire and the production of combustion gases declined dramatically when the foam extinguishing agent was applied (refer to Figs. 11a and 11b). As in the previous tests, the fire produced H_2 , C_2H_2 , C_2H_4 and C_2H_6 gases. The change in concentration of these gases appeared to follow the same general trend of the CO_2 gas concentration.

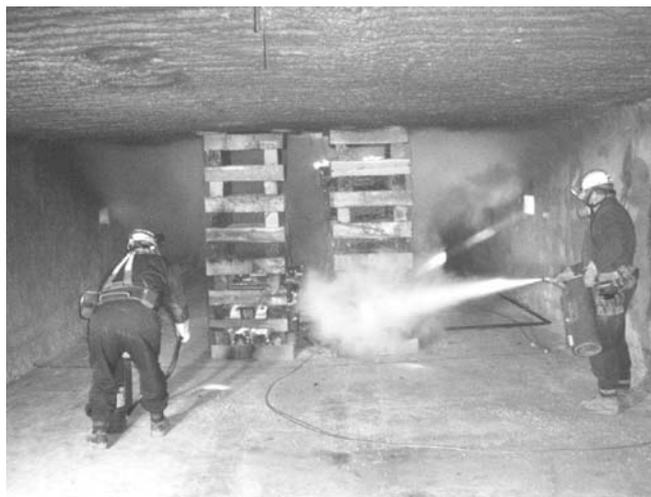
Figure 12 — Use of fire extinguishers during crib block fire Test 5.

ABC-rated fire extinguishers contain monoammonium phosphate and/or ammonium sulfate powder that leaves a nonflammable layer of material (which melts at a low temperature) and blocks gas and heat transfer at the fuel surface. For this test, four 13.6 kg (30 lb) fire extinguishers were placed in the FSF upwind of the crib block sets. To ensure that the extinguishers were in proper working order, they were filled with ABC powder and were outfitted with new CO_2 cartridges the day before the test.

The fire test was initiated in the same manner as the previous tests. Once the gas burners were turned off, the fire for some unknown reason did not achieve a stable condition for a long period of time. At about 121 minutes into the test the rear left crib set fell, whereupon the fire intensified with some smoke rollback. At about 123 minutes into the test, the rear right crib set shifted into the front right crib set followed by an increase in fire intensity as flames were observed at the roof with smoke rollback. Approximately 3 minutes later, the fire returned to about the same level observed before the event occurred. At 128 minutes into the test, the rear right crib set fell followed by an increase in fire intensity shortly thereafter. Use of the fire extinguishers on the fire began at 161 minutes into the test when the estimated heat release rate of the fire had generally stabilized. The extinguishing work continued for about four minutes until the all of the available material was applied (Fig. 12). A total of about 45 kg (100 lbs) of ABC powder was used on the fire. The powder was observed on the horizontal surface

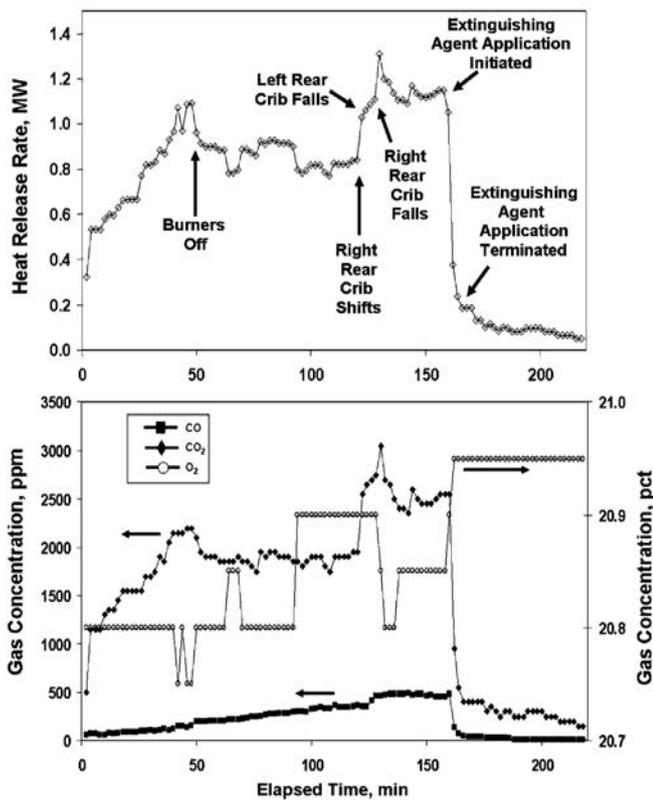
Figure 13a — Plot of estimated heat release rate and products of combustion for crib block Test 5.

As shown in Fig. 13a, the increase in heat output of the fire and CO_2 production was related to the changing geometry of the wood pile as a crib block set fell. CO production increased at a steady rate with only slight changes when the fire intensified or when the crib block set fell. The heat output of the fire and the production of combustion gases declined dramatically as the extinguishing agent was applied. As in the previous tests, the fire produced H_2 , C_2H_2 , C_2H_4 and C_2H_6 gases (refer to Fig. 13b). The change in concentration of these gases appeared to follow the same general trend as the CO_2 and CO gas concentrations.
