ORAU TEAM Dose Reconstruction Project for NIOSH

<p>Document Title:</p> <p>Pinellas Plant – Site Description</p>	<p>Document Number: ORAUT-TKBS-0029-2</p> <p>Revision: 00</p> <p>Effective Date: 08/05/2005</p> <p>Type of Document: TBD</p> <p>Supersedes: None</p>
<p>Subject Expert: Marquis P. Orr</p>	
<p>Document Owner</p>	
<p>Approval: <u>Signature on File</u> Mark D. Notich, TBD Team Leader</p>	<p>Approval Date: <u>08/03/2005</u></p>
<p>Approval: <u>Signature on File</u> Judson L. Kenoyer, Task 3 Manager</p>	<p>Approval Date: <u>08/02/2005</u></p>
<p>Concurrence: <u>Signature on File</u> Richard E. Toohey, Project Director</p>	<p>Concurrence Date: <u>08/04/2005</u></p>
<p>Approval: <u>Signature on File</u> James W. Neton, Associate Director for Science</p>	<p>Approval Date: <u>08/05/2005</u></p>

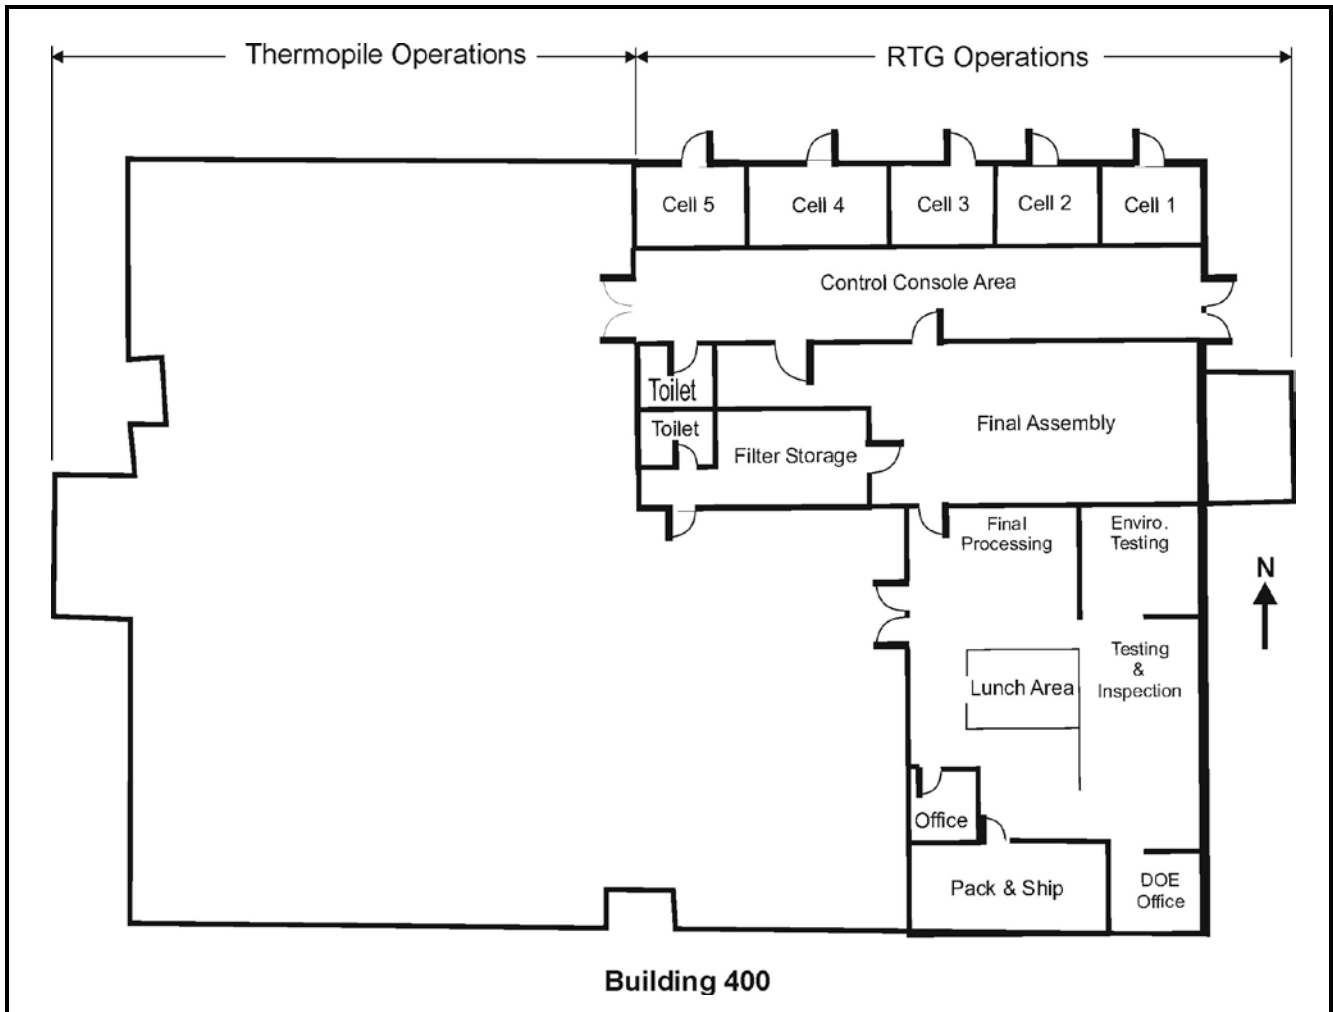
Figure 2-5. Layout of Building 400 (DOE, 1982, pg. 9).

Building 400 was first built in 1968 for development and testing activities. It was expanded in 1978 and again in 1986. The facility was used to assemble and test the Radioisotopically-powered Thermoelectric Generator (RTGs) from 1975 until 1992. Operating cells on the north side of the building were used for equipment testing and not involved with the production of RTGs. Figure 2-5 is a layout of building 400.
