NJ FACE INVESTIGATION REPORT

Fatality Assessment & Control Evaluation Project

FACE 13-NJ-049

Warehouse Worker Falls From Elevated Forklift Platform

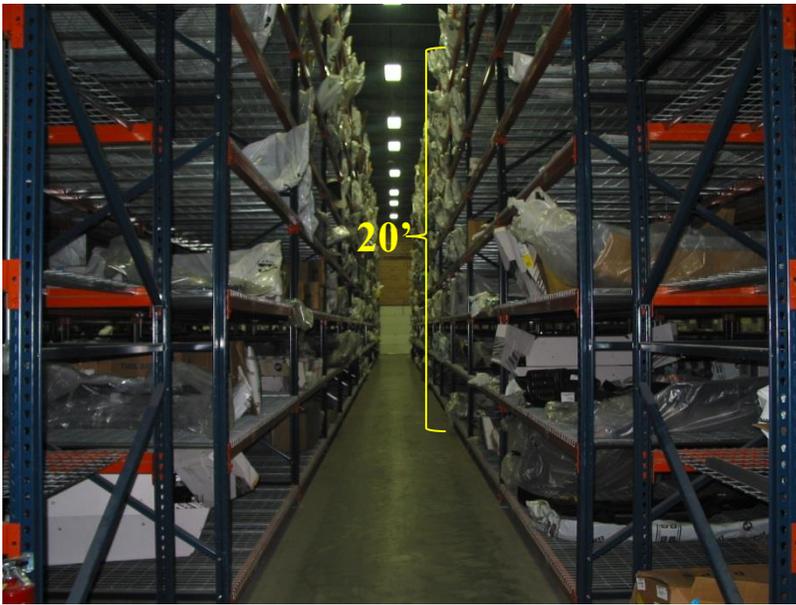
The incident site was a small automotive warehouse located in an industrial park in southern NJ. The warehouse was a new facility, measuring approximately 110-feet-tall by 140-feet-wide, consisting of seven aisles and eight, 20-foot high, metal shelves (Figure 1). The employer was a large autobody parts supplier, with other facilities across the U.S., and serviced car dealers, autobody shops and fleets. Thirteen permanent workers were employed at this specific location, along with a few temporary employees. Parts would come into and be shipped out of the warehouse via a truck loading dock. When a part was ready for shipping, a forklift operator (three total operators were employed, including the deceased) would drive a powered industrial forklift (also known as an "order picker") to the location of the part. The forklift was equipped with a 6-foot-long, 3'4"-wide platform on the forks (Figure 2a). If the part was not reachable at the ground level, the platform (along with the forklift control deck) could be lifted up to 17 feet in the air (Figures 2b-3). The operator controlled the lift by stepping on a round disc on the floor of the forklift's control deck (Figure 4).

FIGURE 1: Incident site, metal shelving and access lane (cement floor).

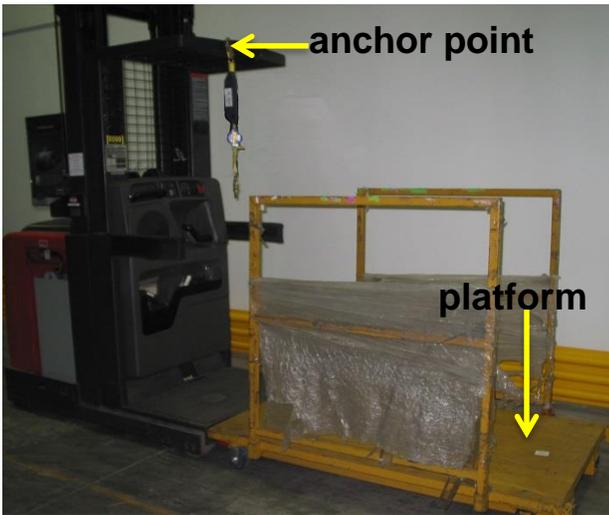
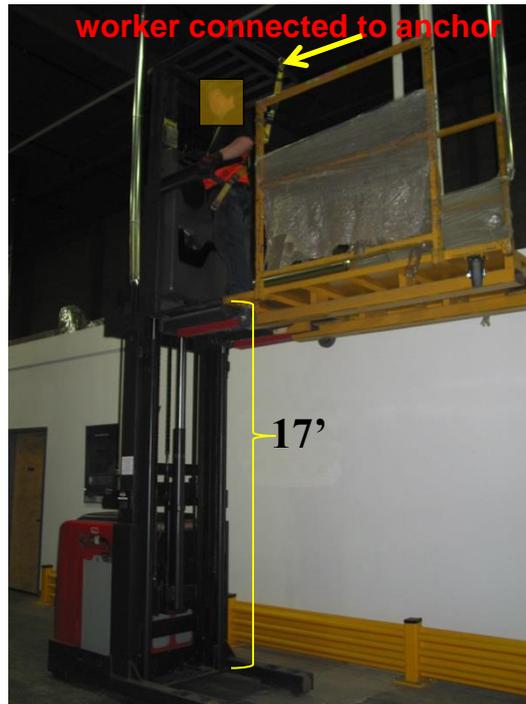
FIGURE 2a-2b. Forklift and platform in down and raised positions; note anchor point for lanyard of fall arrest system.

Discussion: The most fail-safe approach to the use of the personal fall arrest system is for the worker to ensure that their body harness is connected to the anchor point on the cab prior to any activity. This should be done regardless of whether or not there was an anticipated or planned lifting of the platform. Connecting to the anchor does not hinder the worker in any way, and is recommended as the first step when stepping on the control platform.

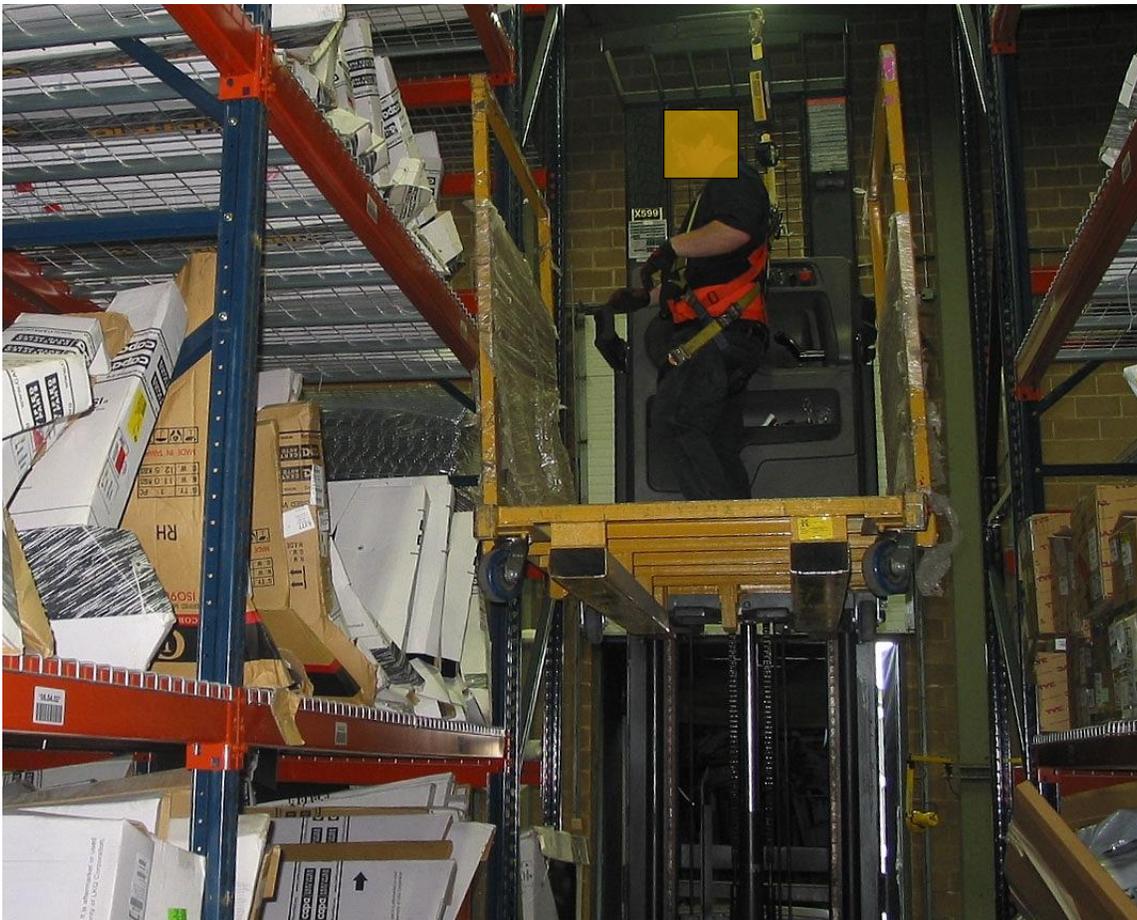
FIGURE 3. Demonstration of worker lifting platform to access shelves.

Discussion: The forklift platform in this case had guardrails on two sides, but the front end remained unguarded (Figure 3). NJ FACE recommends the design of a platform in which the open side is guarded but still allows for a warehouse worker to effectively access pick (or drop-off) points. In addition, NJ FACE recommends that a mechanism be designed such that power to the forklift is cut if the worker is not tied in to the anchor point.

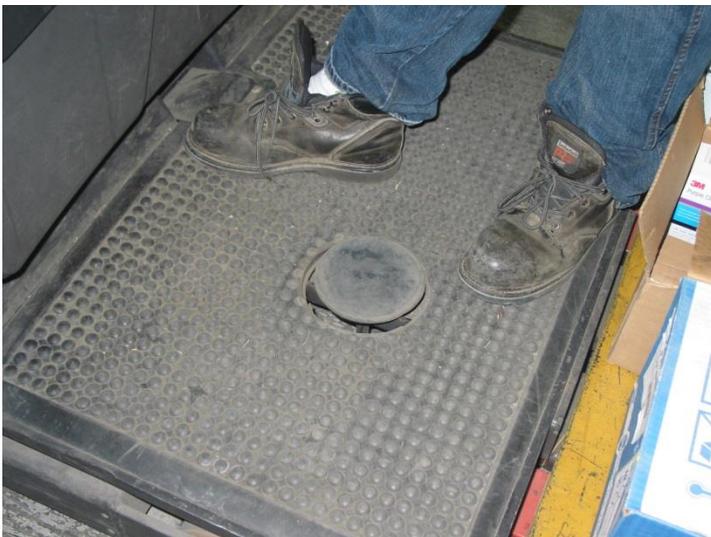
FIGURE 4. Activation pad for lifting forks.

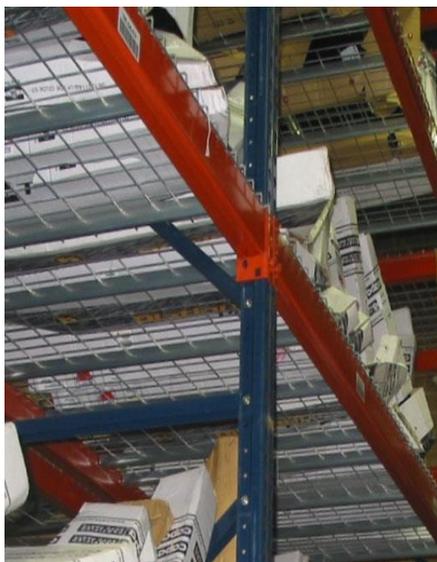
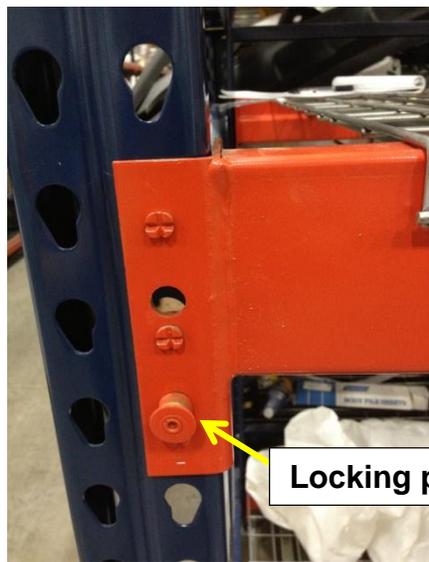
Each warehouse row consisted of multiple metal shelves (approximately 8'6" long by 4 feet wide each) fixed to vertical structural units (Figure 5a). The shelves were locked at connection points using sliding metal locking pins into keyhole-shaped openings (Figure 5b). At the time of the incident, the victim was positioned at a shelf near the end of an aisle and a coworker was on the other side of the shelf in the next aisle over. He was wearing a body harness and lanyard, but it was not connected at the anchor point. It is not known exactly how the victim fell (the shelving unit was blocking the coworker's view of the victim), but the coworker heard the noise and rushed over to spot where the victim had landed. The victim was severely injured, but conscious. The coworker ran to get help, and 9-1-1 was called; the victim was rushed to the hospital, and died there eight days later.

FIGURE 5a-5b: Views of shelf; wire mesh with orange frame (a), and connection point to blue vertical support structure (b).
