ALERT

**Preventing Injuries and Deaths
from Falls during Construction and
Maintenance of Telecommunication
Towers**

DHHS (NIOSH) Publication Number 2001-156

July 2001

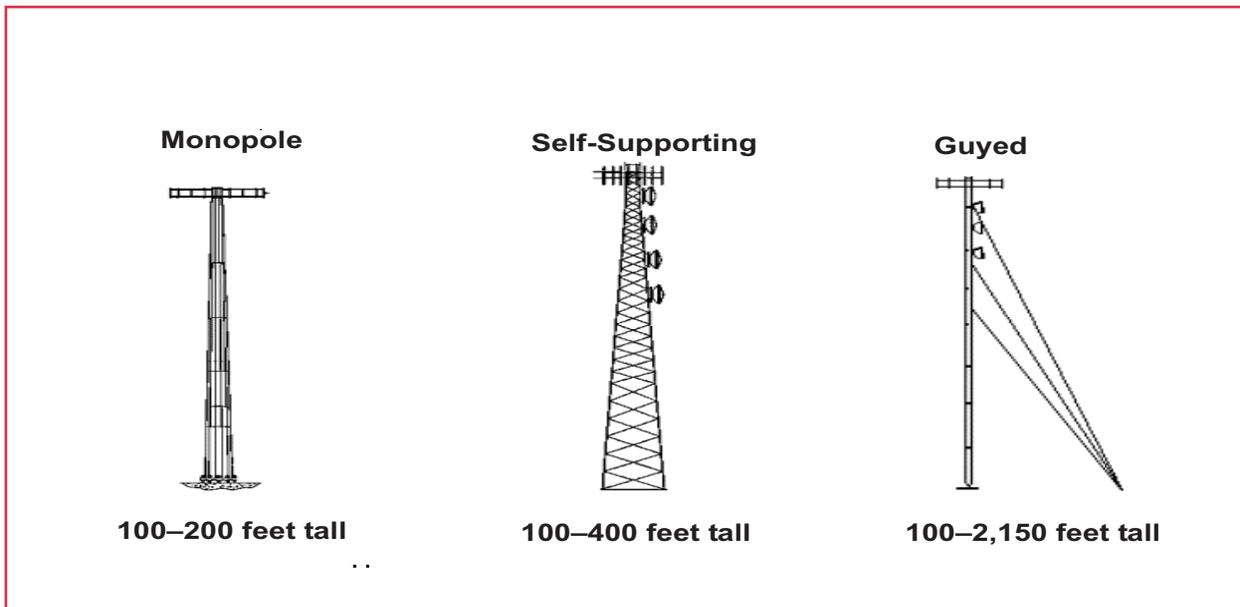
Figure 1. Tower types.

Telecommunication towers may be of several types and range in height from 100 to 2,150 feet or more [OSHA 1998]. Three general forms of telecommunication towers are

- monopoles that consist of tapered steel tubes that fit over each other to form a stable pole,
- guyed towers that are stabilized by tethered wires, and
- self-supporting towers that are free-standing lattice structures (Figure 1).

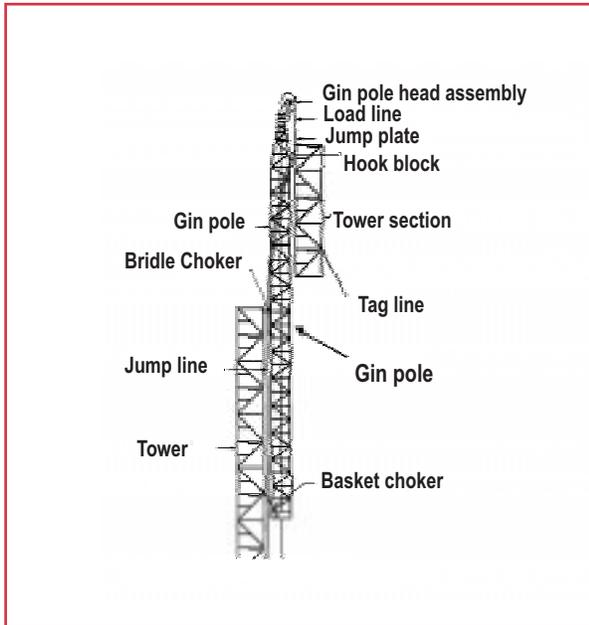
Figure 2. Gin pole attached to communication tower.

Telecommunication towers are generally manufactured as sections and constructed onsite by hoisting each section into place and bolting sections together. Some models of shorter towers are self-erecting. For most towers that are constructed onsite, cranes and gin poles attached to the tower being erected are generally used to hoist each section into place. A gin pole is a device unique to the telecommunication tower industry. The gin pole is used to raise successive sections of steel, equipment, or workers into position. This temporary lifting device uses cables and pulleys to allow enough head room to accommodate the length of the next tower section or equipment being installed (Figure 2).

At a minimum, any future directive on gin poles would require that a registered professional engineer’s drawing be available at the site. The drawing must

- show the gin pole and its track (if any) and indicate lifting capacity and the manner of attachment to the tower,
- indicate track attachment to at least two places (top and bottom), and
- indicate how high the gin pole can be raised above its uppermost attachment to the tower.

In addition, any future directive would require inspection records, documented worker training, and an anti-two block device (a device that prevents contact between the lower load block or hook assembly and the gin pole head assembly).
