A STORY OF **Impact**

Fire Fighter Fatality Investigation Prompts Fire Hose Performance Testing and Revised Standards

DHHS (NIOSH) Publication No. 2017-205

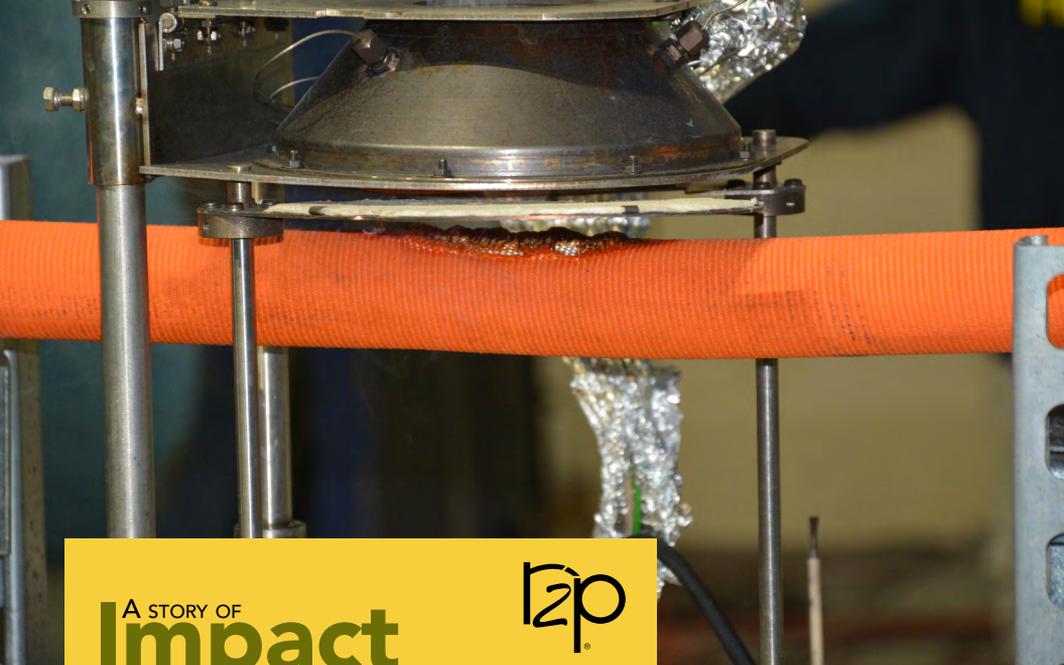
▲ Fire hose bench test with radiant heat exposure in the Bureau of Alcohol, Tobacco, Firearms, and Explosives (ATF) Fire Research Laboratory. Photo courtesy of ATF.

NIOSH provided samples of commonly used hoses to ATF. ATF tested the hoses in controlled fires of actual townhomes to measure approximate heat and temperature exposure at the time of rupture. Testing then moved to a controlled environment at the ATF Fire Research Laboratory. There, tests replicated the heat exposure recorded in the townhouse testing and established a repeatable method to compare the performance of different hose types. Samples of hoses from 5 manufacturers were tested.²
