WORKPLACE SOLUTIONS

Preventing Death and Injuries of Fire Fighters Operating Modified Excess/Surplus Vehicles

DHHS (NIOSH) Publication No. 2011-125

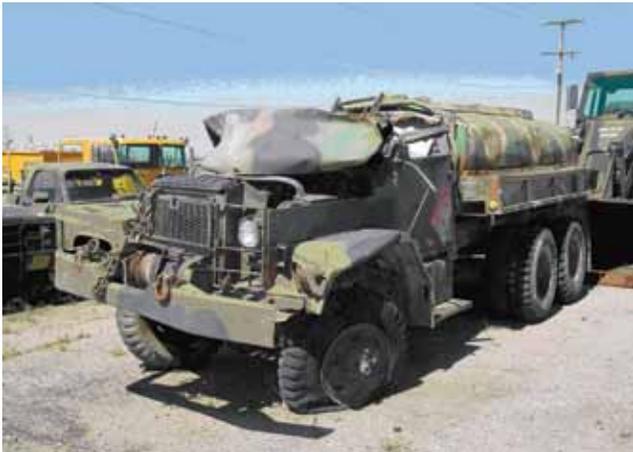
On June 21, 2005, a 52-year-old male volunteer chief died from injuries sustained during a tanker rollover. While driving on a gravel road at approximately

40 miles per hour, the left front tire ruptured, causing him to lose control, leave the road, and roll over several times. The chief was ejected and died on the scene from his injuries. Seat belts were not used during the incident [NIOSH 2006].

The apparatus was a 1981, 2½-ton, 6 × 6 military tanker originally designed to carry gasoline (Figure 1). The truck, primarily used off road, weighed 13,530 pounds empty and had a GVWR of 16,530 pounds cross-country.[†] The tank was divided into three sections and had a capacity of 1,200 gallons. The estimated fully loaded water weight was 9,960 pounds, which exceeded the cross-country weight rating by approximately 7,000 pounds. Both rear axles had dual wheels. The tanker was equipped with lap-type seat belts and still had the original split rim wheels. Eight out of ten tires were bias-ply[‡] tires manufactured in 1981. The apparatus was acquired by the department in 1998 through a loan

Figure 1. Military surplus vehicle involved in Case Study 1.

- Ensure that the weight of a fully loaded vehicle does not exceed the GVWR. This is especially important when using military fuel trucks as water tankers, since water weighs 8.33 pounds per gallon, approximately 20% more than certain fuel types. The weight of additional fire fighting equipment should also be monitored, as this added weight may increase total vehicle weight in excess of the GVWR. Since wildland fire fighting apparatus may see severe off-road use, the cross-country GVWR should be considered the maximum if specified [REC 2009b].

- Ensure that the vehicle maintains ample suspension, steering, and braking ability through periodic vehicle inspections and maintenance.
- Inspect tires often for uneven wear, proper inflation, and deterioration. Adequate tread depth does not necessarily mean that tires are safe. Maintain tire pressures and replace tires according to the manufacturer's recommendations (e.g., replacing tires of a certain age). Tires that show signs of dry rot or cracking should also be replaced. Consider if military grade tires are adequate for the road surfaces the vehicle may be operated on. Some military tire tread patterns may not be suitable for use on wet, hard surfaces.

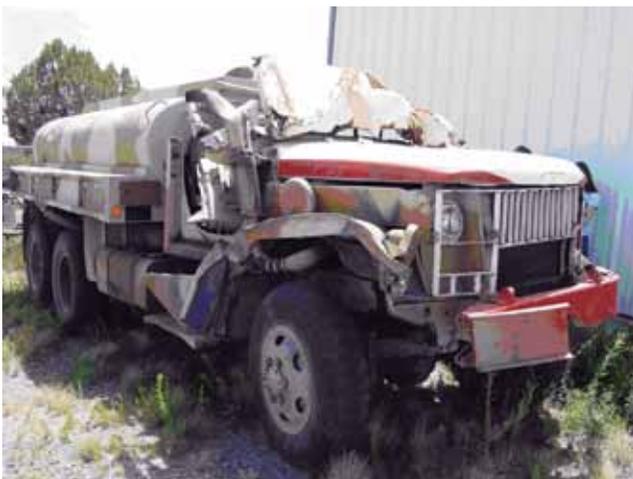
Figure 2. Military surplus vehicle involved in Case Study 2.

The apparatus was reported to be a 1954, 2½-ton military fuel servicing truck acquired through a loan program with a recommended payload weight⁶ (without personnel) of 7,500 pounds (Figure 2). The truck had a 1,200-gallon tank that was originally

used to transport diesel fuel. The estimated, fully loaded water weight was 9,960 pounds, which exceeded the recommended payload weight by more than 2,000 pounds. State police reported that the tanker probably had brake failure before the incident; the master cylinder was leaking brake fluid, and the emergency brake was inoperable. Both front shock absorbers and three tires were defective. The vehicle did not have seat belts.

- Ensure that all fire fighters are seated in appropriate riding positions and are secured by seat belts whenever the vehicle is in motion (NFPA 1500). Vehicles without a restraint system should have one installed that meets current standards of the Society of Automotive Engineers [SAE 1994, 1995a; 1995b].
- Develop a standard operating procedure or guideline for operating modified excess/surplus tankers, including when the vehicle should and shouldn't be used and required training for operators. Consider operating these vehicles only in nonemergency mode (i.e., no lights or siren).
- Develop procedures to declare a vehicle mechanically deficient or unsafe, and immediately remove it from service until it is repaired or replaced.
