Long Haul Trucker Dies After Striking an Embankment at the End of an Interstate Highway Off-Ramp

Incident Number: 05KY074

Kentucky Fatality Assessment and Control Evaluation (FACE) Program

Incident Number: 05KY074 Release Date: May 2, 2007

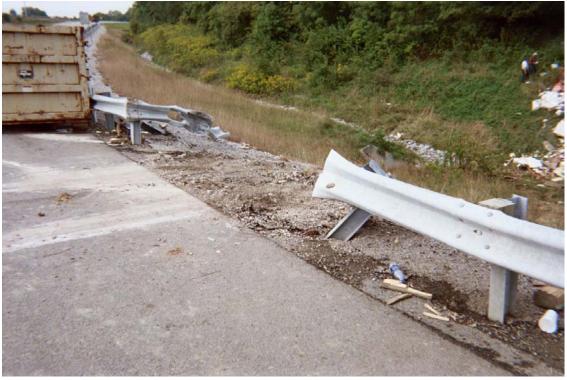
Area where semi went through guardrail.
