# **A 53-Year-Old Male Iron Foreman Dies After Fall From Steel Decking**

**Incident Number: 07KY071**

**Kentucky Fatality Assessment and Control Evaluation (FACE) Program**  
**Incident Number: 07KY071**  
**Release Date: September 5, 2008**  
**Subject: A 53-Year-Old Male Iron Foreman Dies After Fall From Steel Decking**

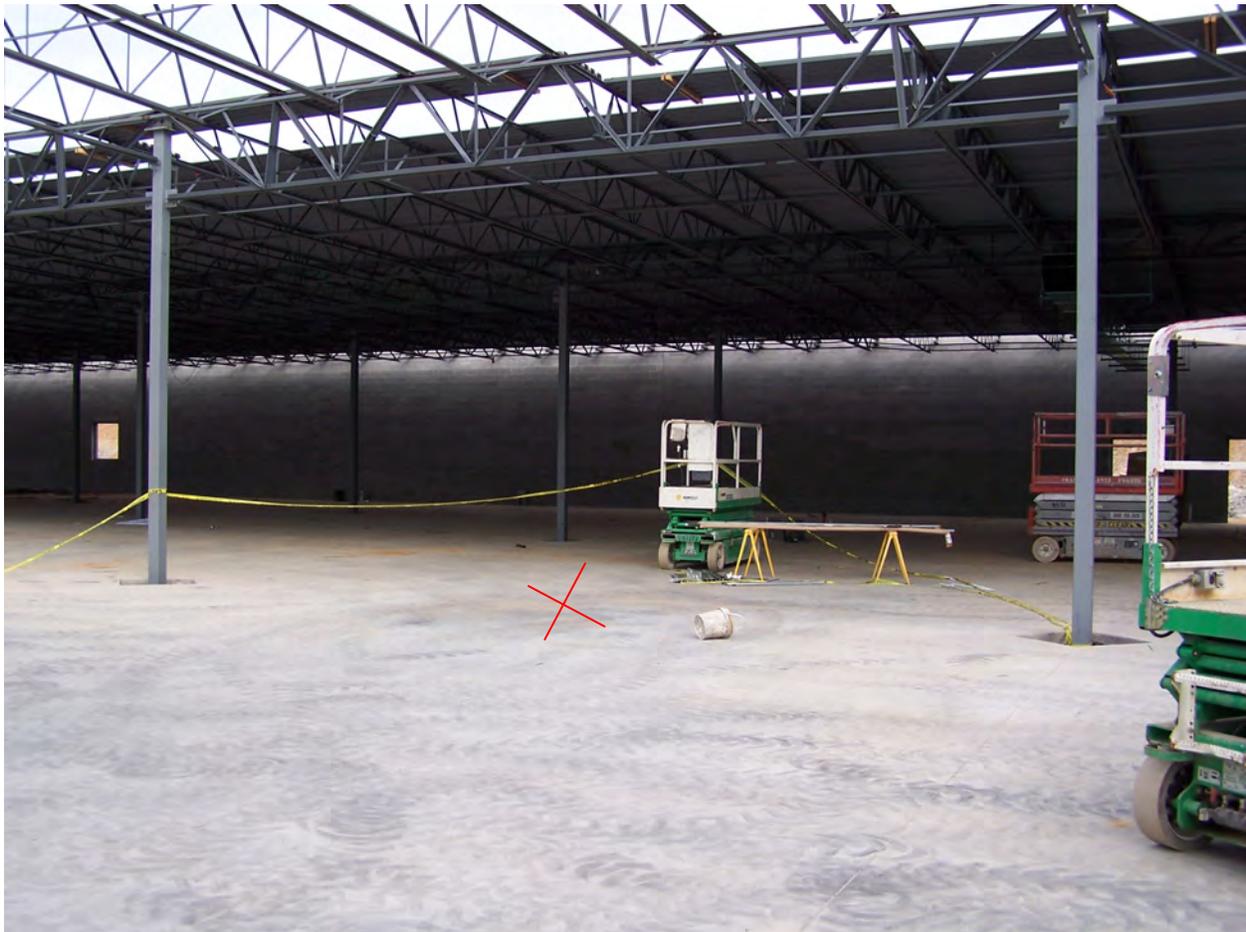
**Location where foreman fell.**

During the fall of 2007, a 53-year-old male iron foreman died when he fell approximately 18 feet from roofing being installed on a retail building under new construction. Two work crews were installing metal decking for a roof by laying corrugated metal sheets to the joists of a retail building being constructed. All workers wore personal fall arrest systems complete with lanyards on the roof; none of the workers were tied off to the building. The foreman had accessed the work site via a 32-foot extension ladder to check on the progress of the work. After speaking to the first crew, the foreman walked along the steel metal decking and joists to talk to the second crew. When he was approximately 71 feet away from the ladder at his origination access point, he fell 18 feet to the concrete floor below. Emergency medical services were contacted. They transported the foreman to the local hospital where the local coroner pronounced him dead due to a brain injury.

On the day before the incident, the crew had prepared the site to install corrugated metal decking (3 feet wide by 22 feet long) to steel joists by setting stacks of the metal sheets offset from each other on the steel joists. That same day, the iron workers attached some decking to the steel joists by screwing it to the joists. At approximately 9 AM on the day of the incident, two work crews continued laying the decking. The general foreman, via a 32-foot extension ladder, accessed the work area to check on the progress of the work and consult with the two work crews. All workers, including the general foreman were wearing harnesses with lanyards on the roof; however, none of the men were tied off to the building. It is unknown if temporary anchors had been installed to support the lifelines. The general foreman walked away from one crew to check on another area where work was also being performed. He was approximately 71 feet from the access ladder, walked off the unsecured decking and fell approximately 18 feet to the concrete floor below. The iron workers heard but did not see the general foreman fall. A supervisor for the general contracting company saw the general foreman fall to the concrete floor. Emergency services were contacted immediately at 10:28 AM and dispatched to the scene at 10:31, arriving at 10:34 AM. Upon arrival, emergency management service personnel found the general foreman unconscious. An air ambulance service was contacted. It was cancelled when the general foreman died as he was loaded into the ambulance that was to transport him to the air ambulance location. The ambulance then transported the decedent to the local hospital where they arrived at 10:48 AM. At 10:50 AM the general foreman was pronounced dead by the local coroner.

Recommendation No. 1: Employers should ensure all employees use personal fall arrest systems appropriately.

The workers involved in this incident were wearing personal fall arrest systems which included harnesses with attached lanyards, but were not tied off. Typically iron workers use a cable system to tie off to. According to an employee for the general contractor, all iron workers on the jobsite were trained and certified in OSHA 10 Hour – Subpart R and knew how to use the personal fall arrest systems they were wearing.

The subcontractor involved with this incident was not a Kentucky based company. The Federal Code of Regulations for steel erection, 29 CFR 1926.760(a)(1) states that steel workers working at 15 feet and above are required to wear and use a personal fall arrest system. Kentucky law, 803 KAR: 2:417 Section 1(1)(b), states that steel workers working at 10 feet or higher have to use personal fall arrest systems. Companies need to be knowledgeable and follow the applicable regulations for the state they are performing work in. In this particular incident, both Federal and KY State regulations were applicable. Standards 29 CFR 1926.760(a)(1) and 803 KAR: 2:417 Section 1(1)(b), state that steel workers working above 10 feet, with an unprotected edge or side are to be protected from fall hazards by use of guardrails, safety nets, personal fall arrest systems, positioning devices, or fall restraint systems.
