Two Tree Trimmers Die When Struck By Errant Semi Tractor-Trailer

Incident Number: 10KY009

Kentucky Fatality Assessment and Control Evaluation (FACE) Program

**Subject: Two Tree Trimmers Die When Struck By Errant
Semi Tractor-Trailer**

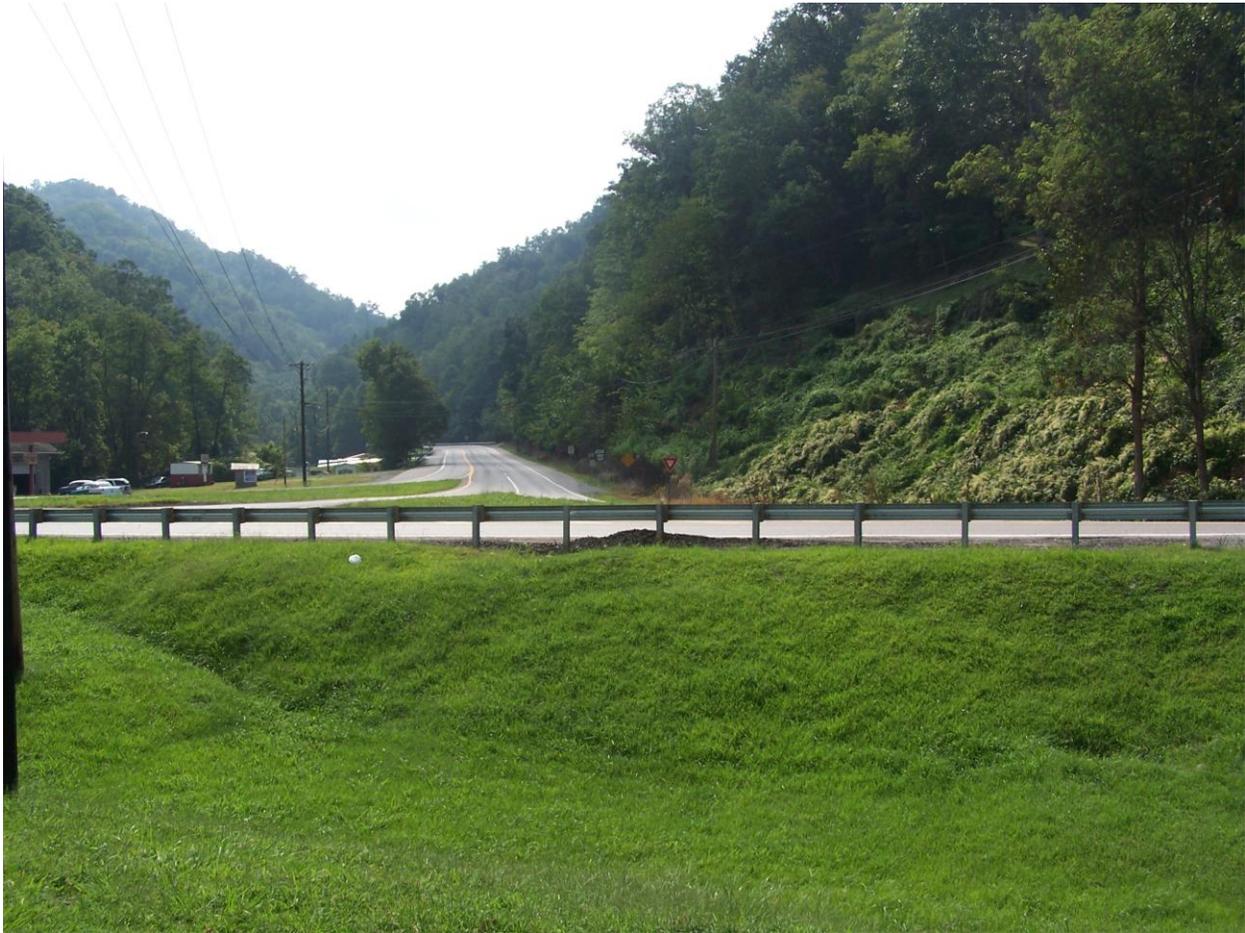
Site where semi tractor-trailer struck two tree trimmers. Photo by KY FACE.

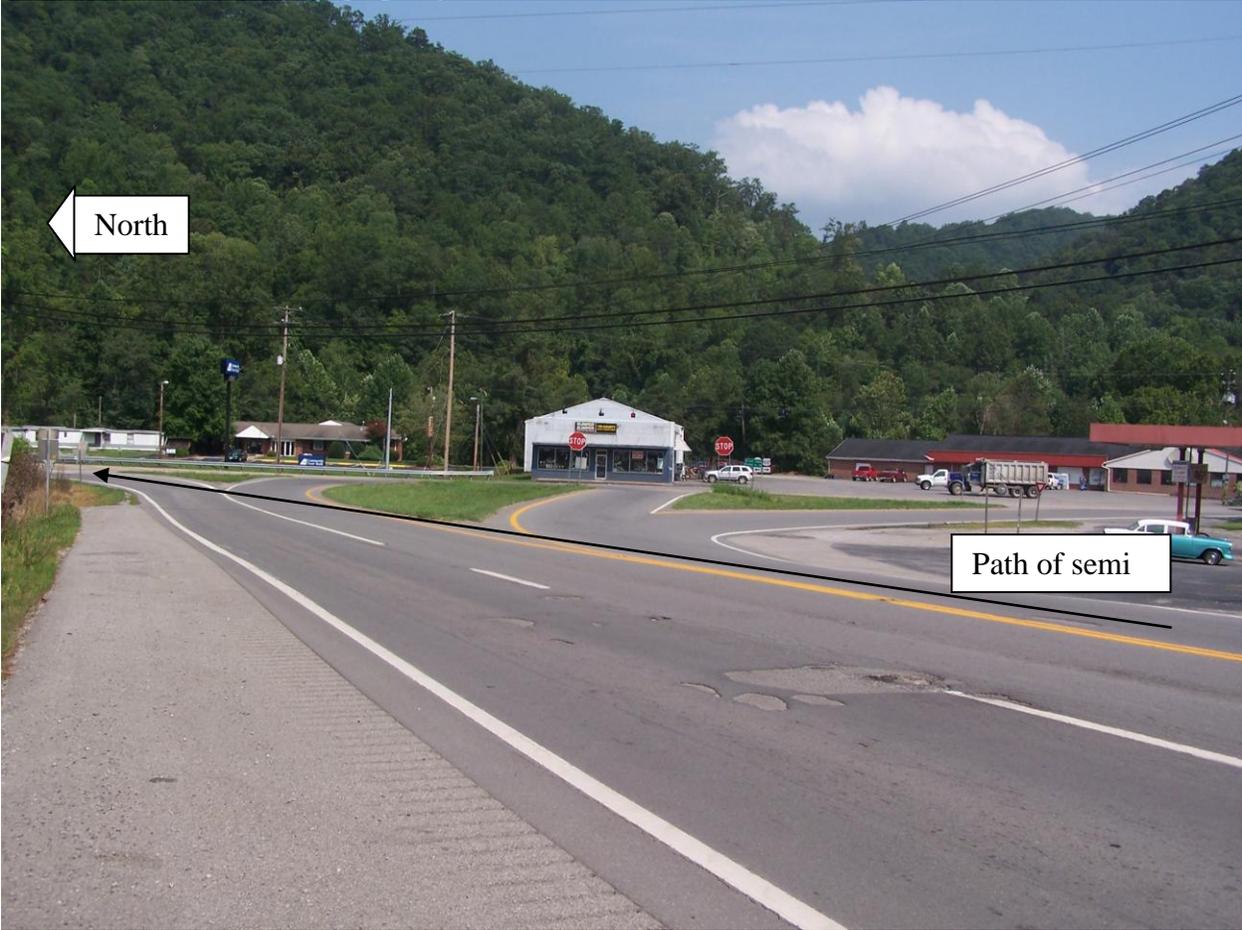
Photograph 1: Federal and state highway intersection where a semi tractor-trailer struck two pedestrian workers. Photograph by KY FACE.

View of intersection coming down the mountain; semi drove to the left

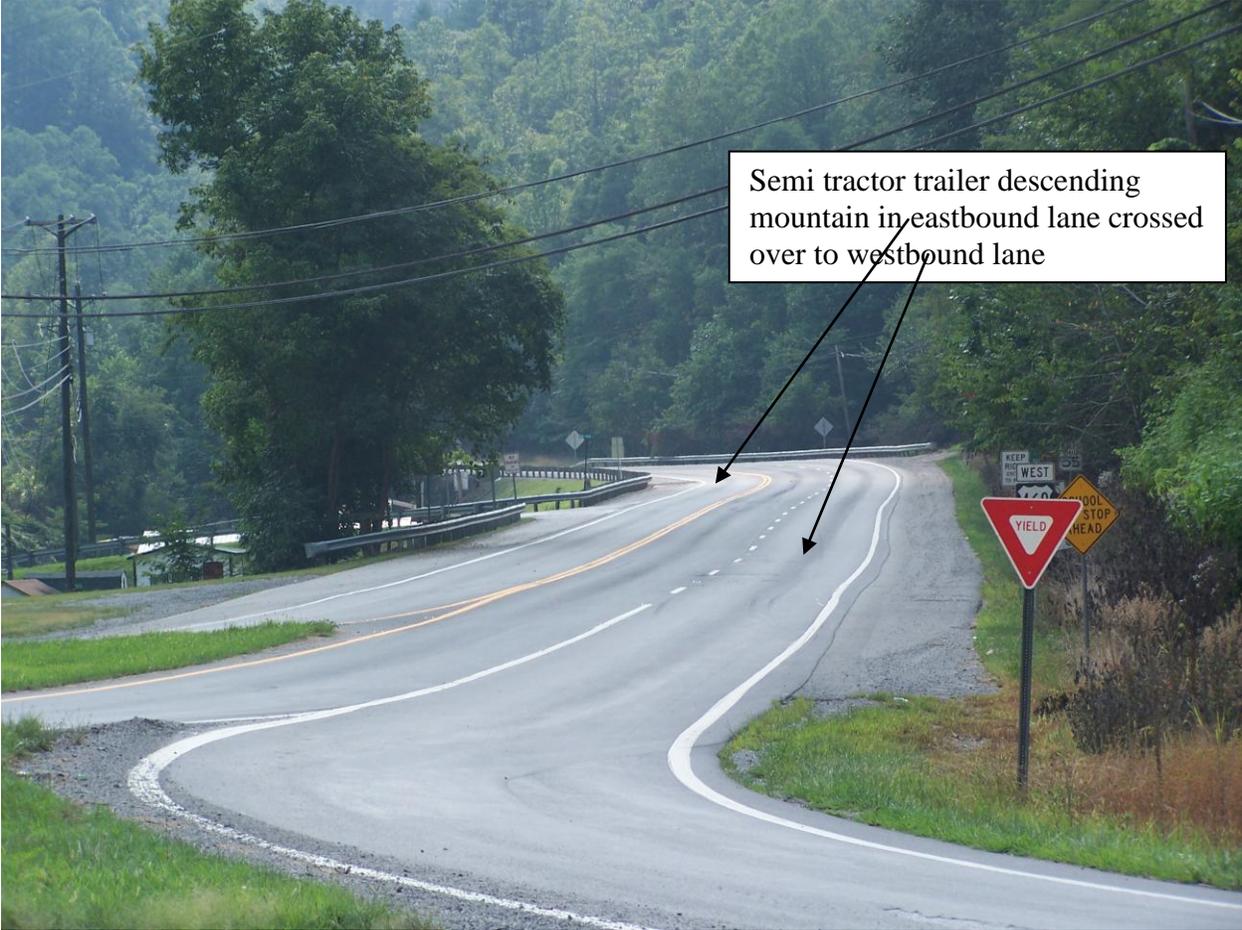
Photograph 2: Incline where brakes failed on semi tractor-trailer

Seven of the 10 brakes on the unit did not function correctly, and nine tires out of the 18 were not within the tread allowance set by the Federal Motor Carrier Administration guidelines. His logbook was not up-to-date. There was some confusion regarding the status of his commercial drivers' license. According to roadside inspection reports conducted in several states, his commercial drivers' license had been suspended in three states. However, a month prior to the crash, the leasing company performed a verification of the drivers' CDL and found it to be valid and in good standing.
