**Two Semis Collide - Fire Ensues;
Both Drivers Perish
Incident Number: 11KY031**

Kentucky Fatality Assessment and Control Evaluation (FACE) Program

Incident Number: 11KY031

Subject: Two Semis Collide - Fire Ensues; Both Drivers Perish

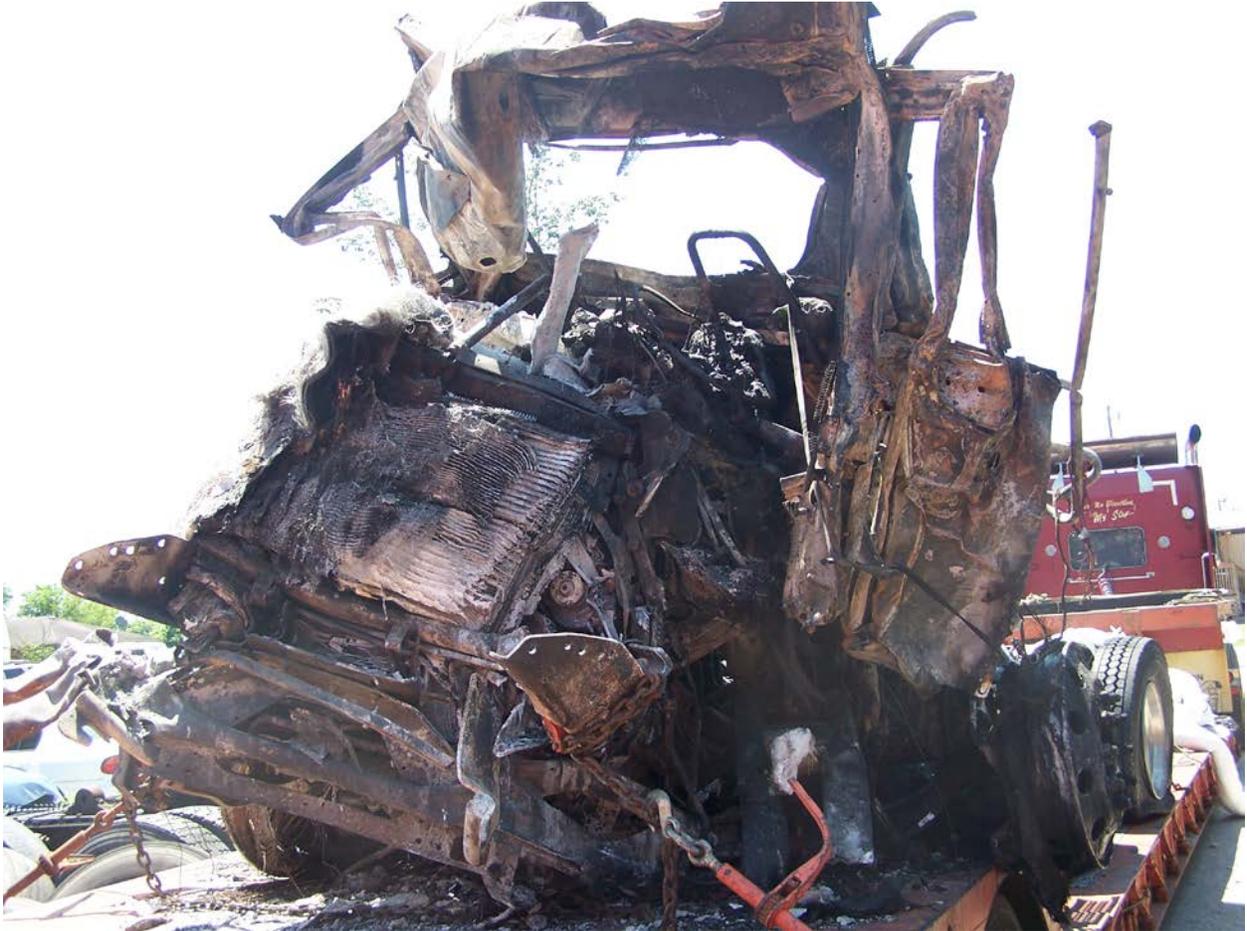
Photograph of semi struck by another semi. Property of KY FACE.

As the units collided, eight of the salvage cars came loose. Six slid between the guardrail and the trailer hauling beverages, and two of the cars struck D2's cab head-on. Bottles of beverages went forward into D2's cab.

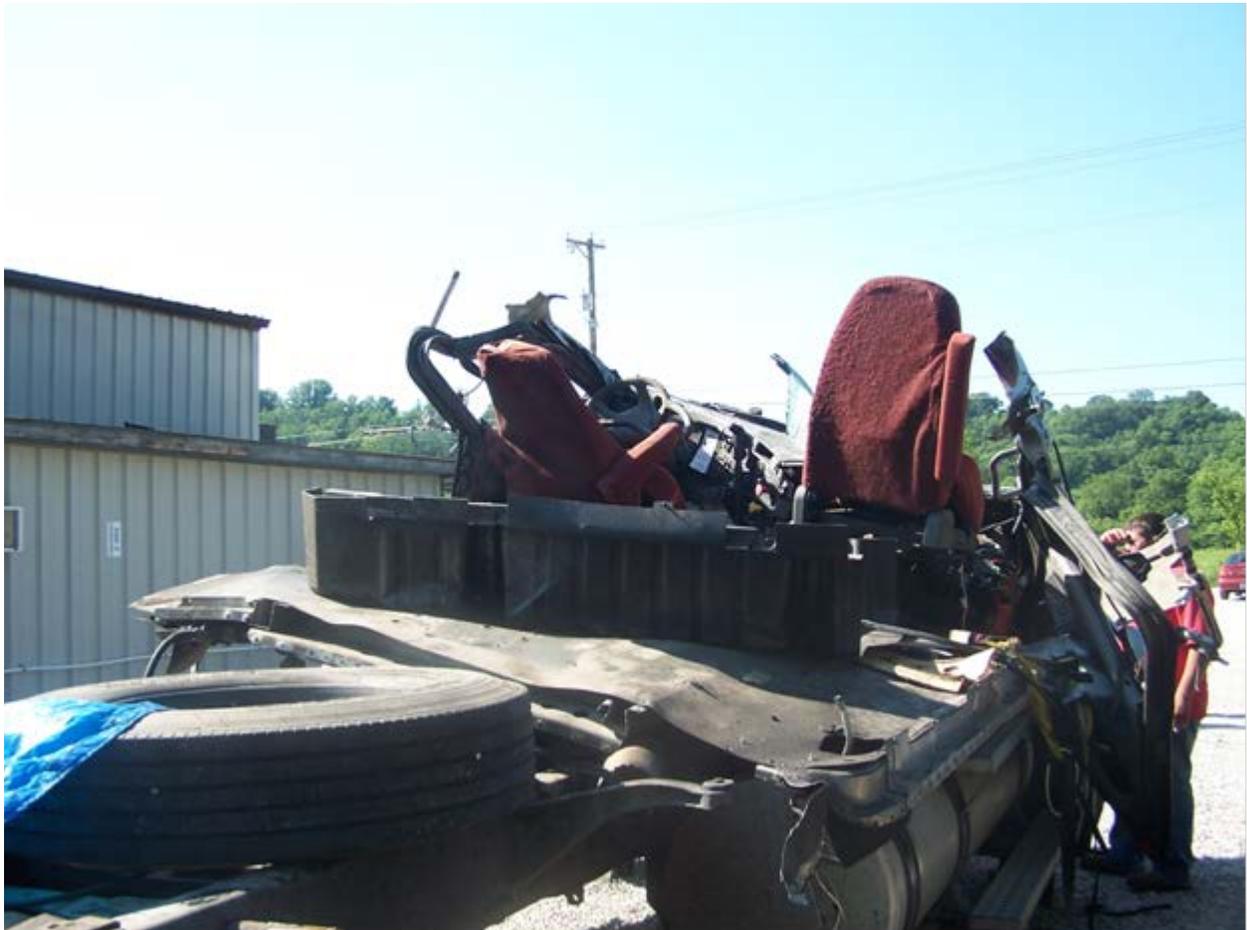
D1 was not utilizing the semi's restraint system and was traveling north on the same state highway. He topped a hill, entered and exited a right-hand curve, applied the brakes, the semi and flatbed rolled onto the driver's side, crossed the center line and proceeded to slide down the hill in the south bound lanes, and the flatbed trailer rotated to the left. D2 drove toward the guardrail trying to avoid D1, sideswiping the guardrail. The back rear of D1's flatbed then struck the guardrail. D2's unit was struck by D1's unit at its fifth-wheel connection. Upon impact, both semis caught fire and D1's semi detached from the flat bed, rolled up-right onto all four tires then traveled back across the northbound lanes into the ditch along the northbound side of the highway. D1 was ejected from the semi across the northbound lanes.

Photograph of semi which struck another semi. Property of KY FACE.

Recommendation No. 1: Transportation companies should educate commercial drivers on proper load securement.

Recommendation No. 3: Electronic stability systems should be mandatory equipment on all commercial vehicles.
