Truck Driver Dies When Tractor-Trailer Leaves The Road And Plunges Into A Creek-Bed

Incident Number: 13KY039

**Kentucky Fatality Assessment and Control Evaluation (FACE) Program
Incident Number: 13KY039
Release Date: November 20, 2013
Subject: Truck Driver Dies When Tractor-Trailer Leaves The Road And
Plunges Into A Creek-Bed**

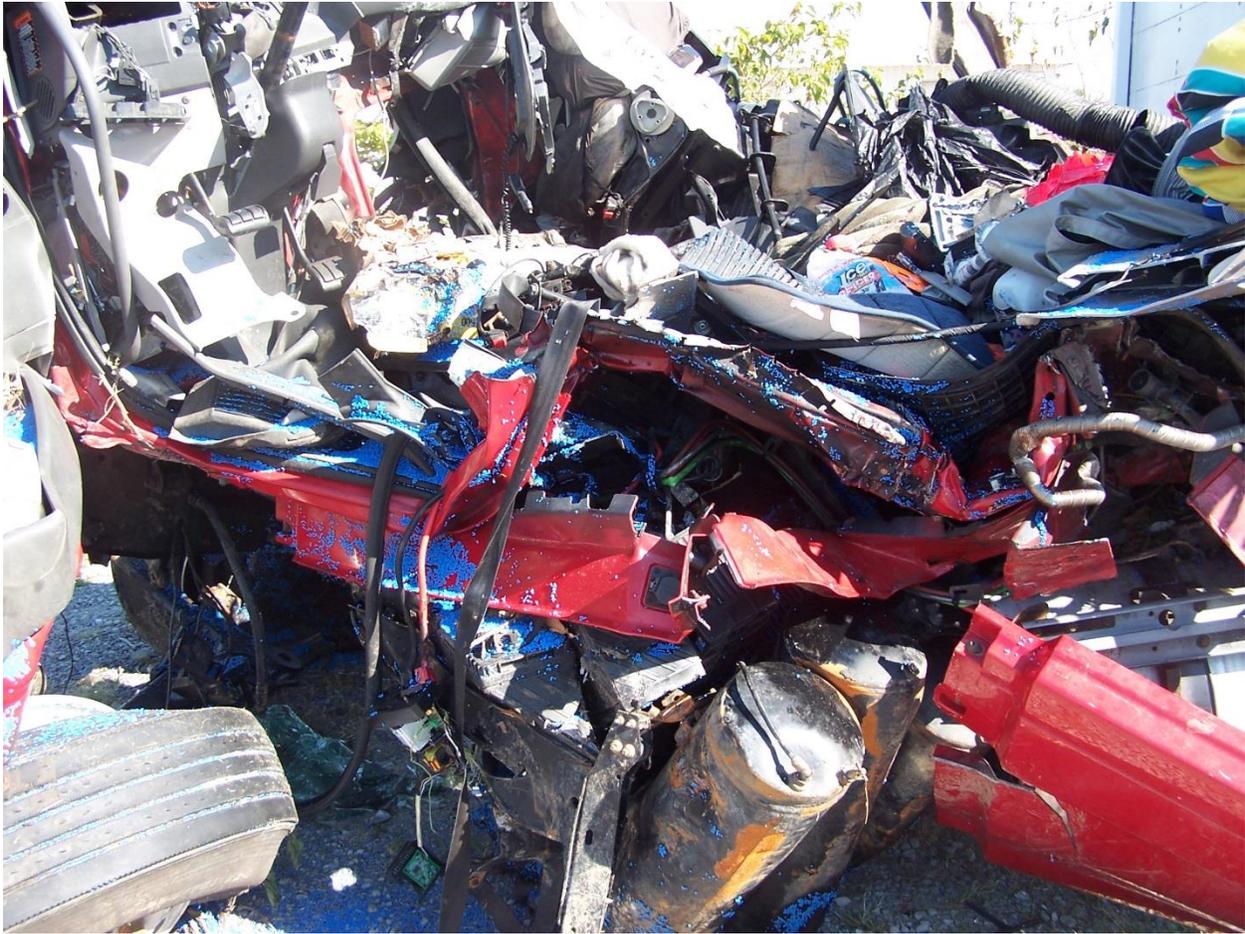
The Tractor involved in the crash. Photograph property of KY FACE program

The tractor trailer exited the roadway on the right side of the interstate, traveled down a culvert and through a wire fence taking down trees before nosediving into a creek. From where the semi-truck left the interstate, it was approximately 1,320 feet to the creek bed. There were no skid marks or brake marks on the pavement prior to leaving the interstate lane. The force of the collision caused the fifth wheel to rip away from the tractor but remained on the trailer as the trailer came up over the cab. The driver became trapped in the semi-tractor. There were no other motorists who witnessed the crash.

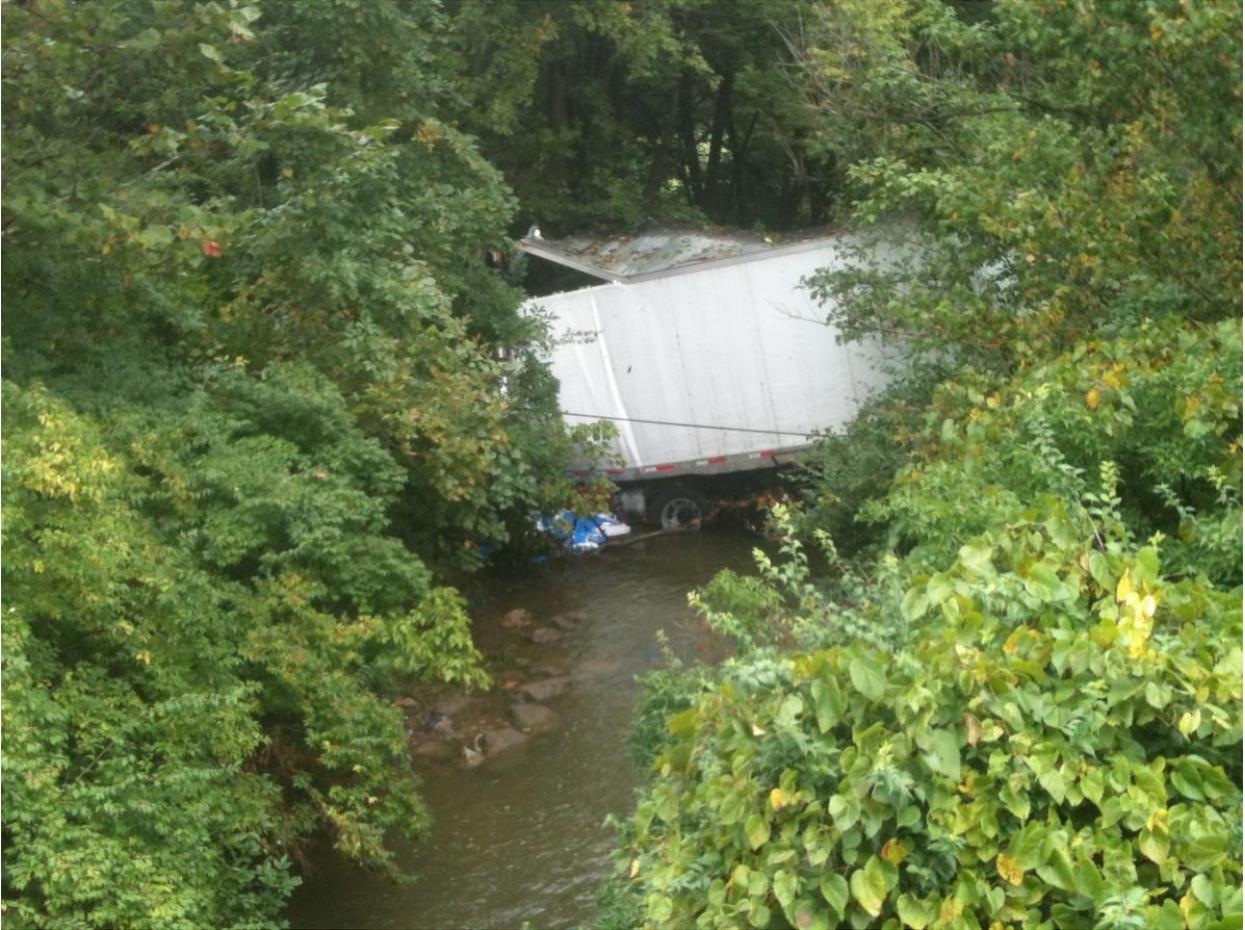
The creek where the truck landed after crashing. Picture courtesy of WLEX 18 News.
