REPORT#: 15MI061

Truck Driver Freeing Frozen Rear Brakes on a Dump Truck was Run Over When the Truck Rolled Forward

Michigan Fatality Assessment and Control Evaluation (FACE) Program

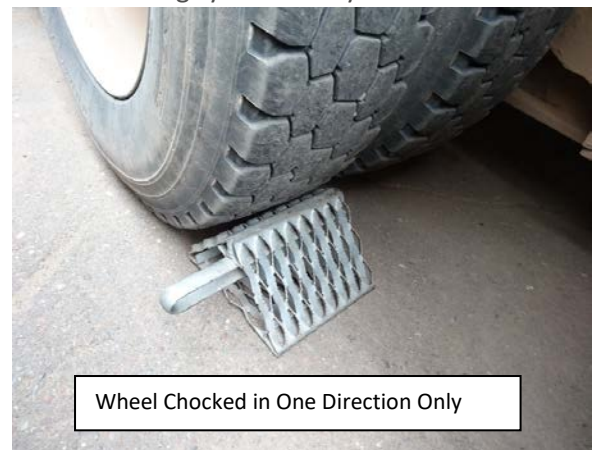
Photo 3. Example of a wheel chock in one direction

Wheel Chocked in One Direction Only

Coworker A and the decedent went back to the dump truck. The decedent instructed the Coworker A to chock the front tire (Photo 3) and push the knob with the yellow diamond in towards the dash to release the parking brake. Coworker A did so. He placed a metal tire chock at the back of the front passenger side tire and accessed the cab through the passenger door to release the brake (Photo 2). The dump truck was positioned on a slight incline, facing the driveway and two-lane road. Coworker A expected the truck to roll back against the chock when the brake was freed. The decedent laid on his back in front of the passenger rear quad tires and started to tap the break drum with the hammer, waiting for it to “pop” (Photo 4). Coworker A, who was not sure of the procedure for “freeing” a brake using this method, stood between the rear quad tires to watch the decedent. After tapping the brake, the decedent asked the driver if there was a “pop”. Not hearing a “pop”, the decedent tapped on the brake drum a few more times.

- RULE 408.17234(1): A vehicle being serviced, adjusted or repaired while the motor is running shall have 2 wheels chocked from front and rear or parking brake set or other vehicle restraint controls provided.

There was only one (1) wheel chocked while employees were performing maintenance on the braking system on the 2006 Mack dump truck in the Department of Public Works Yard. The truck was running at the time without the parking brake set or other vehicle restraint device utilized.

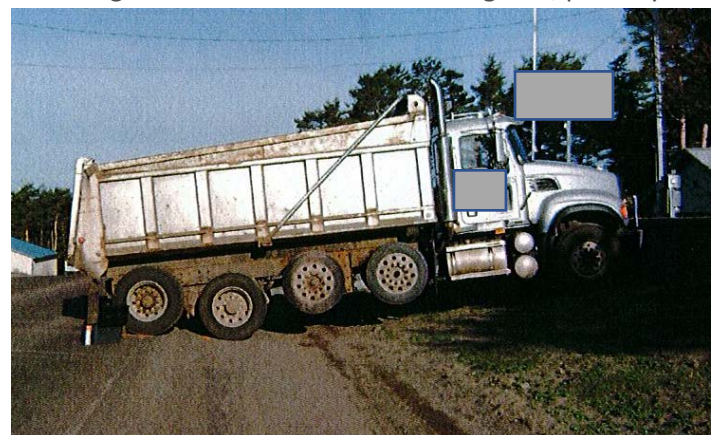
Photo 5. Location of truck when stopped by wall

The brake freed, but because the truck was in gear, it rolled forward. Coworker A stated to the responding police that he felt the dump truck start to move forward a little bit and thought the truck had just sprung loose and was just going to roll a little bit. He then could feel the truck was under its own power and was going forward and that his leg was stuck. The truck rolled forward. Coworker A called for the decedent but didn't get a response. After the truck rolled over his leg and moved away, he saw the decedent. Coworker A yelled for help, but the employees in the breakroom could not hear him. Coworker A called 911 but nobody answered so he called a coworker in the building as he had this individual on speed dial. Both of the rear quad tires ran over the decedent and struck Coworker A's leg as the truck moved forward. This employee ran outside, called for emergency response and then gave the decedent CPR while waiting for emergency response to arrive. The truck continued to move forward (northbound) approximately 175 feet, crossed the two-lane road, and came to rest against a concrete block retaining wall, partially blocking the westbound lane (Photo 5).
