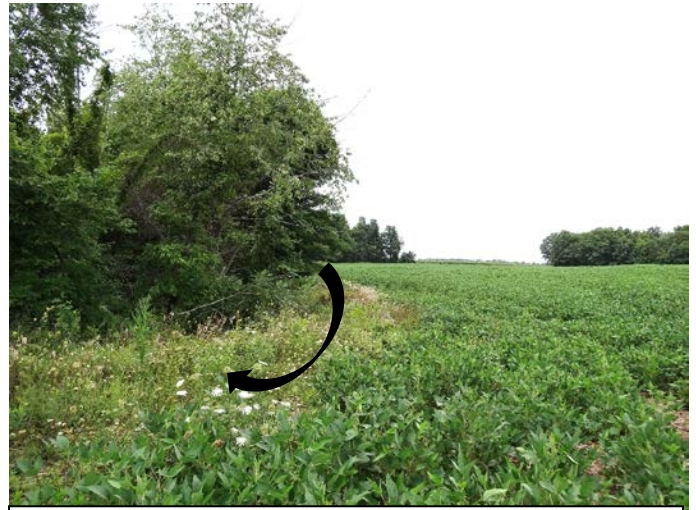
When a ditch/ravine depth is unknown, if possible, make a best effort to have marking posts several feet away from the edge of ditch when equipment movement occurs between the crop field edge and the ditch/ravine edge. It is unknown how well the ditch was defined at the time of the incident. The path, as shown in Photo 4 (taken at the time of the MIFACE site visit) has tall grass and shrubbery at the very edge of the ditch and growing up from the sides of the ditch, making it difficult to determine the ditch edge.

It does not appear that the ditch bank caved in, but the victim was operating the tractor too close to the ditch according to the police report, thus allowing the tractor to enter the ditch.

*Photo 4. Field edge close to ravine edge. Arrow shows direction of travel*

Consideration should be given to field edge clearing and maintenance timing. Factors to consider include but are not limited to:

- Are there hidden hazards at the time of activity?
- Are control practices required when crops are present or can they be completed when the field is fallow, pre-plant or post-harvest?
- Can specific hazards, such as ravine edges, be effectively marked for growing season passage?
