**California Department of Public Health
Occupational Health Branch**

**FATALITY ASSESSMENT AND CONTROL EVALUATION
PROGRAM (CA/FACE)**

**A Custodian Dies When He Falls Off a Step Ladder
Case Report: 16CA006**

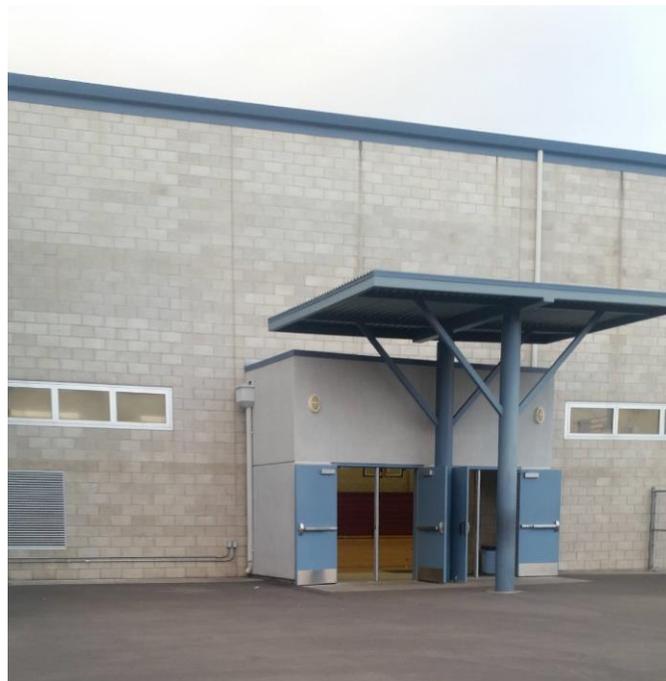
The scene of the incident was the exterior of a gymnasium for a middle school. The ground surface around the perimeter of the building was paved and level. The tops of the windows that were being cleaned in this incident were 15 feet above ground level, and the windows measured approximately 10 feet long by 3 feet high.

EXHIBIT #1. The incident scene.

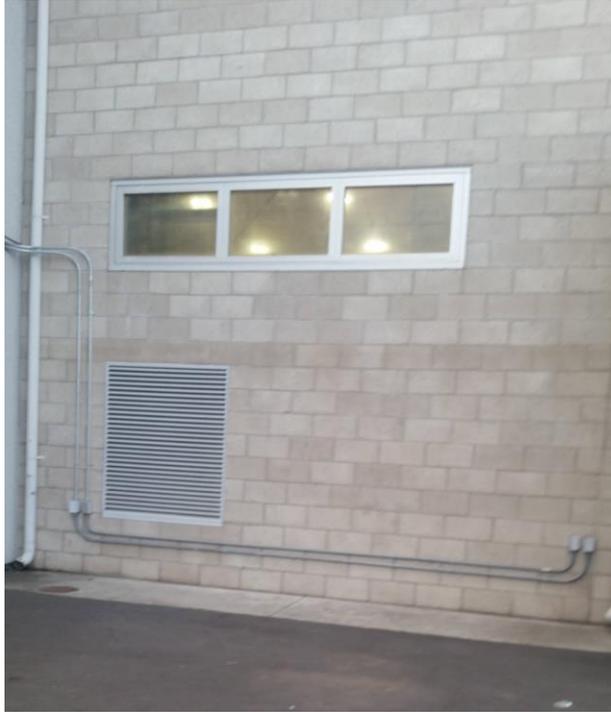
Discussion: In this incident, the victim was washing windows that were elevated at the top 15 feet above the ground. As he was 5 feet 6 inches tall, the 7-foot ladder that he used would have raised his head height to approximately 10½ feet. With a 7-foot ladder, in order to reach the top of the window for cleaning, the victim likely stepped on the top rung of the ladder. This may have required a greater reach to clean the window, thereby leading to instability and the risk of falling. With a fall from this height, the victim was at high risk of a severe head injury. If the

EXHIBIT #2. The window the victim was washing when he fell.

victim had used a 10- or 12-foot ladder, he would have been able to stand on a lower rung and reach the top of the window for cleaning. As an alternative to a taller ladder, there are extension tools that allow standing on the ground or a lower ladder level to clean windows. If the victim had used either a taller ladder or an extension tool, this incident may have been prevented.

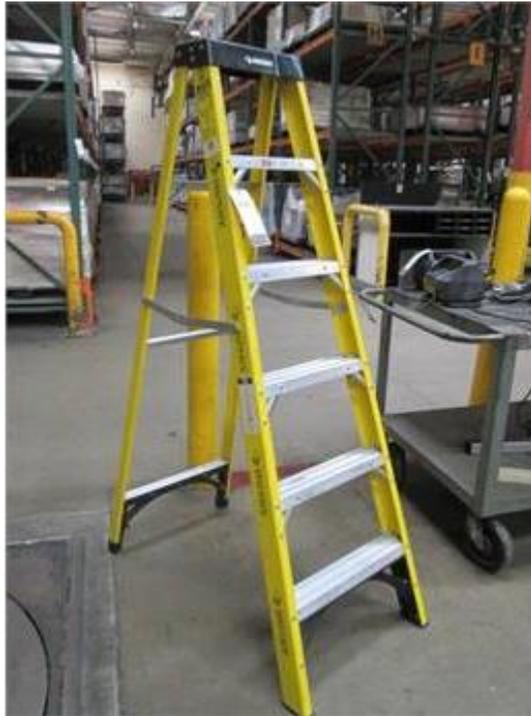
On the day of the incident, the victim, along with two other co-workers, was preparing the school campus for the start of the new school year. After their lunch break, they reviewed the list of custodial tasks and the victim selected to wash and clean the windows in the gymnasium. According to employer representatives, there was a ten-foot ladder available on school grounds. The ladder used by the victim in this incident was a seven-foot step ladder that was in

proper working order and met all safety and OSHA requirements (Exhibit 3). After obtaining this ladder, towel, and a spray bottle with window cleaning liquid from the supply room, the victim went to the outside of the gymnasium while a basketball game was underway.

EXHIBIT #3. A ladder similar to the one involved in the incident.
