**FATALITY ASSESSMENT AND CONTROL EVALUATION
PROGRAM (CA/FACE)**

A 16-year-old tire repair assistant died when a vehicle slipped off a hydraulic jack and fell on him while he was changing the oil

Case Report: 21CA001

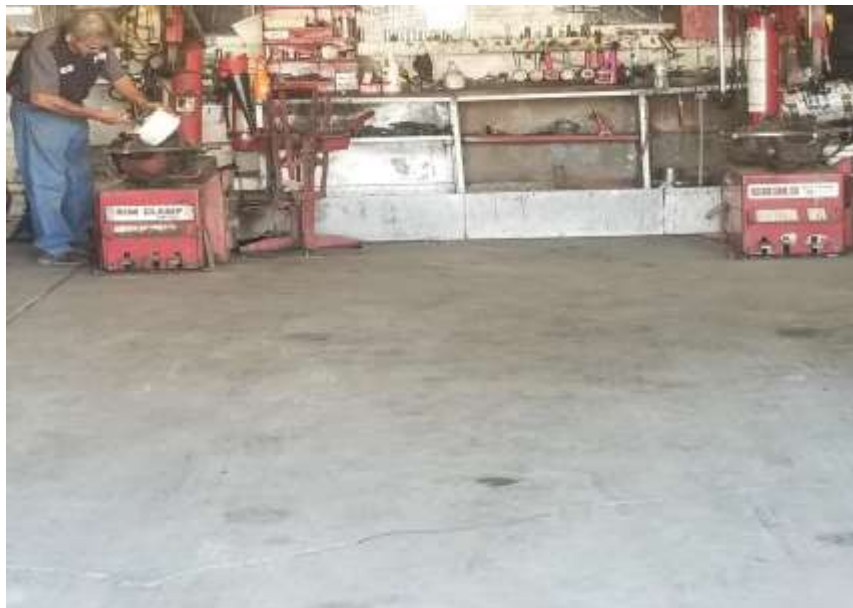
Exhibit #2. The tire shop bay where the incident occurred.

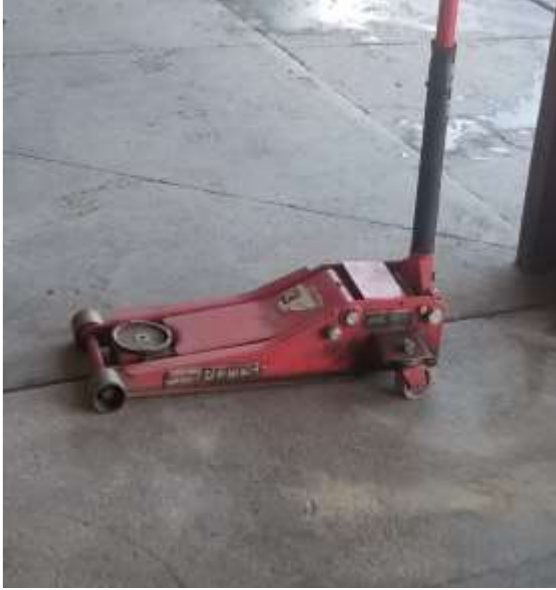
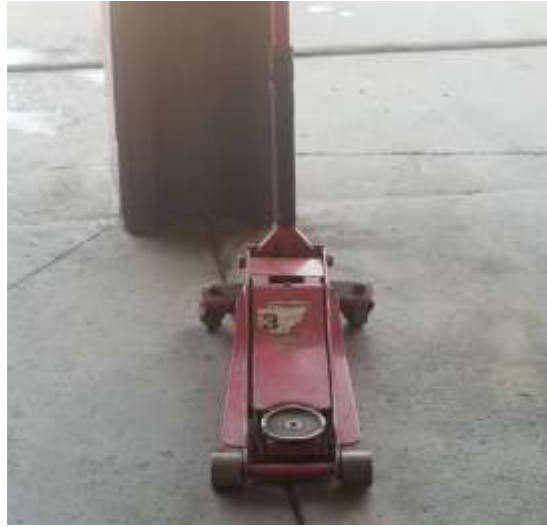
Exhibit #3 & 4. Different views of one of the two hydraulic jacks used in the incident.

At approximately 5:30 p.m. (30 minutes before closing), a customer came in with a flat tire and the two teens agreed to change it. The vehicle was guided into the service bay and a hydraulic jack (Exhibits 3 & 4) was placed underneath the vehicle behind the left front tire. The vehicle was raised up to a height just high enough to remove the flat tire. While the vehicle was being serviced, the customer also requested an oil change. The victim placed a second hydraulic jack behind the right front tire of the vehicle and raised it off the floor. The front of the vehicle was now suspended by two hydraulic jacks. The victim then crawled underneath the vehicle to access the engine’s oil pan drain plug. The owner’s father went to the back of the shop to find a pan to contain the used oil that would be drained from the vehicle. The teen co-worker was standing in front of the raised vehicle and the vehicle owner was standing outside the shop bay. Suddenly, the hydraulic jack on the left side of the vehicle shifted, and the raised vehicle fell on the victim. The teen co-worker, using the same jack, raised the vehicle up and pulled the victim out from under the vehicle by his legs and helped him stand up for a very short time before he

Discussion: The victim was underneath a raised vehicle that was supported by two hydraulic jacks. Hydraulic jacks are lifting devices, not holding devices (such as jack stands). Hydraulic jacks alone should not be used alone when an employee needs to perform work underneath a vehicle. Cal/OSHA regulations state that employees shall not be permitted to enter the zone beneath a jack-supported load unless it has been effectively blocked or cribbed. If cribbing or jack stands had been used to support the vehicle (see Exhibit 5), the fatal collapse would not likely have occurred.

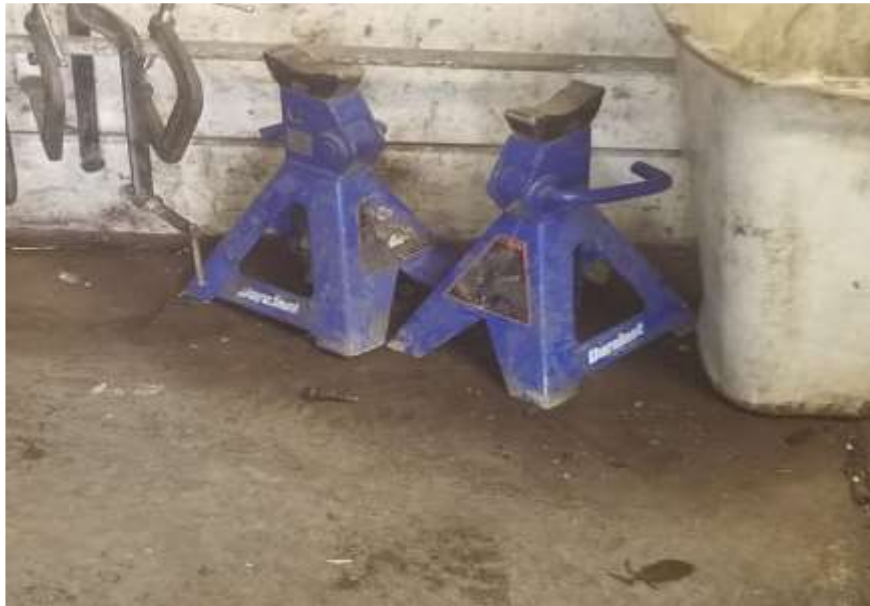
Exhibit #5. The jack stands that were available in the shop but not used on the day of the incident.
