Volunteer Fire Fighter Killed and Career Chief Injured During Residential House Fire - Tennessee

Fatality Assessment and Control Evaluation Investigative Report #F2002-12

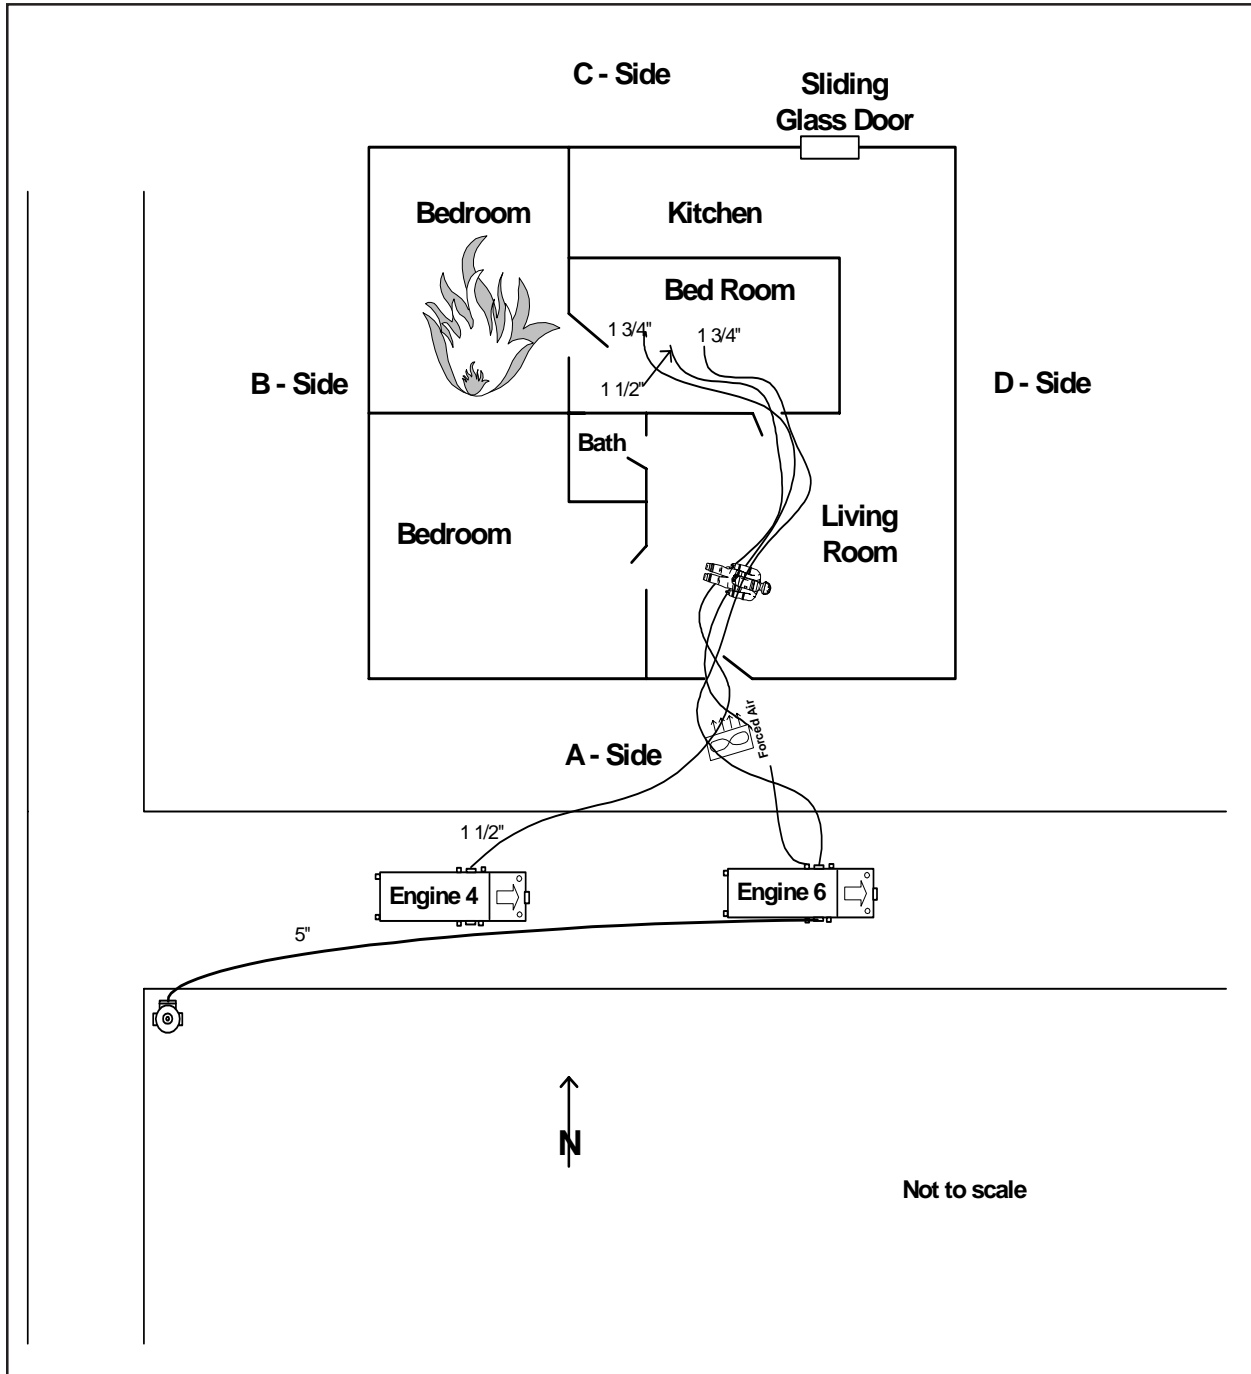
Figure. Residential House Fire - Floor Plan; Overhead View

Structure. The single-story residence was of wood-frame construction and had a partial basement. The roof was constructed of plywood sheeting covered with asphalt shingles, and the exterior walls were of wood covered with vinyl siding. The main floor and the partial basement consisted of approximately 2,064 square feet. The attic, used for storage, was being renovated at the time of the incident. The dwelling had two exterior doors, a door in the front (A-Side) and a sliding glass door in the back (C-Side)(see Figure).

The Chief, a Lieutenant, and the victim reentered the house and continued the interior attack with the 1 3/4-inch preconnect line. Making no progress on the fully involved fire in the bedroom (Figure), the fire fighter from Engine 6 was ordered to bring in the 1 1/2-inch backup line from Engine 4. While the fire fighter used the 1 1/2-inch line, the victim and Chief used the 1 3/4-inch hoseline to fight the fire; however, their efforts had little effect in knocking down the fire. At about 1523 hours, the booster tank on Engine 4 ran dry, and the 1 1/2-inch line lost pressure. Following the Chief's orders, the fire fighter dropped the line and brought a charged 1 3/4-inch line into the interior to continue fire fighting. Several minutes

The structure now fully involved, fire fighters used the deck gun from Engine 6 to try to control the fire. At approximately 1553 hours, fire fighters saw the victim lying on the floor of the front room (Figure) about 5 feet from the front door. After two attempts, fire fighters grabbed the victim by his SCBA straps and dragged him into the front yard. He was not breathing and was unresponsive. He received cardiopulmonary
