A summary of a NIOSH fire fighter fatality investigation

May 25, 2011

Volunteer Assistant Fire Chief Dies at a Silo Fire/Explosion - New York

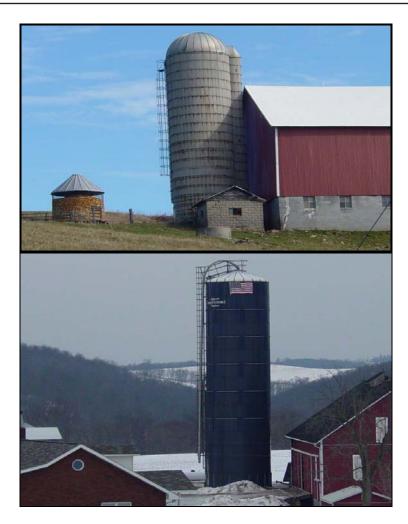
Conventional silo (top) and oxygen-limiting silo (bottom) (NIOSH Photos)

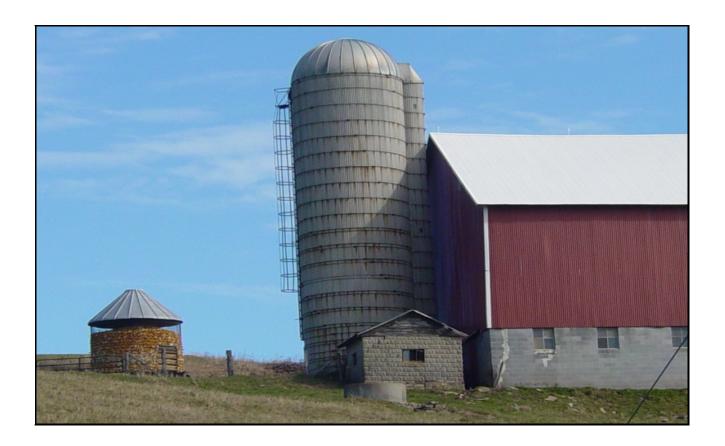
Photo 1. Conventional silo. This type of silo is distinguished by the round-domed top and the enclosed unloading chute seen on the right side of the silo, adjacent to the barn. (NIOSH Photo)

There are two types of upright silos: conventional silos and oxygen-limiting silos or "sealed" silos. Conventional silos are typically used to store corn, hay or other foodstuff for livestock feed. These silos provide for the preservation, storage and disbursement of the feedstock. Conventional silos usually have outside doors stacked up the silo wall. Conventional silos are normally unloaded from the top (see Photo 1).

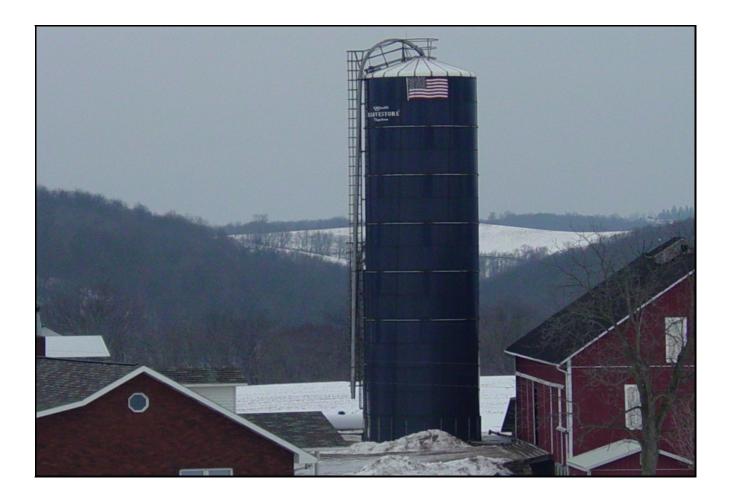
Photo 2. Oxygen limiting silo. This type of silo is distinguished by the flat or the slight-pitch to the roof, the lack of unloading doors along the length of the silo and the lack of a chute. (NIOSH Photo)

silo is filled, the oxygen concentration should be insufficient to support a fire. The silo involved in this incident was the oxygen-limiting type. The silo was approximately 60-feet high and 20-feet in diameter, and was constructed of steel. The silo was filled to one third of its volume with the previous year's high moisture corn crop. The silo had been built over 20 years ago (see Photo 2 for an example of a similar silo).
