A Career Captain Dies and 9 Fire Fighters injured in a Multistory Medical Building Fire—North Carolina

Executive Summary

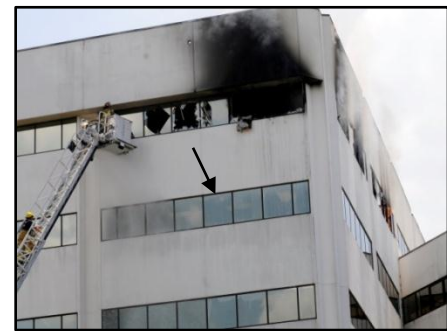
**Area of fire origin – A/B corner
(Courtesy of Fire Department)**

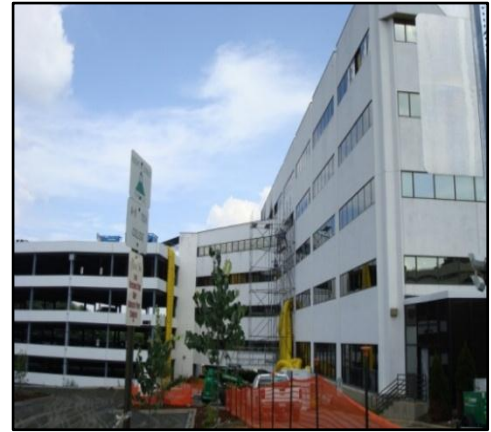
Photo 1. Side A of the fire structure; skywalk and parking garage on the left. (NIOSH photo)

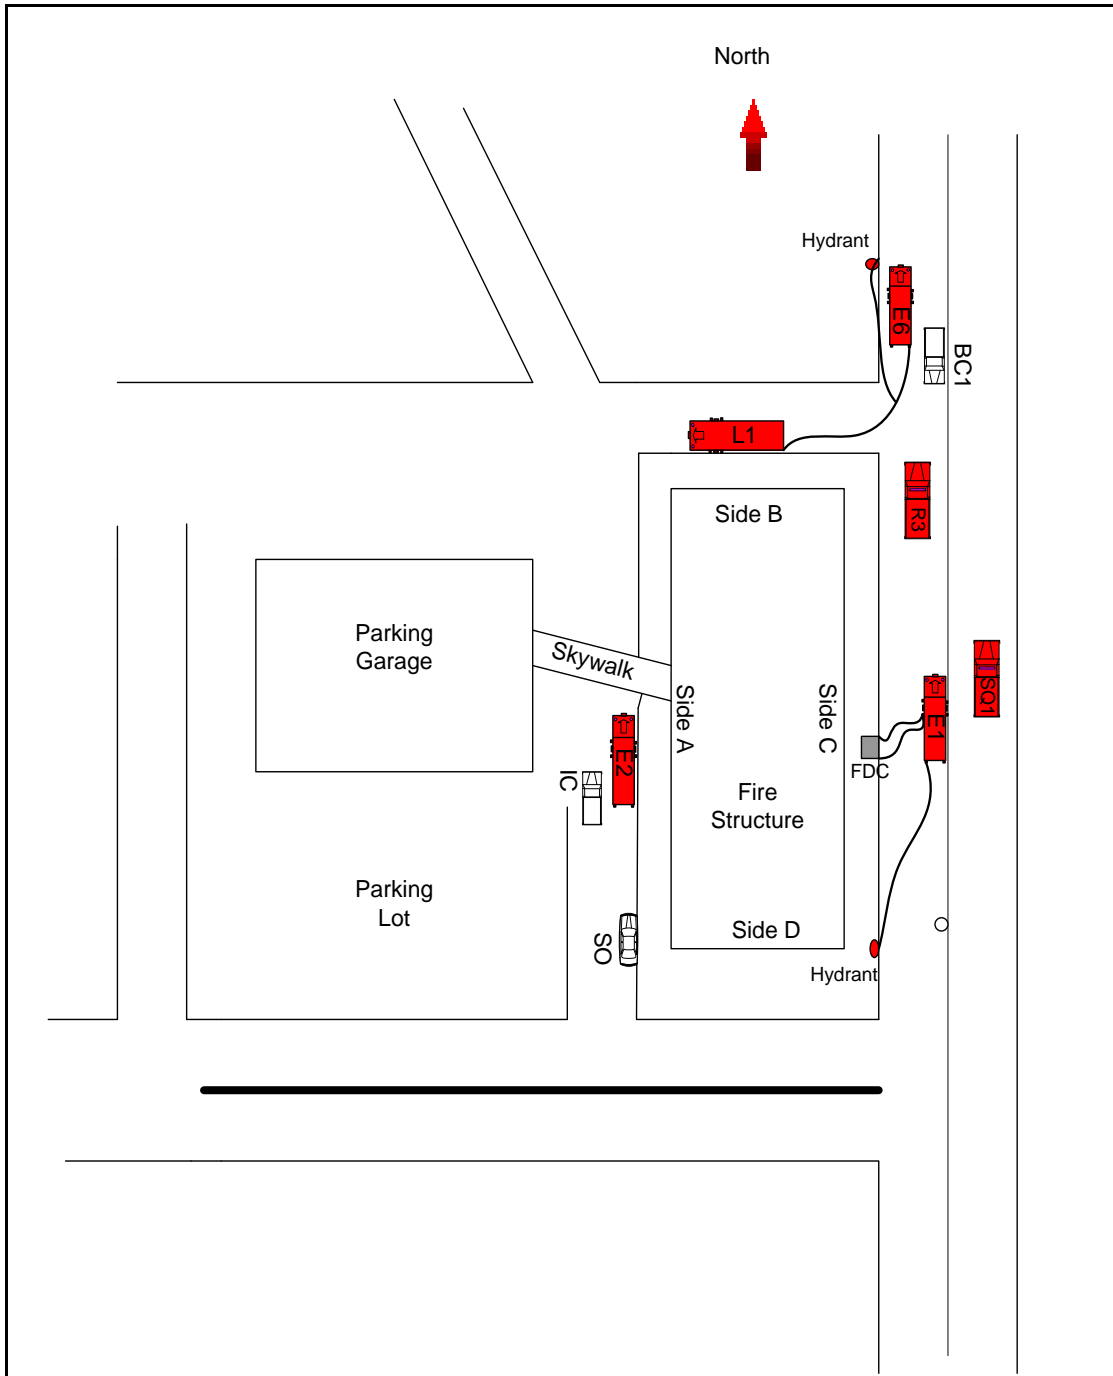
Diagram 1. Placement of 1st alarm apparatus.

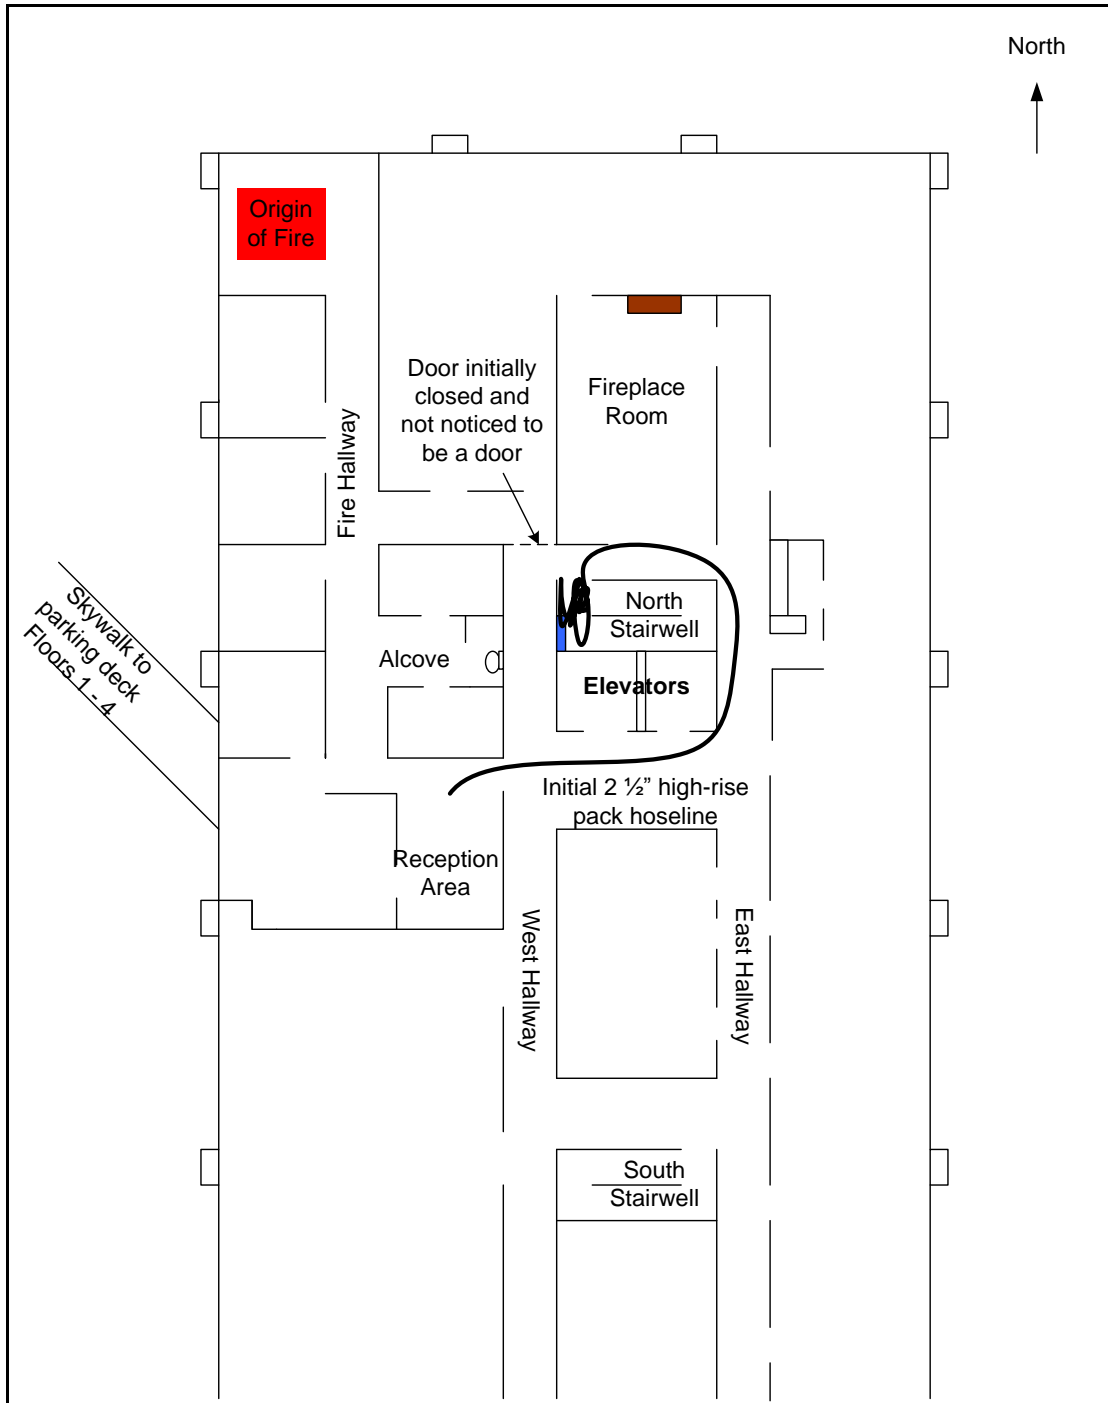
Diagram 2. Placement of initial hoseline at 5th floor standpipe. Hoseline on landing had numerous kinks in it.

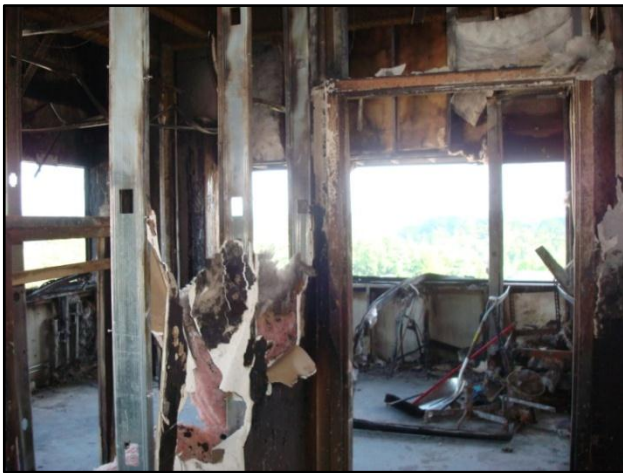
Photo 2. Fire room at A/B corner of structure. View from the end of Side A hallway.
(NIOSH photo)

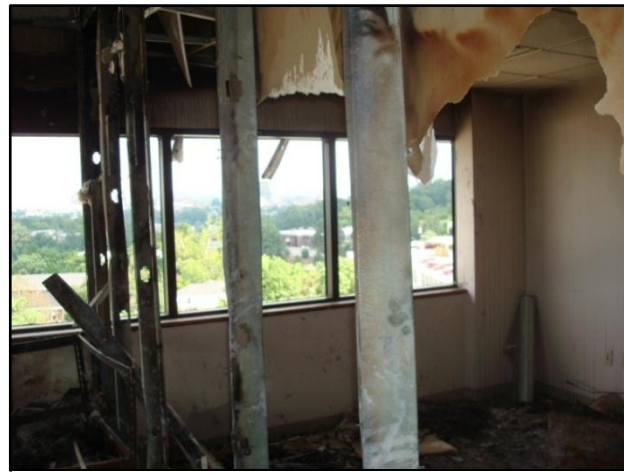
Photo 3. Interior studs of east wall of the fire room that the E1 fire fighter went through to get to the T1 platform at the window.
(NIOSH photo)

At 1311 hours, E6 got water on the fire for the first time. R3 was back on E2's original hoseline but reported to Command that there was no water and the IC ordered them out. E6 requested air bottles be brought to fire floor. At 1316 hours, E8 was on the fire floor, reported heavy smoke and heat and requested that the north stairwell be ventilated. Flames began venting out the side A windows that were broken. BC1 requested a ladder truck be positioned on side A for possible use in getting water on the fire venting from the windows. E6 requested additional hoseline to reach the fire venting on side A. The R3 crew, at the 5th floor north stairwell door, noticed the E8 captain and another fire fighter were untangling high-rise hoseline in the stairwell. One of the fire fighters from R3 was extremely low on air and the victim (R3 Captain) told the R3 engineer to take him down the stairs. The victim proceeded down the hallway instead of exiting down the stairwell. Another R3 fire fighter (with only a few years' experience) and an E1 fire fighter noticed the victim headed down the hallway so they followed after the victim. The victim and two fire fighters ended up in a small alcove with a bathroom at the end of it off the hallway to the fire room. All 3 fire fighters' SCBA low air alarms were going off. The two fire fighters grabbed the victim and headed back into the Side A hallway. The victim was following the R3 fire fighter but the E1 fire fighter got separated from them in the hallway due to the heavy smoke. The E1 fire fighter realized he was extremely low on air and thought about calling a Mayday. He took about ten steps and ran into the E6 fire fighter on the hoseline from T1. Shortly after, the E1 fire fighter followed the E6 hoseline to the window and got on the ladder just as he ran out of air (see Photo 3).

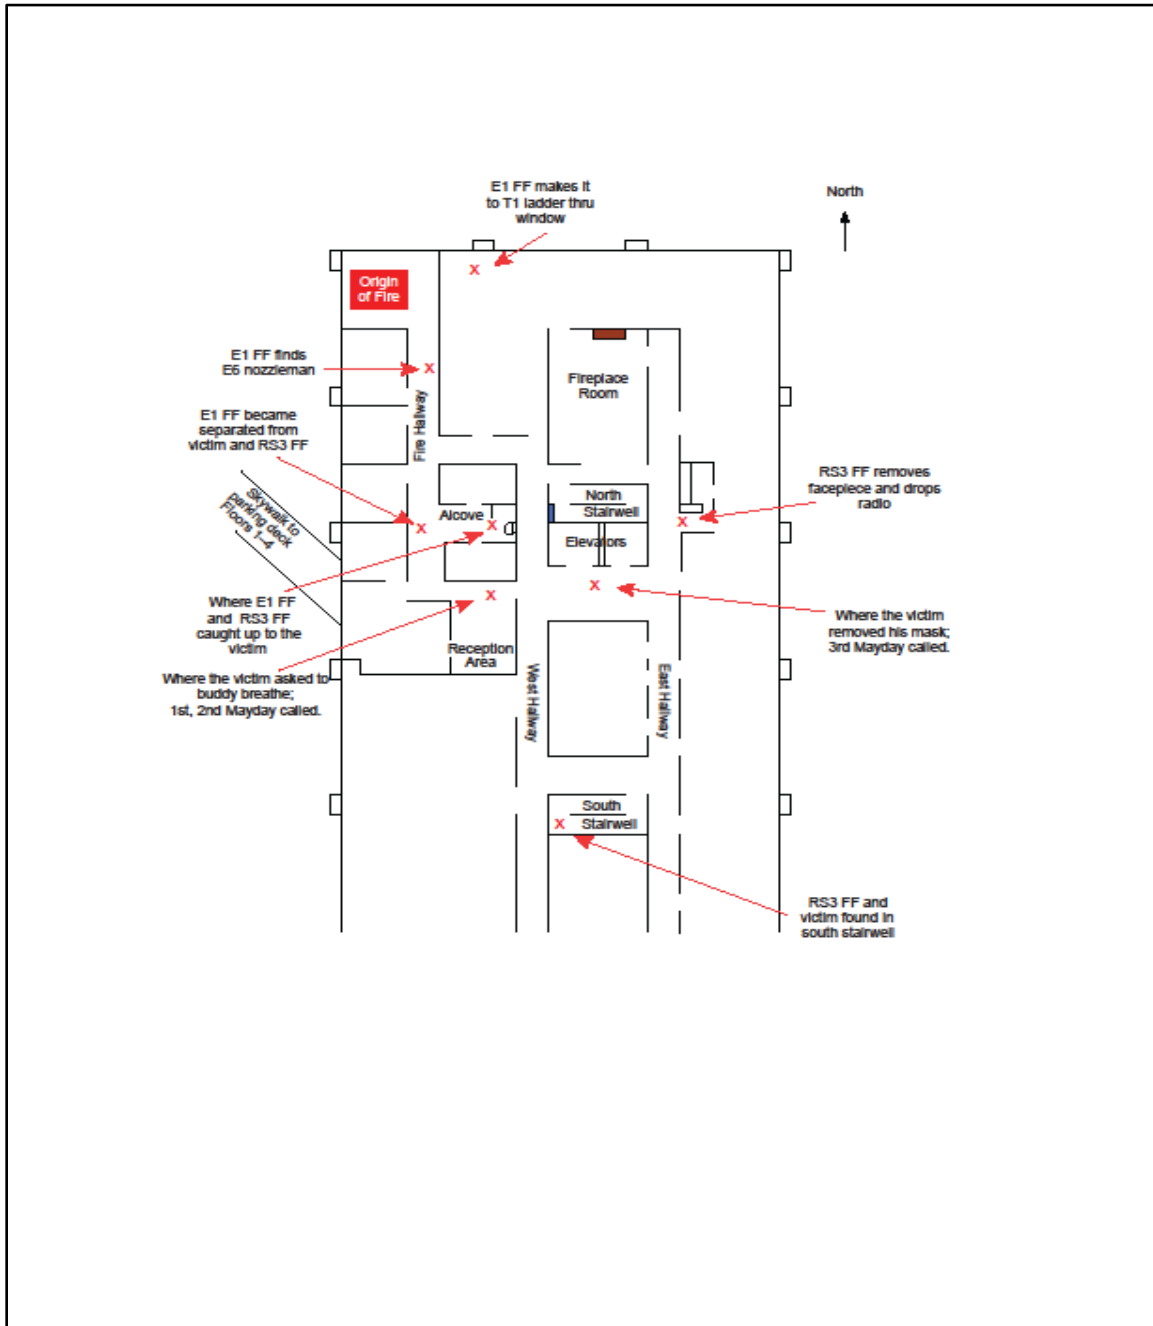
Diagram 3. Critical movement of the E1 fire fighter, RS3 fire fighter, and the victim.

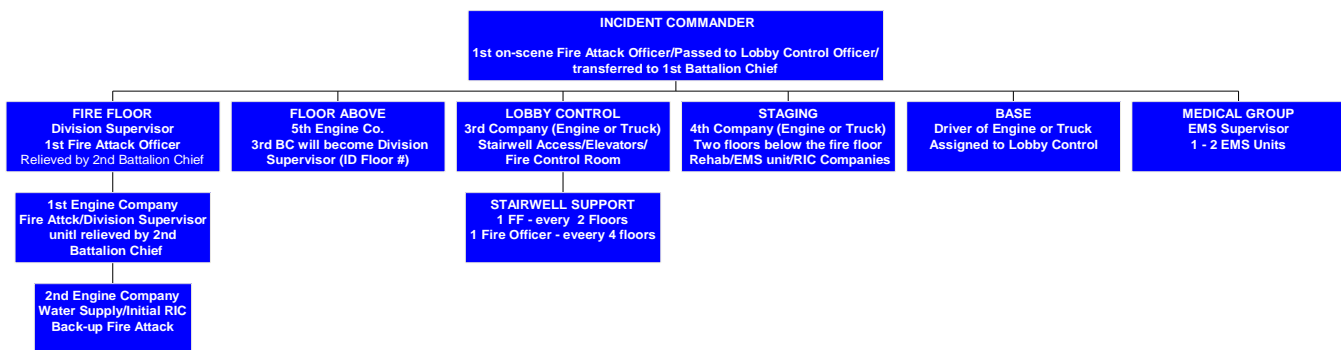
1st Alarm Assignment - High Rise

Below is an example model of a first-alarm response to a reported high-rise fire. The resources deployed are four engine companies, two truck companies, one heavy-rescue company, and one battalion chief. Every fire department having high-rise buildings in their response area should develop a deployment model for a high-rise response. The model can be modified to meet a department’s deployment strategy for a high-rise response.
